Service Bulletin

Bulletin No.: 22-NA-168

Subject: Diagnostic Tip for Checking Exhaust System for Leaks, Malfunction Indicator Lamp (MIL) Illuminated - DTC P2C7A and/or P0421 Set

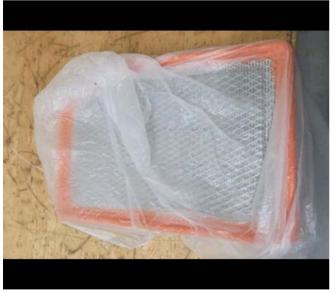
6140930

1. Remove the air filter (3) from the air filter housing. Refer to *Air Cleaner Element Replacement* in SI.

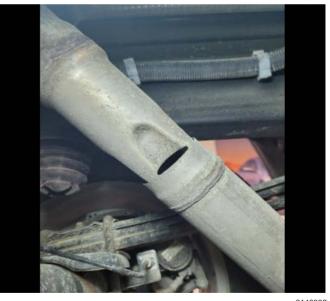
6140932

- 2. Put the air filter in a plastic bag.
- 3. Re-install the air filter into the air filter housing.
- 4. Raise the vehicle.

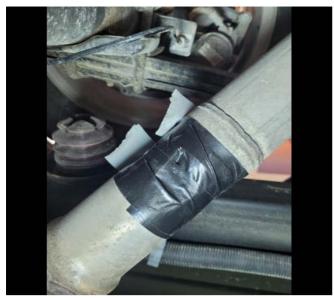
6140943

5. Locate the cooling ports in the exhaust system.

Note: The graphic depicts a single exhaust system. If equipped with a dual exhaust, both cooling holes will need to be taped off and one of the tail pipes sealed with a rag or equivalent.

6. Tape the holes utilizing duct tape or equivalent.

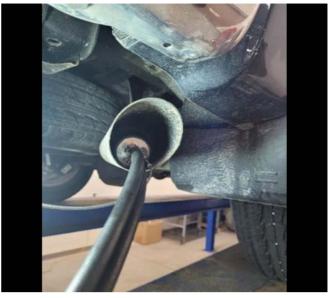
6140928

- 7. Install the inflatable adapter (second largest adapter for our application) for the GE-52250 machine and insert it into the tailpipe.
- 8. Attach the GE-52250 to the adapter and shop air supply.
- 9. Command the vapor test, and adjust the test pressure to 34–55 kPa (5-8 psi).
- Using a soapy water mixture, spray all connections, welds, and sensors with the soapy water mixture, and look for air leaks (See Examples of Exhaust Leak Areas of Concern section below).
- 11. Once all the leaks are detected and corrected, verify that the exhaust is sealed by retesting with the GE-52250.

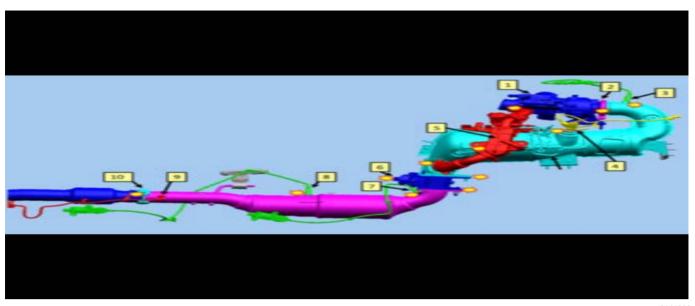
6141008

LM2 After Treatment Exhaust System					
Note: The areas that have been marked on the graphic require inspection for leaks.					
Exhaust Leak Areas of Concern					
1	Turbocharger				
2	V-Band Clamp				
3	NOx Sensor				
4	Def Injector				
5	LP EGR Cooler				
6	EXH. Throttle/Back Pressure Valve				
7	NOx 2 Sensor				
8	NOx 3 Sensor				
9	Particulate Matter Sensor				
10	Norma Band Clamp
