Service Bulletin

Bulletin No.: 22-NA-176

Subject: 8L45 8L90 No Movement After Valve Body Replacement

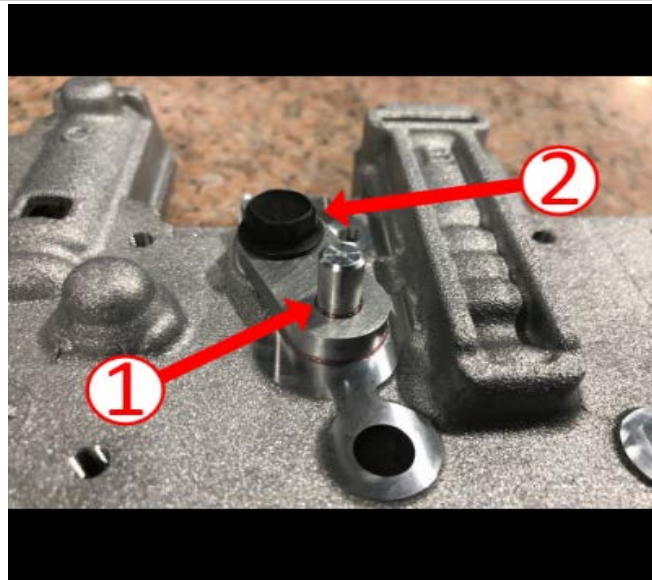
6144951

Involved Region or Country	North America
Condition	Some technicians may comment on no movement after the valve body replacement.
Cause	This may be caused by a plug and retaining bolt missing on valve body.

Inspect for the plug (1) and retaining bolt (2) as noted in the graphic above.

If the plug and retaining bolt are missing, fill out the WPC part request form and send it to the WPC following the instructions below.

- ⇒ The plug and retaining bolt are packaged as a kit.
- ⇒ The kit part number is WPC 853 and can be obtained from the Warranty Parts Center (WPC) using the TSP Dealer Request Form
