Service Bulletin

Bulletin No.: 19-NA-237

Subject: Diagnostic Tip - Diesel Exhaust Fluid System Contamination

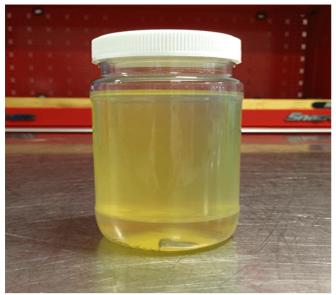
4373642

Diesel Exhaust Fluid (DEF) mixed with Diesel Fuel.

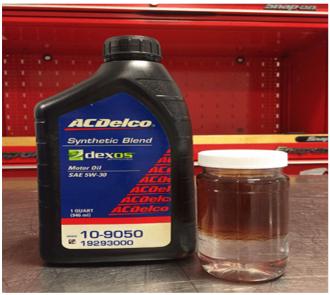
4373644

Diesel Exhaust Fluid (DEF) mixed with Engine Oil.

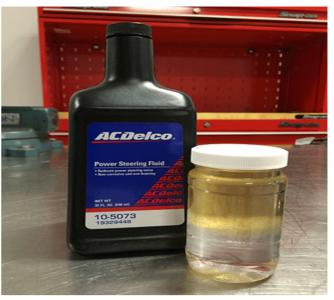
4373645

Diesel Exhaust Fluid (DEF) mixed with Power Steering Fluid.

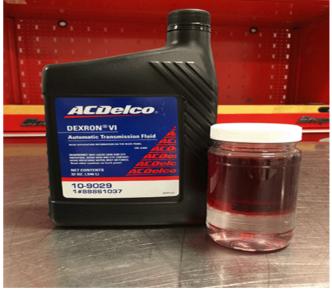
4373646

Diesel Exhaust Fluid (DEF) mixed with Transmission Fluid.

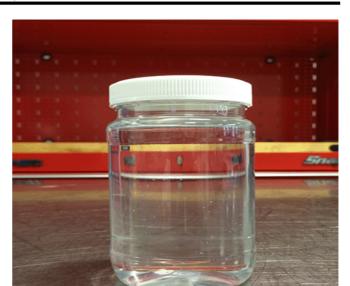
4373647

Diesel Exhaust Fluid (DEF) mixed with Windshield Washer Fluid.
