TECHNICAL SERVICE BULLETIN

2.7L/3.0L EcoBoost - Oil Pan Leaking

22-2181

17 October
2022

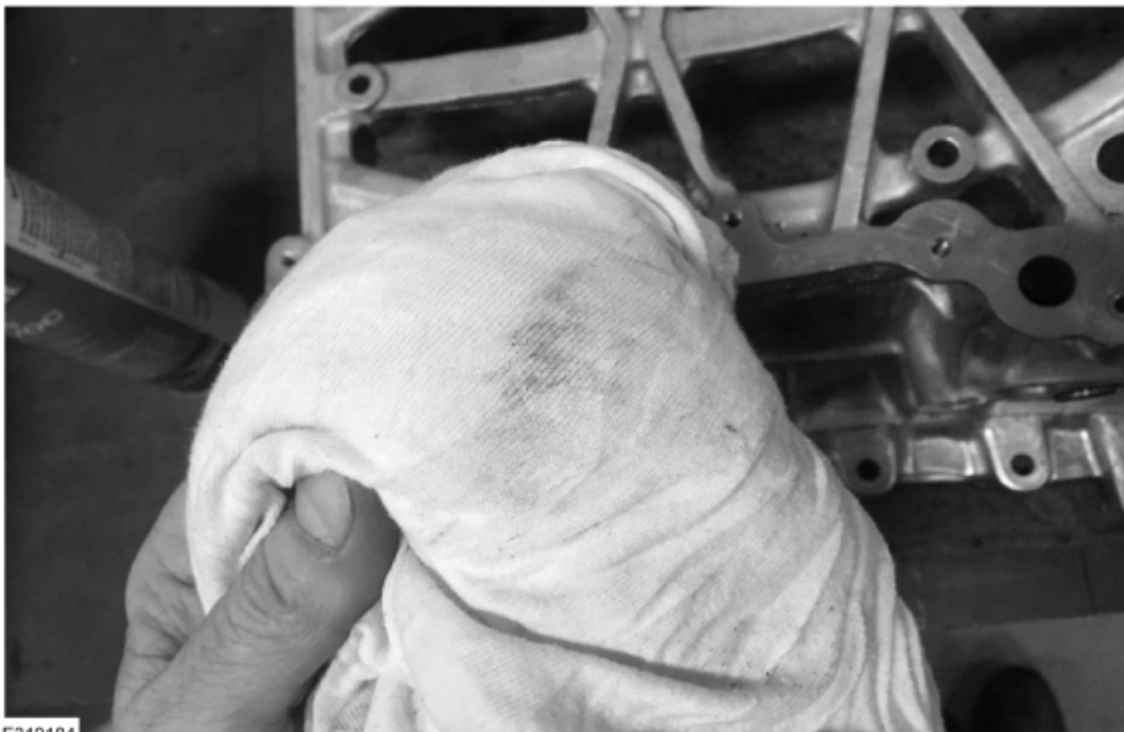
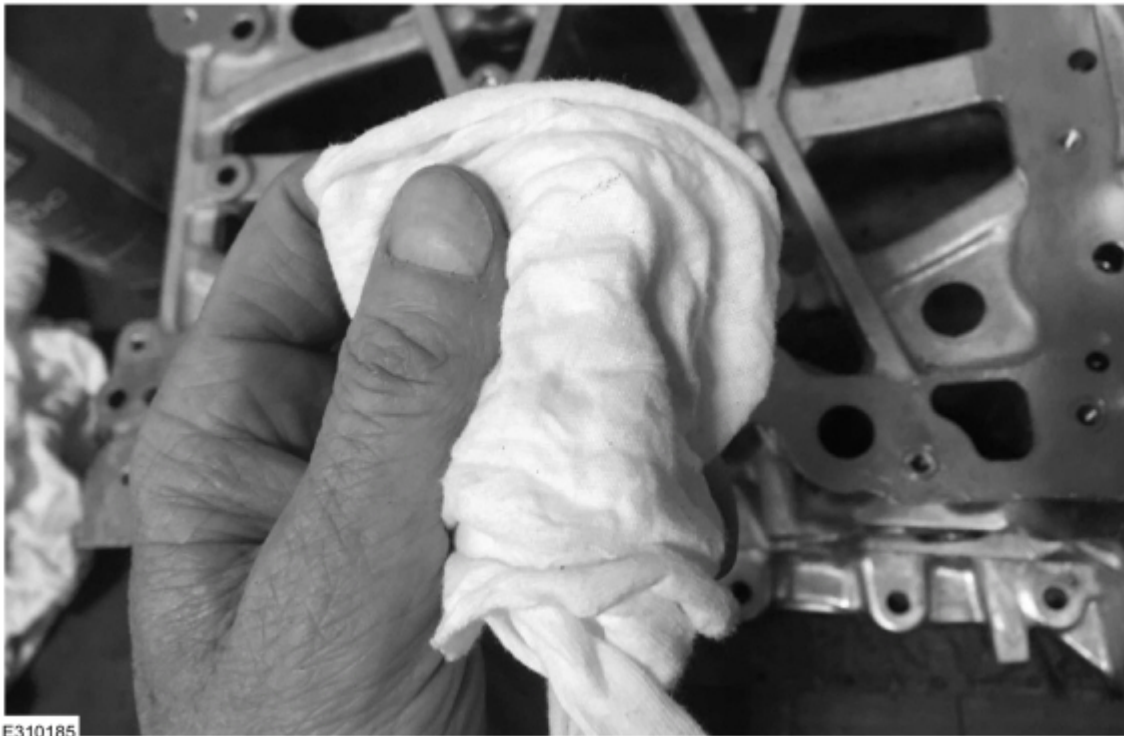
Figure 1

3. Use a lint free towel and Motorcraft® Metal Brake Parts Cleaner to remove all residual sealant and oil from the engine sealing surface until a clean lint free towel no longer shows any residual oil when wiping the surface. (Figures 1-2)

(1). Use only Motorcraft® Metal Brake Parts Cleaner to clean the engine sealing surface. Some unapproved brake parts cleaners contain chemicals that inhibit RTV adhesion or may evaporate without removing all of the residual oil from the sealing surface resulting in a repeat leak condition.

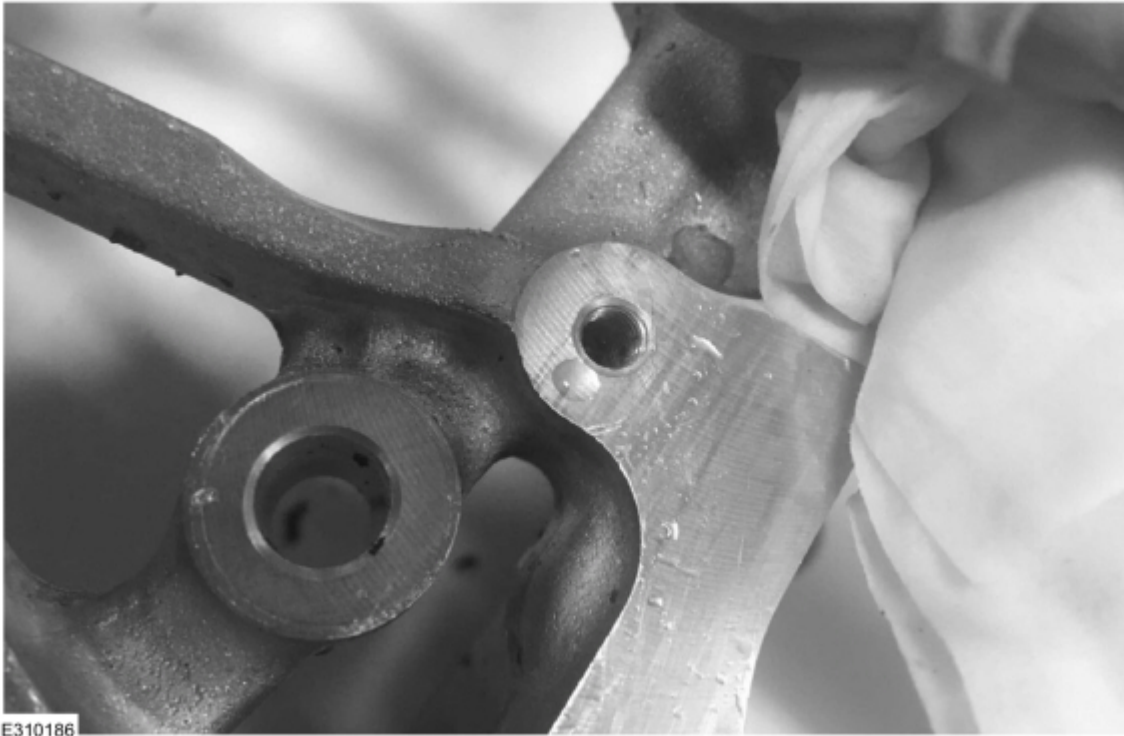
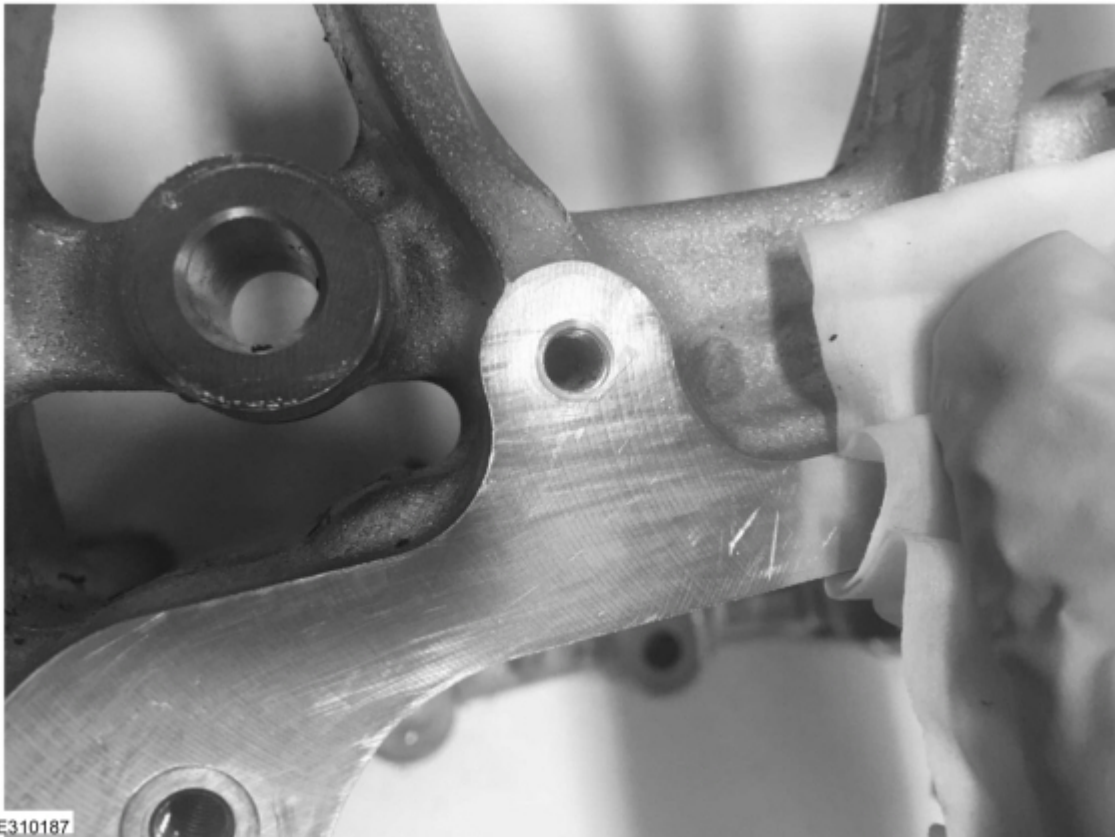
Figure 3

5. Wipe the metal engine block skirt stiffener sealing surface using Motorcraft® Metal Surface Prep Wipes. Thoroughly coat the surface with the fluid. Discard the wipes after a single use.

(1). Motorcraft® Metal Surface Prep Wipes create a conversion coating providing an improved base for RTV sealing. The wipes use a water-based, slightly acidic solution that etches and bonds to the metal providing a microscopic layer for the RTV to adhere to. If the surface is oily, the solution beads and the surface is not properly treated. If the solution beads when applied to the sealing surface, clean the surface again and reapply the Motorcraft® Metal Surface Prep Wipes. (Figures 3-4)

NOTE: If the sealing surface or an area of the sealing surface becomes contaminated after it has been prepared, use a lint-free towel soaked in isopropyl alcohol to clean the area. Prepare the area again using Motorcraft® Metal Surface Prep Wipes.

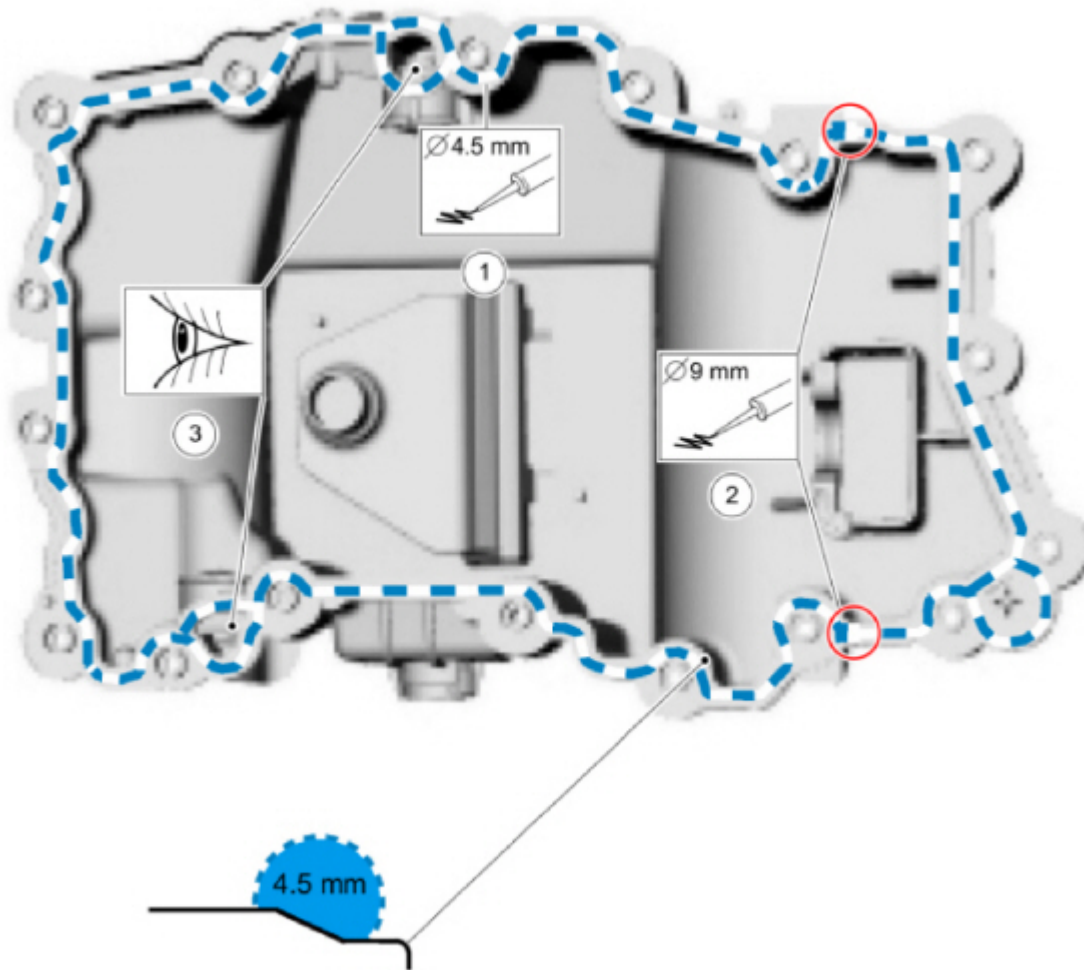
Figure 5

8. Apply a 4.5 mm (0.18 in) bead of Motorcraft® High Performance Engine RTV Silicone to the new oil pan. The RTV bead must be applied to straddle the step chamfer and sealing face. (Figures 5-6)

(1). Using too little sealant may result in oil leaks and using too much sealant may result in oil contamination and engine damage.

- 9.** Apply a 9 mm (0.35 in) bead of Motorcraft® High Performance Engine RTV Silicone to the engine front cover-to-cylinder block joint areas on the new oil pan as shown in Figure 5.
- 10.** Install the new oil pan. Refer to the WSM, Section 303-01.
