SERVICE BULLETIN

APPLICABILITY: 2013MY Outback Models

NUMBER: 12-149-13

SUBJECT: Improper PZEV Badging On Rear Gate

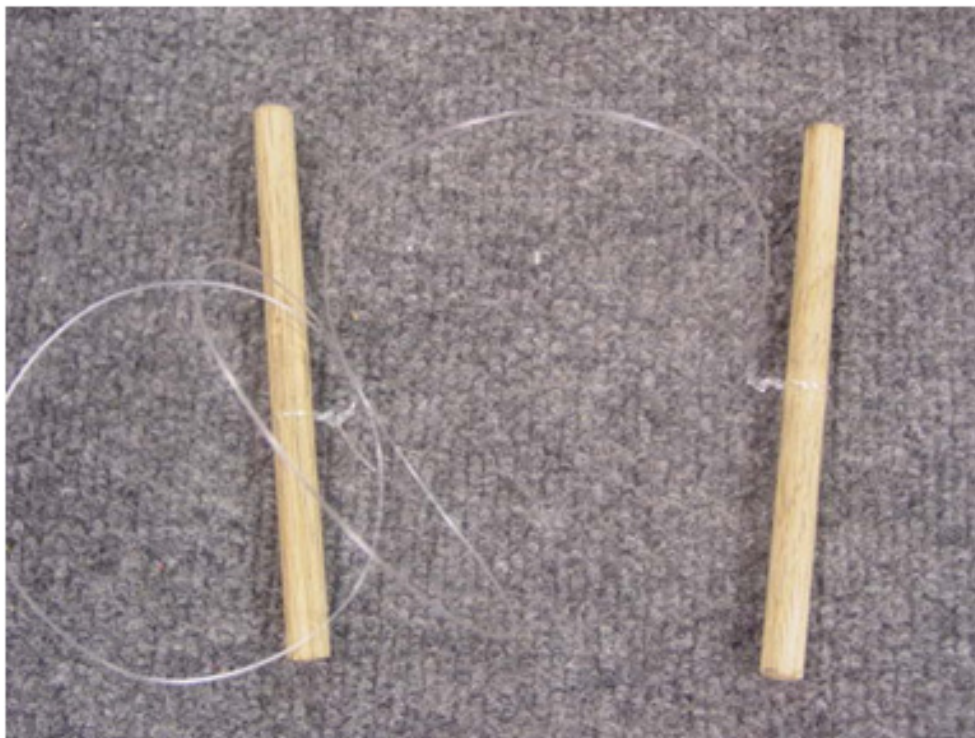
- Approximately 4 feet of 20 pound test monofilament fishing line tied to....
- 2 pieces of wooden dowel approximately 6” in length (or equivalent)

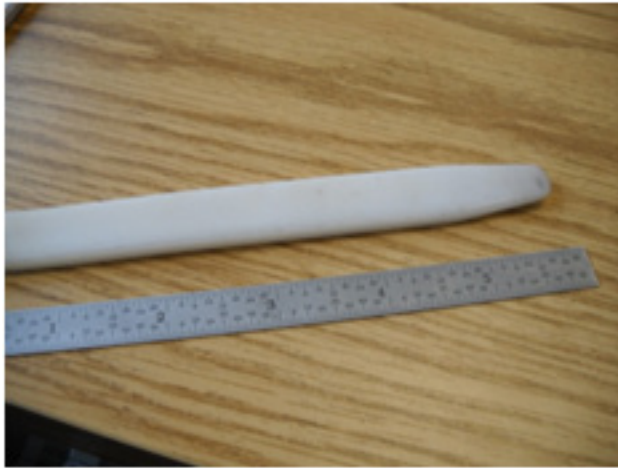
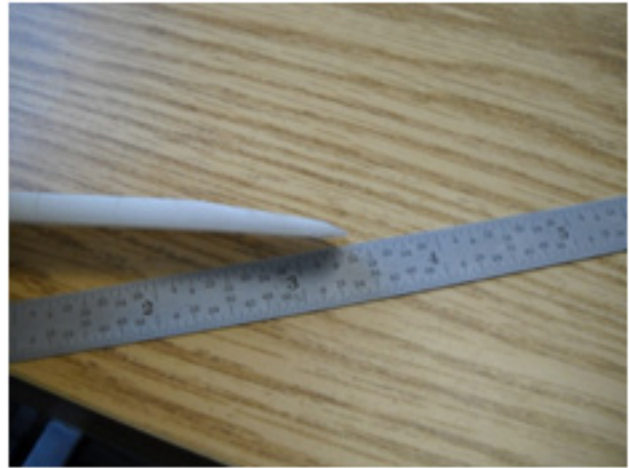
- **OR** a plastic trim tool with one end filed down to a thin edge

Method 2: A plastic trim tool with a very thin leading edge can also be used. Care must be taken to not dent or scratch the rear gate surface when removing the badging.

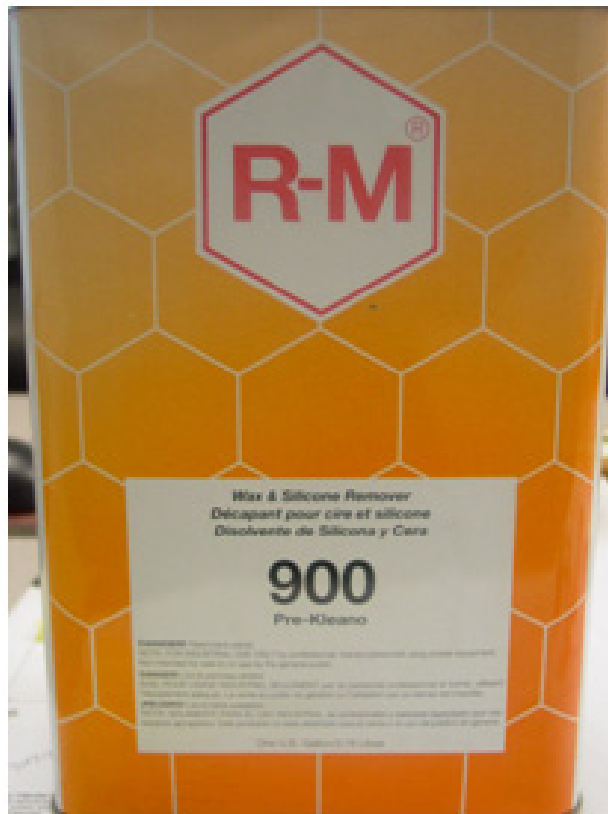
- R-M #900 Pre-Kleano prep-solvent (or a vehicle finish-safe equivalent)

Once the badging is removed, use a small amount of the RM 900 Pre-Kleano solvent or equivalent on a clean shop cloth to remove any residual adhesive. Use caution to not rub the finish excessively or use excessive pressure which may scratch the painted surface of the vehicle.

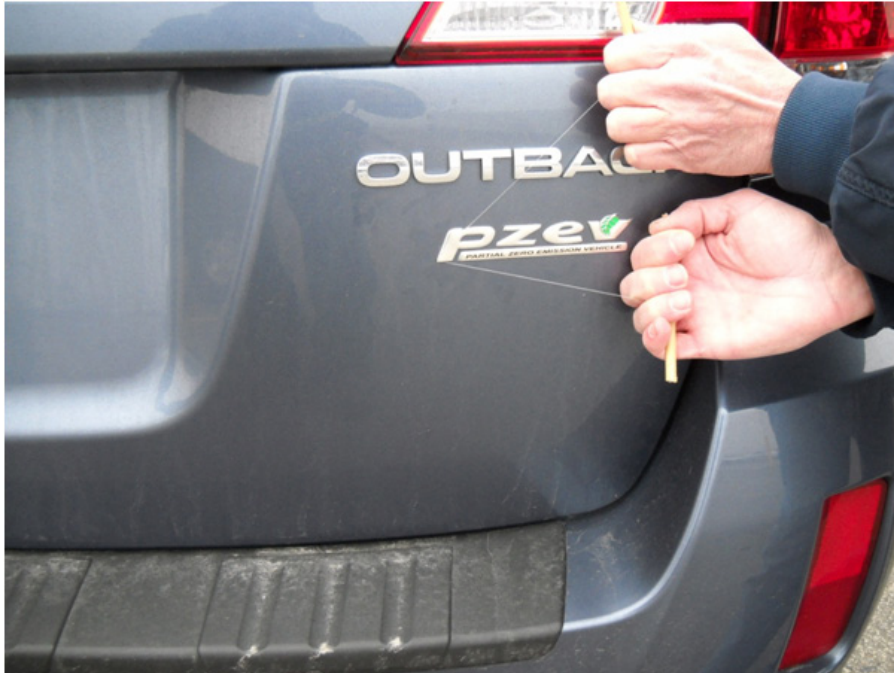
NOTE: The “P” “Z” “E” “V” and the “PARTIAL ZERO EMISSION VEHICLE” badging all require removal.

Method 1: Start the fishing line under one corner of the badge to be removed. Use care not to get the line caught under the car model letters above the PZEV badge. **TAKE YOUR TIME** and be careful to not scratch the painted surface of the vehicle throughout this process.

Once the line is under the badge, grasp the dowels and pull firmly at a slight angle AWAY from the vehicle. This will separate the badge from the adhesive.

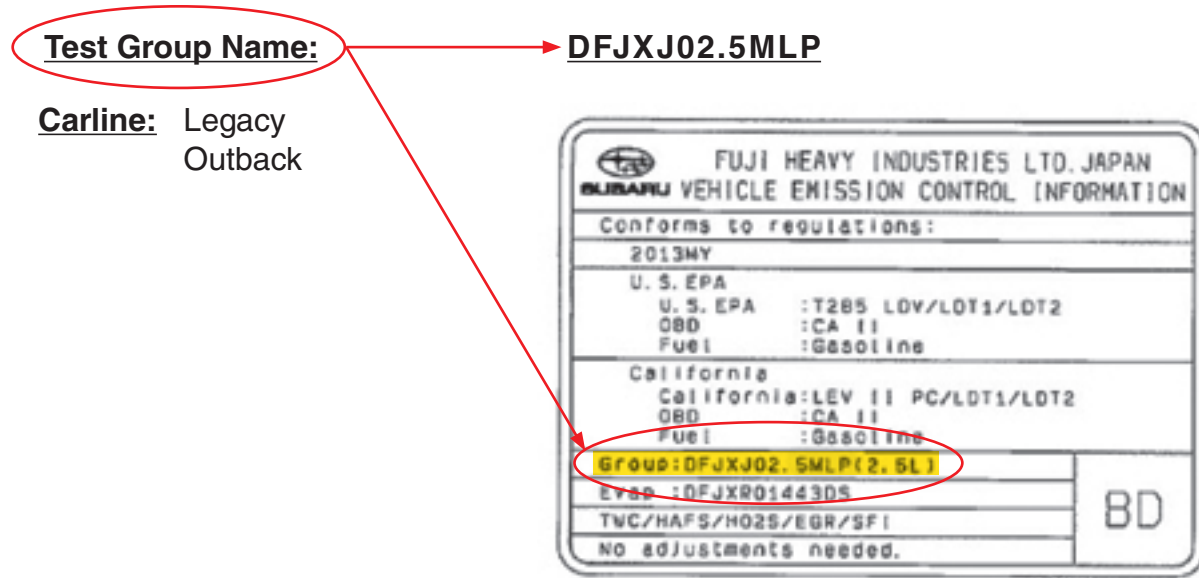
NOTE: For reference and verification on vehicles which need the PZEV badging removed, the under-hood labeling should look like this:
