**SERVICE BULLETIN**

**APPLICABILITY:** 2019-23MY Forester

**NUMBER:** 07-218-23R

**SUBJECT:** Genuine Alternative Battery Replacement

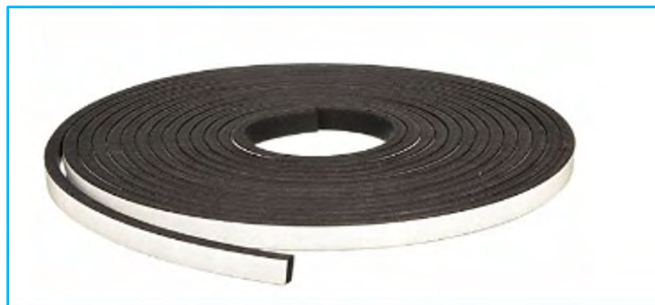
**EPDM Neoprene SBR Strip**  
 2 in x 50 ft, 1/16 Thick, Black, Closed Cell, Smooth  
 Item # 6YHD7  
 Available from Grainger®

Used for battery tray modification

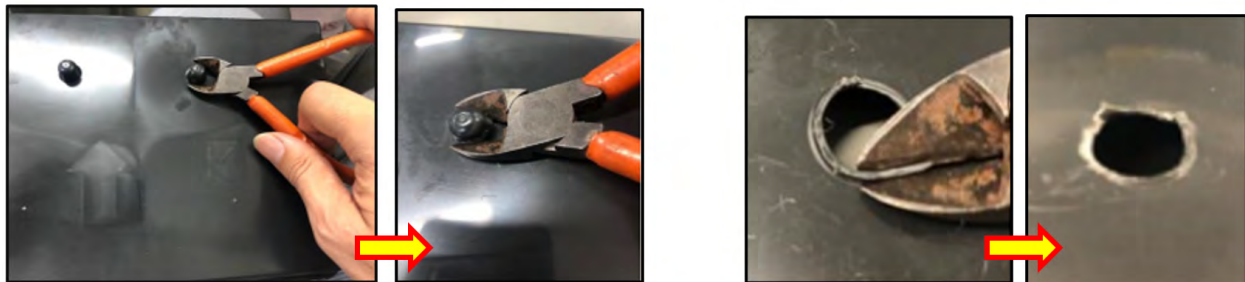
- A. CAREFULLY** cut off and trim the two protrusions on the bottom of the battery tray. This will allow a more streamlined fit when installed on the vehicle. Try to make the cut as flush as possible.

**CAUTION:** Be sure the protrusions are trimmed flush. The remaining protrusion height **MUST** be less than 2mm to provide proper fitment.

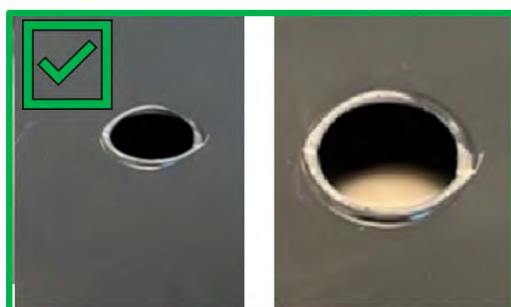
Remaining Height Is Less Than 2mm

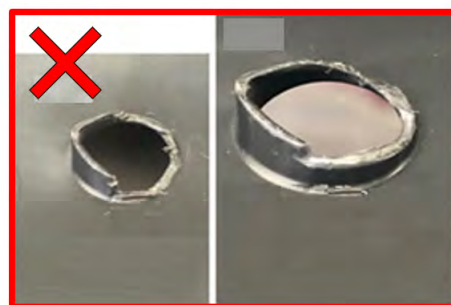
Remaining Height Is More Than 2mm

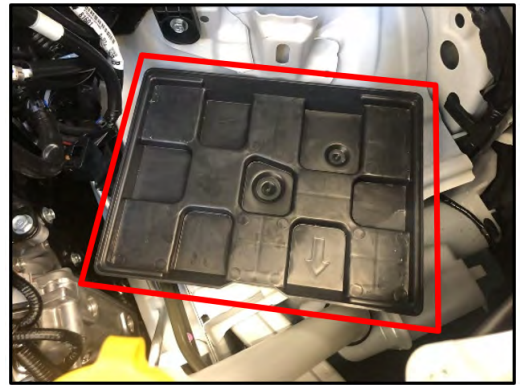
- B.** Remove the original battery tray. **DO NOT** discard, this must be returned to the customer.

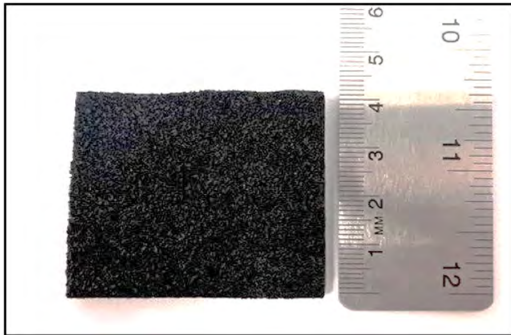
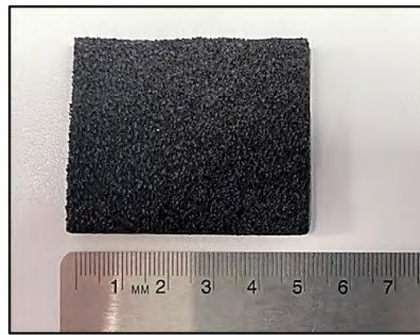
- C.** Prepare two pieces of EPDM neoprene sponge strip. Cut the sections approximately 40 mm tall and 50 mm wide. EPDM Neoprene SBR Strip (item # 6YHD7) supplied by Grainger® was used in the example photos below.

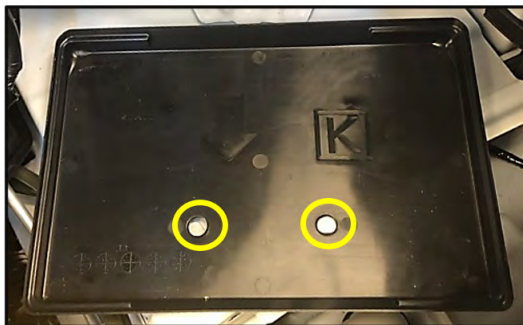
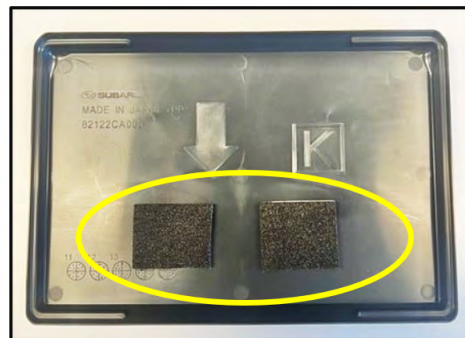
- D.** Cover the newly made holes with the two previously prepared EPDM neoprene sponge strip pieces.

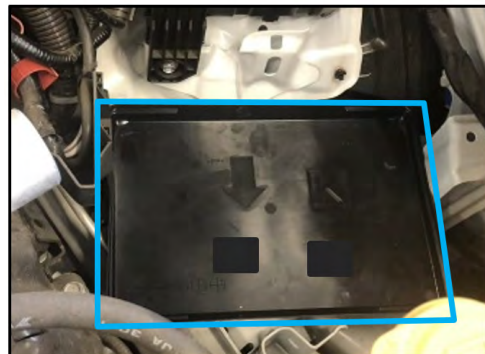
- E.** Securely fit the replacement battery tray to the vehicle.

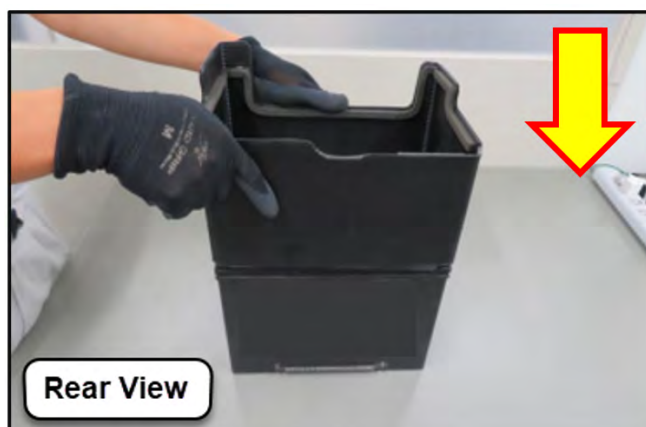
**STEP 4:** Install the NEW battery cover (p.n. 82123AN000) to the alternative replacement battery. Confirm the bottom of the cover is aligned flush with the bottom of the battery.

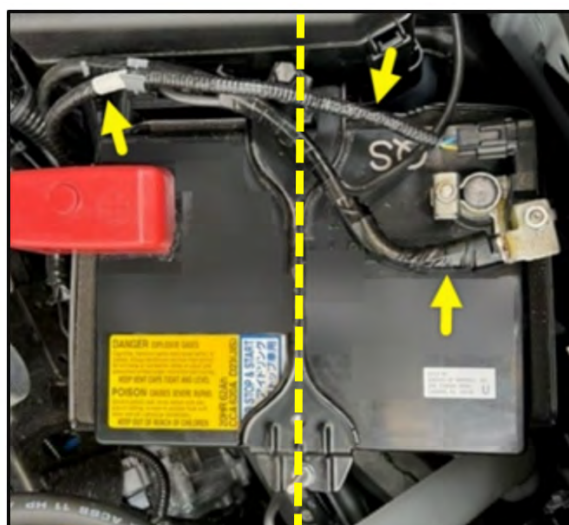
**STEP 6:** Install the original battery holder and holding rods on to the battery.

- A. Torque the two holding rod mounting nuts to **3.5 N·m (2.6ft.-lbs. or 31inch.-lbs.)**.
- B. Torque the positive terminal to **6 N·m (4.4ft.-lbs. or 53inch.-lbs.)**.
- C. Torque the negative terminal to **7.5Nm (5.5ft.-lbs. or 66inch.-lbs.)**.
- D. If the battery sensor is removed or disconnected torque to 7.5Nm (5.5ft.-lbs. or 66inch.-lbs.) while supporting the sensor with the other hand as outlined in the applicable Service Manual under: STARTING/CHARGING SYSTEMS > Battery Sensor.

**NOTE:** Confirm the battery holder is center mounted with the battery cables secured and routed correctly.
