## SERVICE BULLETIN

**APPLICABILITY:** 2017-22MY Impreza  
2018-22MY Crosstrek

**NUMBER:** 12-247-23R

**SUBJECT:** Rear Gate Stay / Design Change

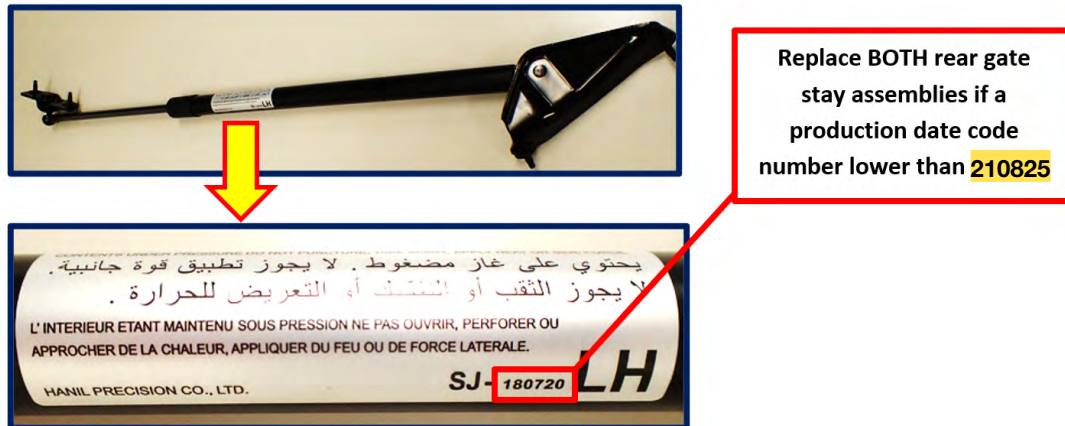
### Identification:

It is important to identify the production date code of the rear gate stay assemblies to verify if new parts have or have not been installed on to the vehicle. If the new parts are already installed, confirm fault sources such as mechanical resistance, gate alignment, physical damage etc. are not the cause before proceeding with rear gate stay replacements.

The service procedures for the rear gate stay assemblies remain unchanged. Always refer to the applicable Service Manual and review the full requirements of the repair being performed. The Service Manual procedures contain information critical to performing an effective repair the first time, every time. This includes but is not limited to important SAFETY precautions, proper inspection criteria, necessary special tools, required processes and related one-time-use parts needed for a complete and lasting repair.

Refer to the applicable Service Manual: Body & Electrical/WIRING SYSTEM > EXTERIOR BODY PANELS > Rear Gate
