**SERVICE BULLETIN**

**APPLICABILITY:** 2011-12 MY Forester Models with 2.5L FB Engines **NUMBER:** 02-147-13R  
 UP to and Including VIN C\*411693 **DATE:** 12/09/13  
**SUBJECT:** Surface Treatment Change To Oil Control Piston Rings **REVISED:** 05/27/14

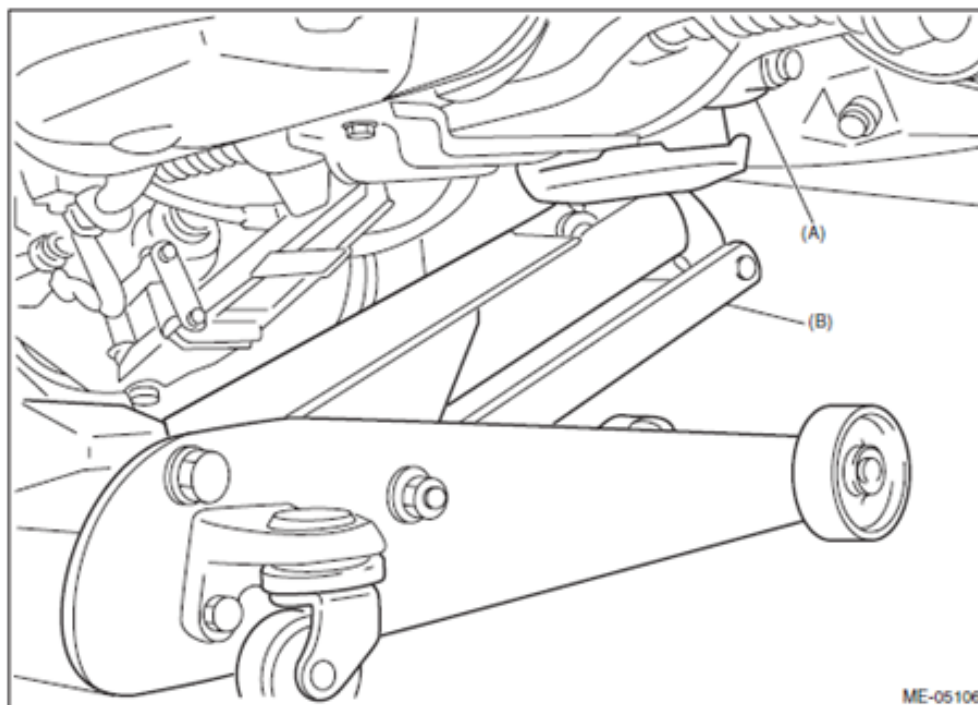
- When draining the engine oil, do not remove the engine oil filter. Leave the existing oil filter in place through engine disassembly, reassembly, installation and initial startup after engine reassembly.
- When removing the engine, there is no need to remove the transmission case cover (CVT only) or to disconnect / disturb any of the transmission harness connectors. While raising the transmission with the service jack placed under the front differential as shown in the illustration below, **only raise it enough to access and remove the engine mounting hardware**. Raising it too high can push the transmission up into the bulkhead / transmission tunnel and possibly cause damage.

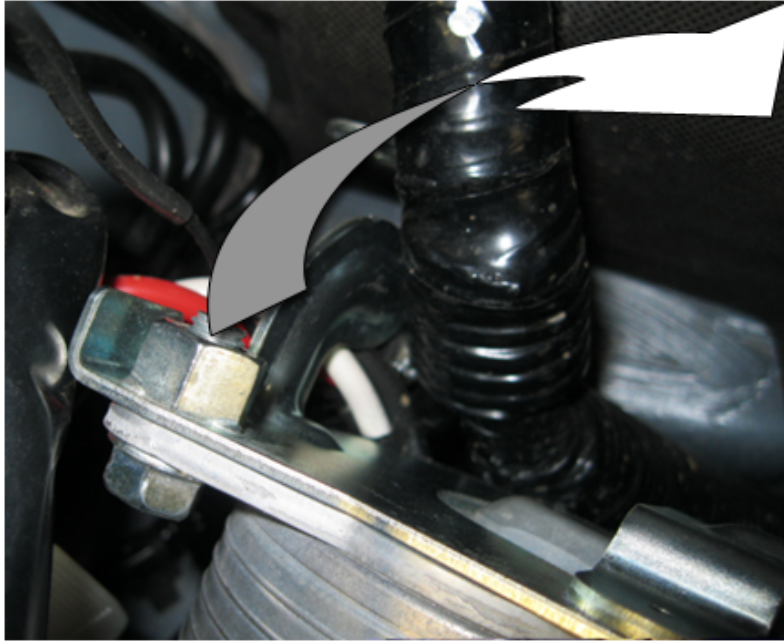
- When removing the CVT fluid cooler, leave it attached to its mounting bracket and remove as an assembly (3 bolts) from the transmission. Disconnect just the engine coolant hoses from it and do not disturb the 2 short CVT fluid lines. Hook one of the cooler's mounting bracket "ears" behind the bulkhead harness as shown in the photo below to keep the cooler assembly out of your way. Use a shop cloth between the "ear" and the bulkhead harness to prevent any chafing.

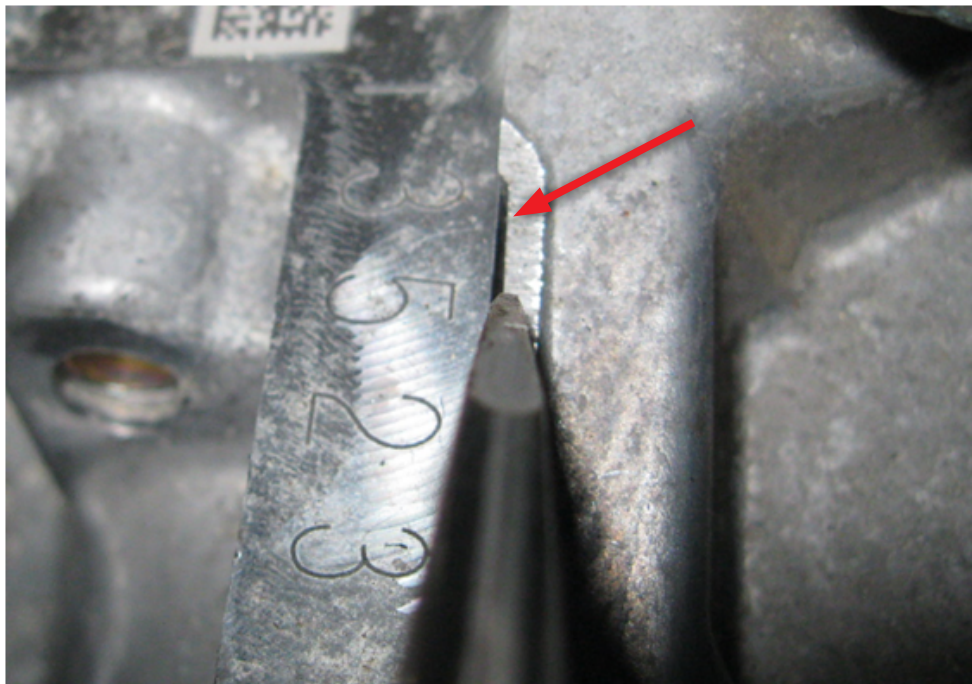
- To make separating the transmission (CVT) from the engine easier, there is a pry relief shown below in the machined mounting surface of the transmission case near the engine number. Use caution when applying any prying pressure and avoid twisting the tool to prevent case damage.

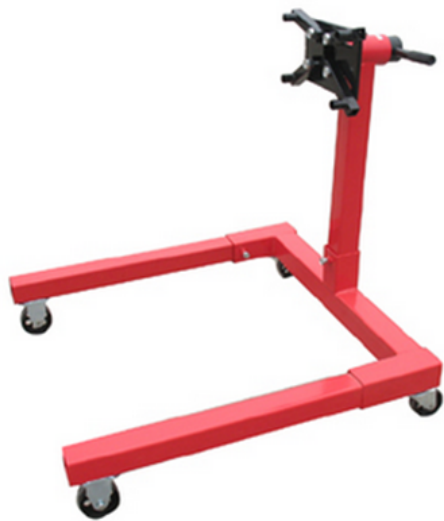
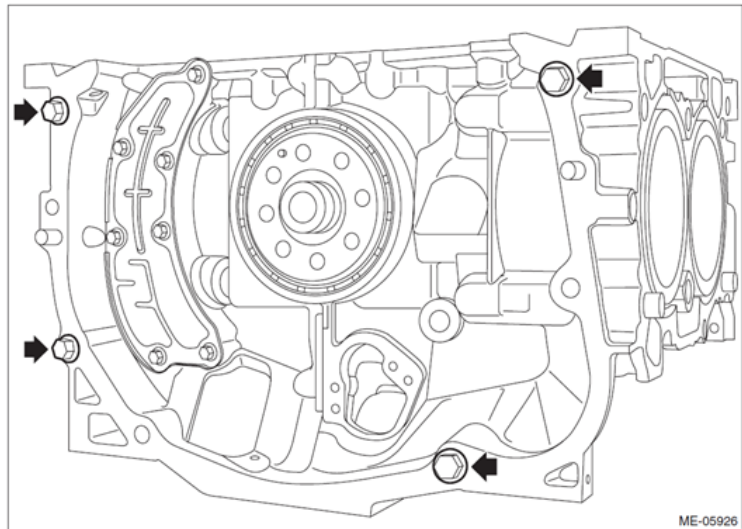
- Once the engine is removed, if you are using a generic engine stand (preferable since engine rotation is necessary), use the four mounting holes on the engine block shown below to mount it. **NOTE:** Do not use the mounting studs in the upper oil pan.

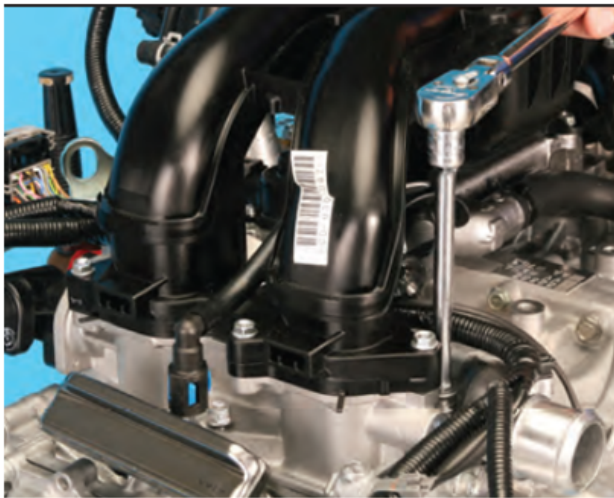
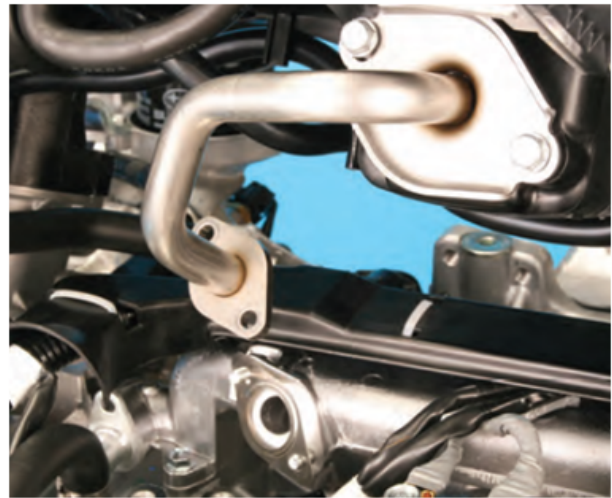
- When removing the intake manifold, as shown in the photos below, leave the TGV assemblies attached to the upper intake, remove the 2 nuts holding the EGR tube to the water pipe then remove the complete assembly from the cylinder heads as a unit.

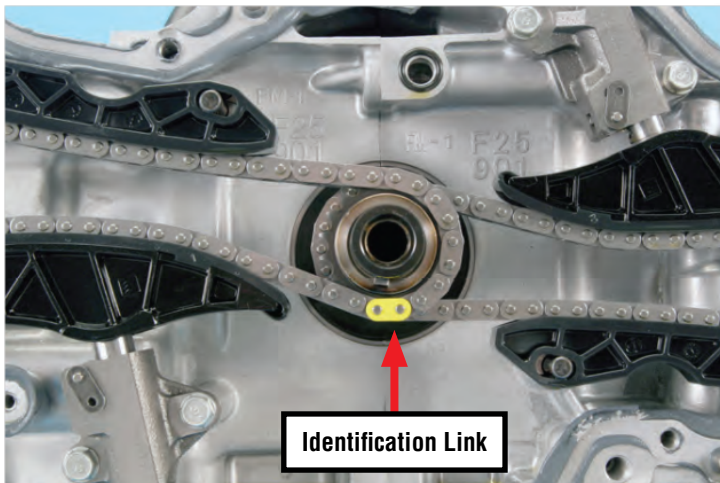
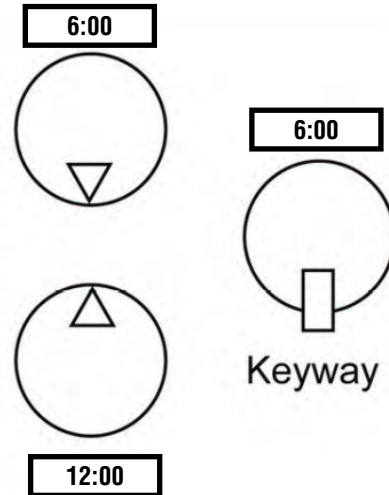
- Begin timing chain removal by positioning the crankshaft keyway at the 6:00 position. The RIGHT bank intake camshaft timing mark ( $\Delta$ ) must be at 6:00 with right bank exhaust timing mark at 12:00 (camshafts will be unloaded).

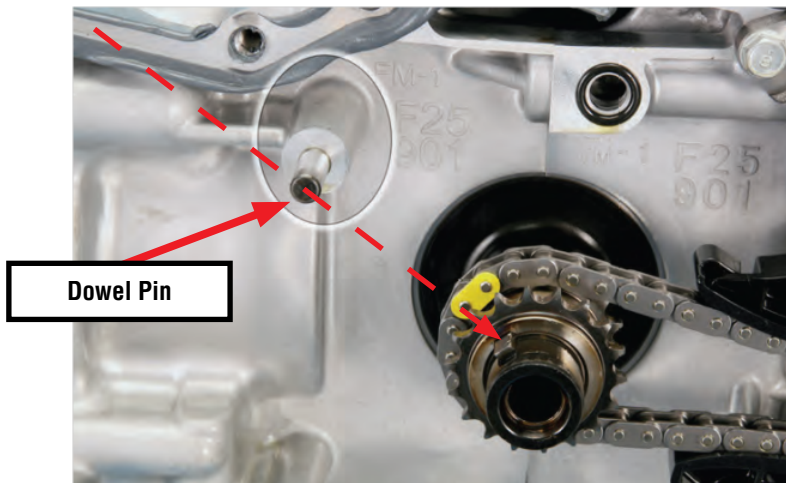
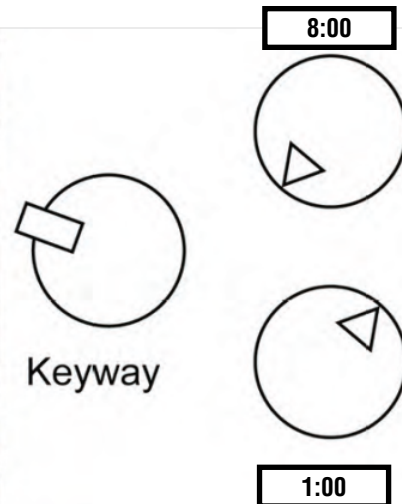
- Compress the chain tensioner by hand, insert a pin through the lever into the access hole to lock the plunger in place then remove the 2 bolts, tensioner, guides and right side timing chain.
- After turning the crankshaft CLOCKWISE, repeat the procedure for the LEFT side with the timing marks ( $\Delta$ ) positioned as shown below. Align the crank sprocket keyway with RH chain dowel pin (shown in red below).

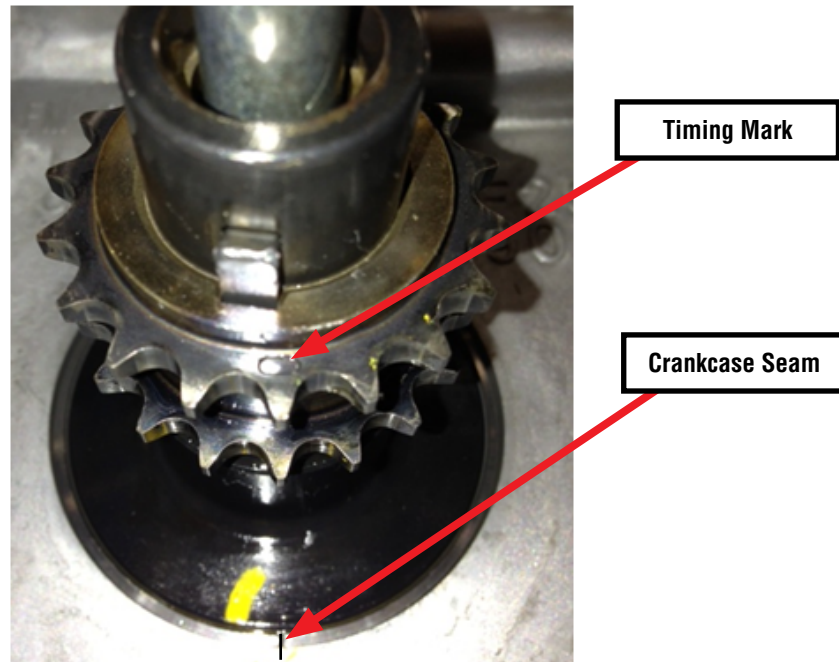
- Compress the chain tensioner by hand, insert a pin through the lever into the access hole to lock the plunger in place then remove the 2 bolts, tensioner, guides and the left side timing chain.
- After the left chain is removed, turn the crankshaft in a COUNTER CLOCKWISE direction until the timing mark on the crankshaft sprocket (NOT the keyway) is back to the 6:00 position as shown below. This positions all the pistons away from TDC and prevents accidental contact between the pistons and valves.

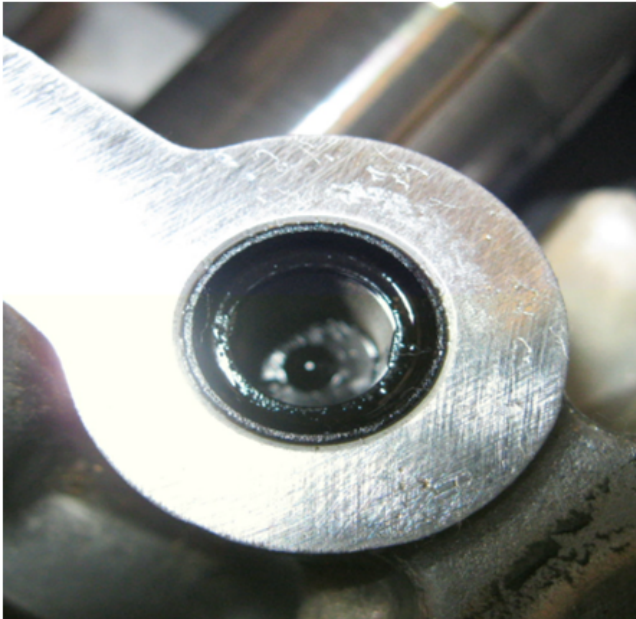
**Cam Carrier Filter Screen**

- Don't forget to clean (**without removing**) the filter screens in the cam carriers (one filter in each carrier). In addition, always be sure to do a thorough inspection and cleaning of the oil pan, pick-up tube and screen as shown in the photos below before reassembly.

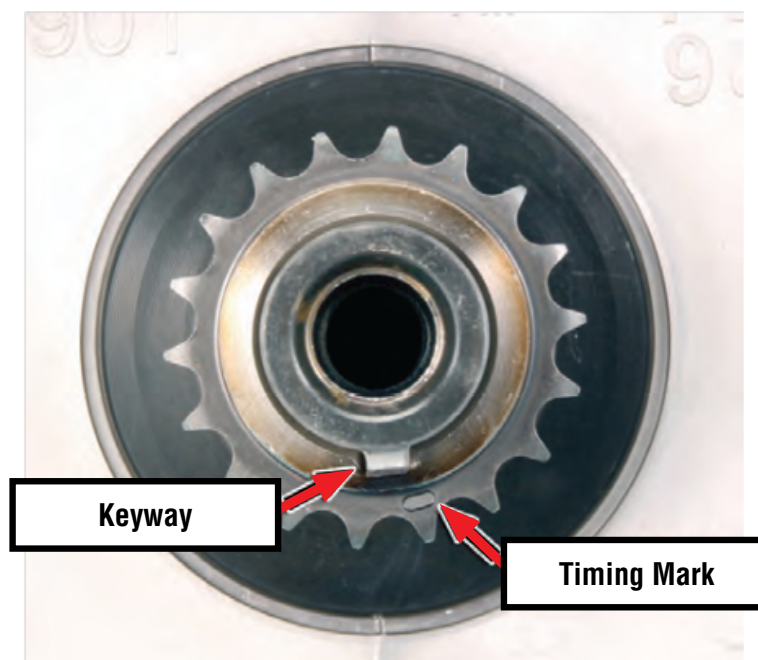
- To begin timing chain re-installation, turn the crankshaft **COUNTER-CLOCKWISE** until the crankshaft sprocket keyway is back to the 6:00 position. This positions the pistons away from TDC and prevents accidental contact with the valves. **NOTE:** The keyway is **NOT** a timing mark.

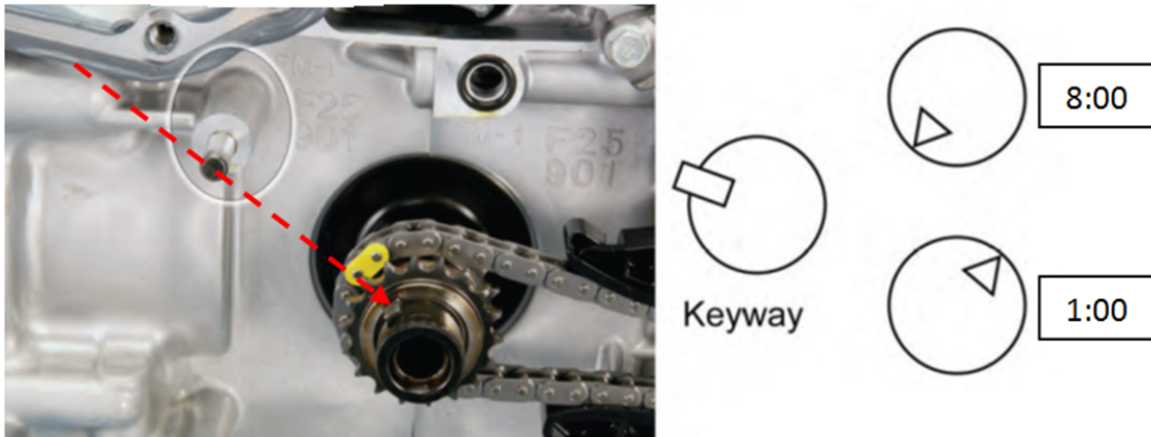
- Arrange the timing marks as shown below, turning the crankshaft **CLOCKWISE** into position. Align the indicator link with the timing mark on the crankshaft sprocket, keyway with the dowel pin.

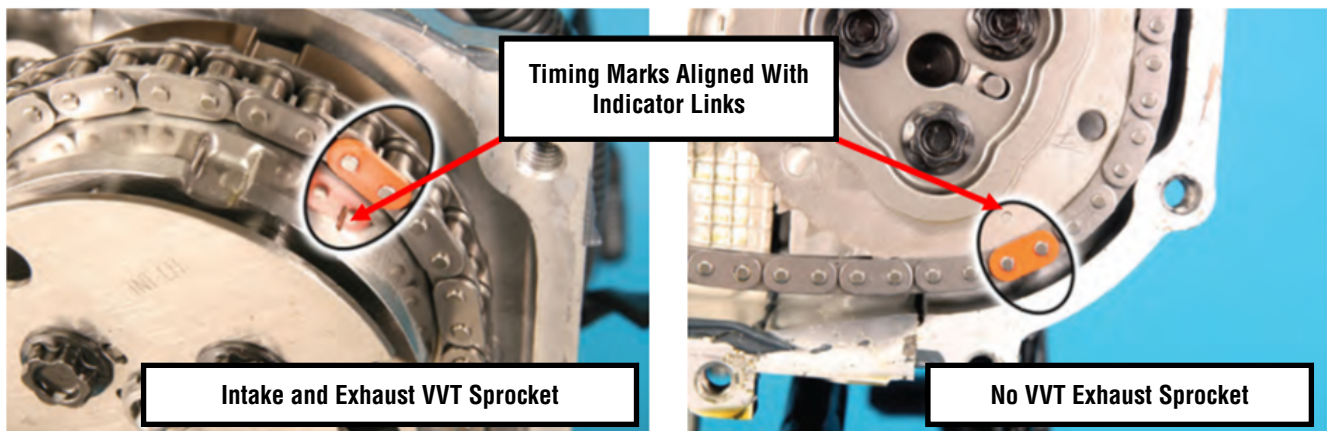
- Align the indicator links to the timing marks found on the outside of the sprocket assemblies as shown in the photos below (Exhaust sprocket face images vary with / without exhaust VVT).

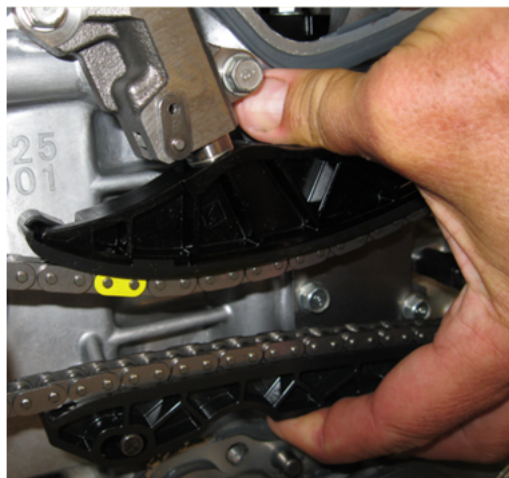
- Install the chain guides and tensioner. Once proper positioning has been confirmed, pull the pin to release the tensioner. With your hand, grab and squeeze the upper and lower chain / guides together as shown in the reference photo below to allow the plunger in the tensioner to fully extend and click into its furthest notch.

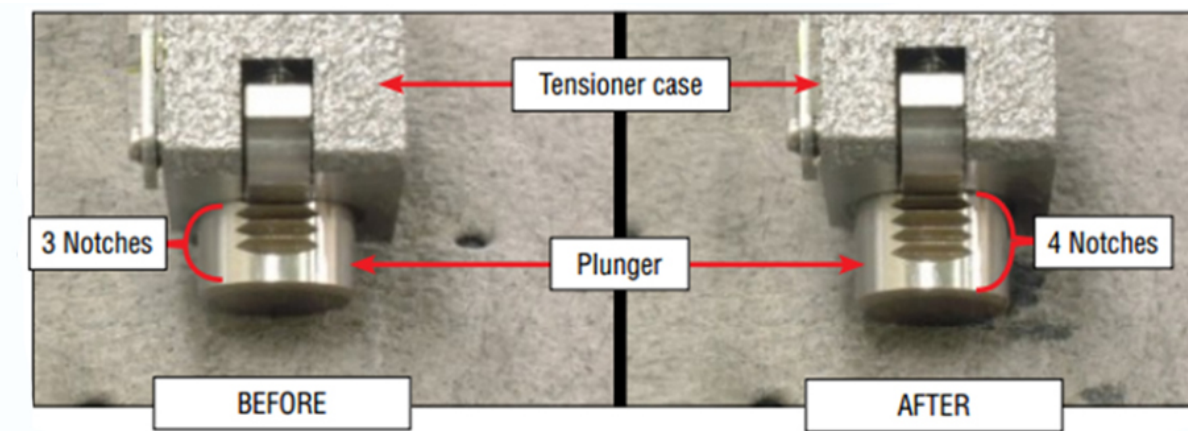
- If you have 3 notches showing, you want to get one more “click” so that 4 notches are visible as shown in the photos below. If you have 4 showing, you want to end up with 5. Whether you start with 3 or 4 will depend on the amount of wear present on the chains and guides. The number of clicks listed here is simply a guide. The point is to ensure proper initial chain tension is applied to avoid creating a brief rattle sound at engine start.

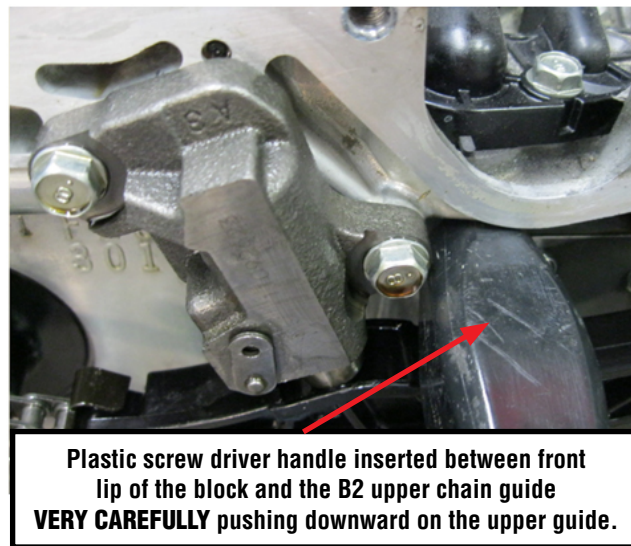
- If necessary, insert a plastic screwdriver handle between the lip of the block and the left side (B2) guide. Then, **VERY CAREFULLY** push down on the guide just enough to get the extra tensioner notch / “click”. When using this method, always make sure you are using plastic on plastic and NOT metal on plastic to avoid damaging the chain guides.

**Plastic screw driver handle inserted between front lip of the block and the B2 upper chain guide VERY CAREFULLY pushing downward on the upper guide.**

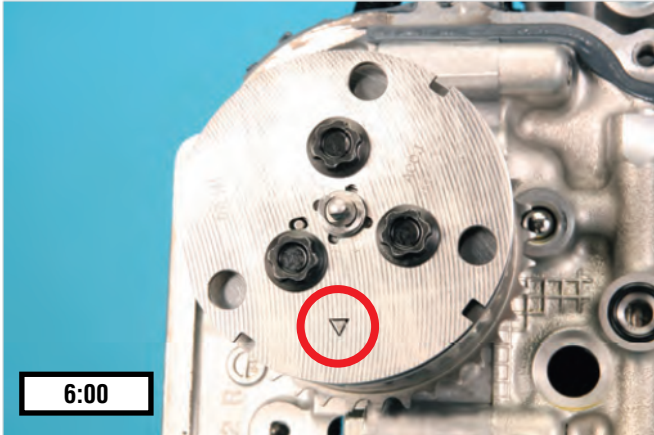
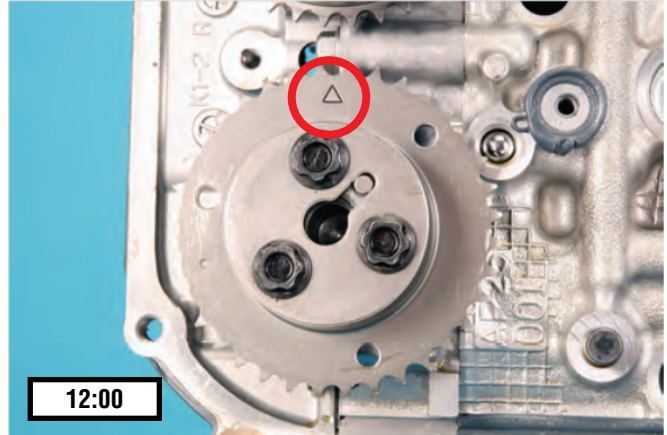
- Rotate the crankshaft **COUNTER-CLOCKWISE** until the crankshaft sprocket timing mark is at the 6:00 position. Position the cam sprocket timing marks as shown below; intake 6:00, exhaust 12:00.

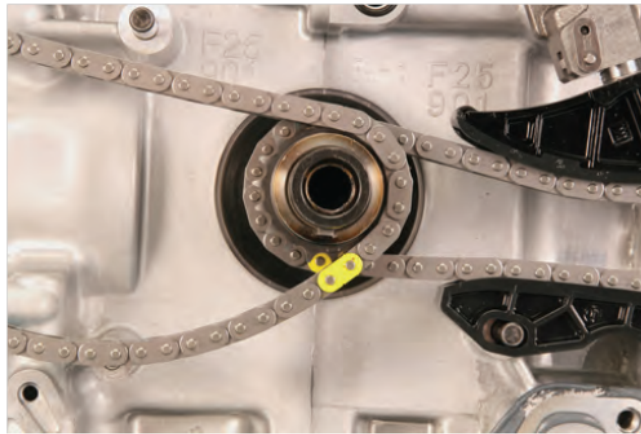
- Align the indicator link with the timing mark on the crankshaft sprocket as shown below.

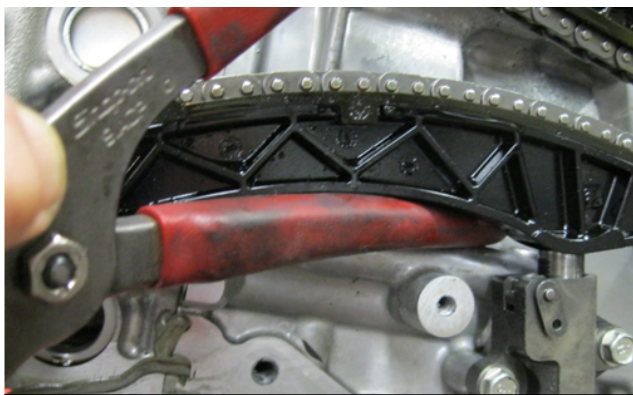
- Same as the left side, align the indicator links to the timing marks found on the cam sprocket assemblies. Install the chain guides and tensioner. Once proper positioning has been confirmed, pull the pin to release the tensioner. With your hand, grab and squeeze the upper and lower left side chain / guides together to allow the plunger in the tensioner to extend fully and click into its furthest notch as shown in the previous (right side) photo. If necessary, insert a rubber-coated plier handle between the ledge area on the front of the block and the right side (B1) lower chain guide. Then, **VERY CAREFULLY** lift up on the guide just enough to get the extra “click” on the tensioner as shown in the photo below.

Rubber-coated plier handle inserted between a ledge area on the front of the block and the B1 lower chain guide **VERY CAREFULLY** lifting upward on the lower guide.

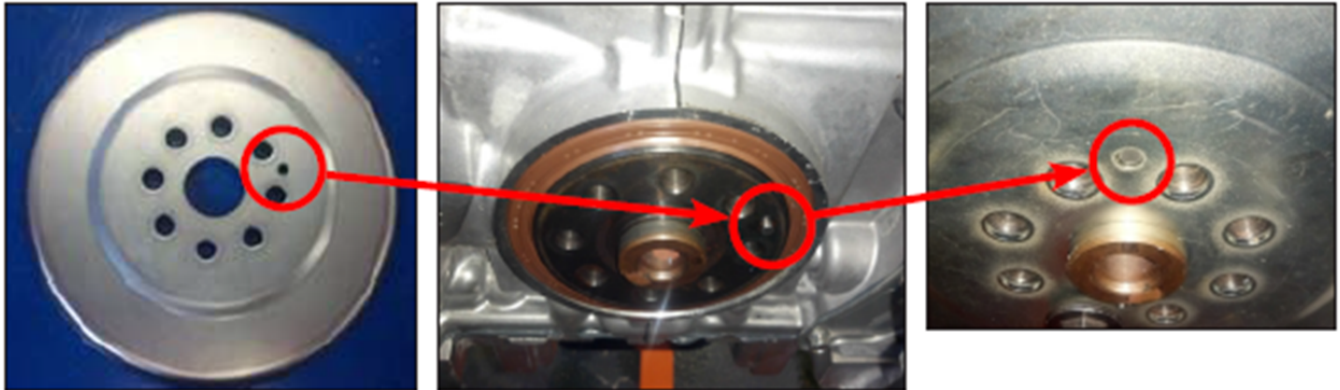
- **REMINDER:** When replacing the short block, in addition to transferring the crankshaft position sensor, be sure to index the reluctor properly onto the crankshaft as shown in the photos below. The reluctor is indexed by a dowel pin in the rear crankshaft flange which aligns with a corresponding hole in the reluctor. It is possible to install the reluctor without indexing it correctly. Failure to index the reluctor correctly will result in a no-start condition due to an out of time crank position signal to the ECM.
