# TECHNICAL SERVICE BULLETIN

## Front Seat Cushion Sagging - Built On Or Before 11-Feb-2021

**23-2235**

<b>Ford</b> 2019-2021 Transit	Built on or before 11-Feb-2021
----------------------------------	--------------------------------

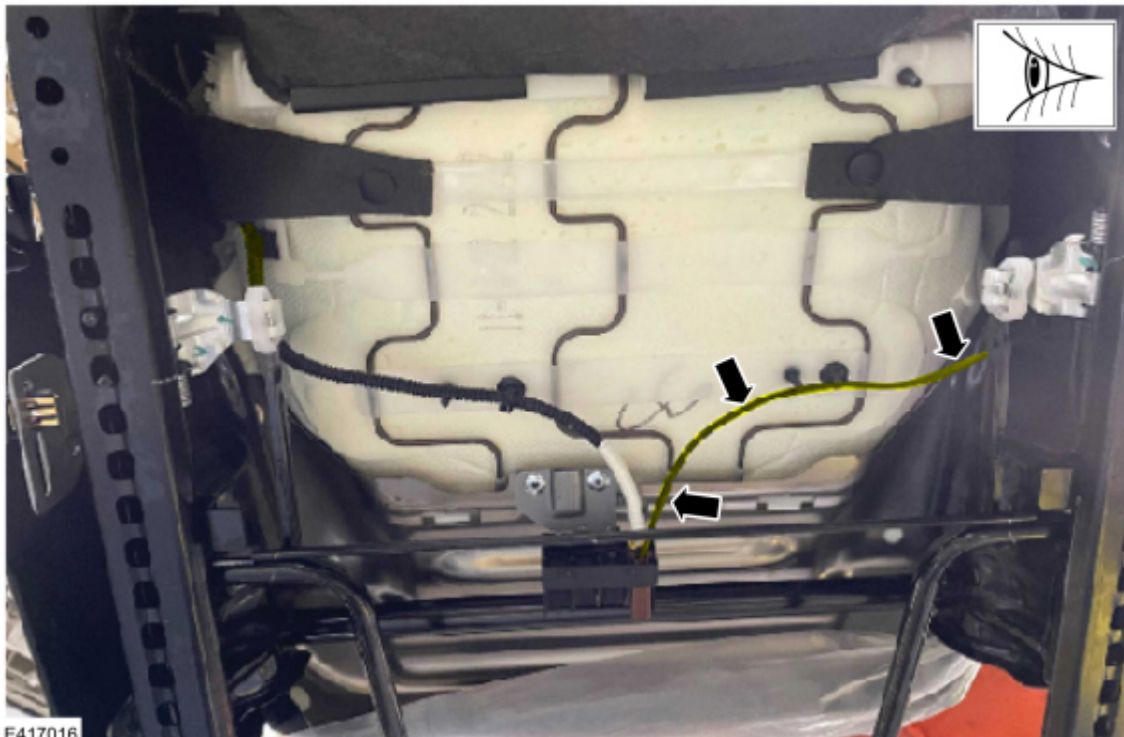
Figure 1

1. Remove the affected driver seat track. Refer to Workshop Manual (WSM), Section 501-10A, starting with Step 2.
2. Inspect the seat airbag deployment circuit for damage as shown in Figure 1. If damage is present, replace the seat airbag harness.

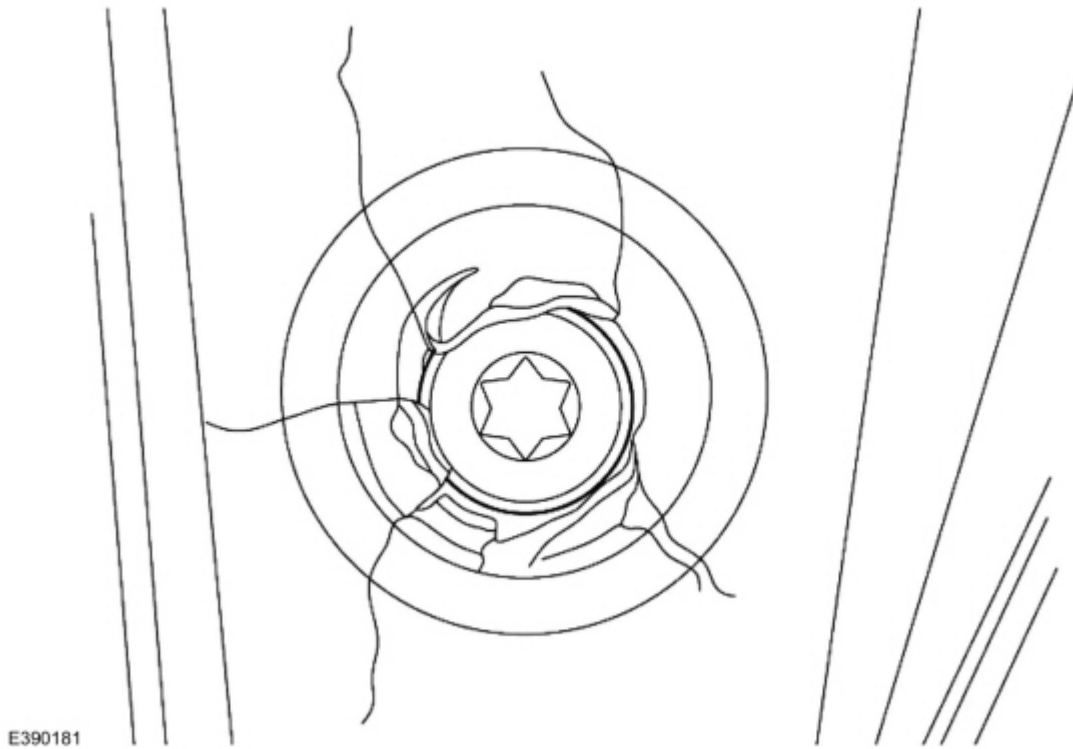
Figure 2

3. Inspect the driver seat track assembly for damage. Is the driver seat track assembly damaged?

**NOTE: Small cracks around the bolt are considered normal. (Figure 2)**

(1). Yes - replace the seat track assembly. Refer to WSM, Section 501-10A Front Seats > Removal and Installation > Front Seat Track. Proceed to Step 5.

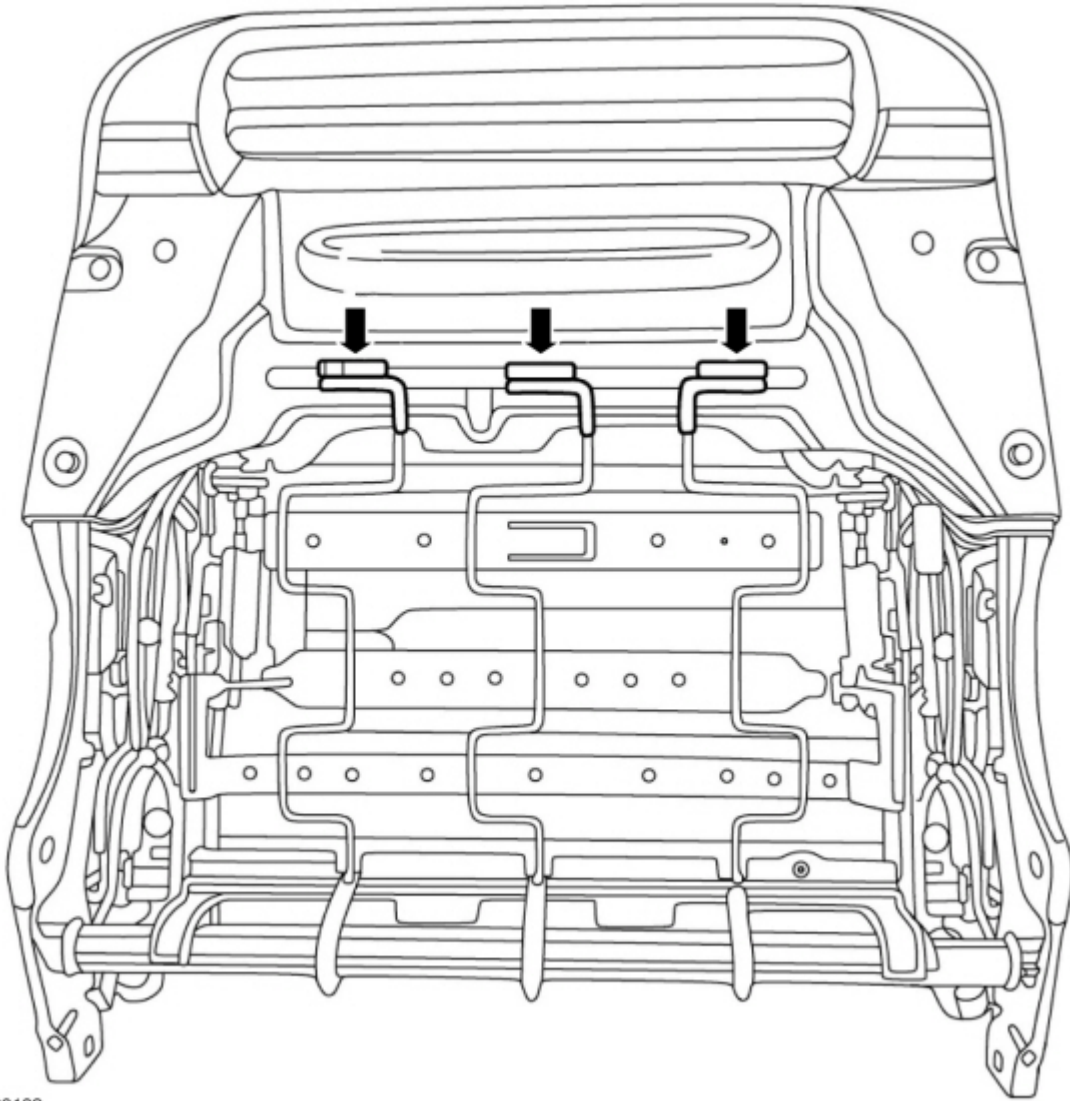
Figure 3

(2). Disengage the 3 suspension mat assembly forward attachments from the cushion pan. (Figure 3)

(3). Remove the suspension mat assembly 3 rearward attachments. The suspension mat assembly has a snap fit on the rear tube. (Figure 3)

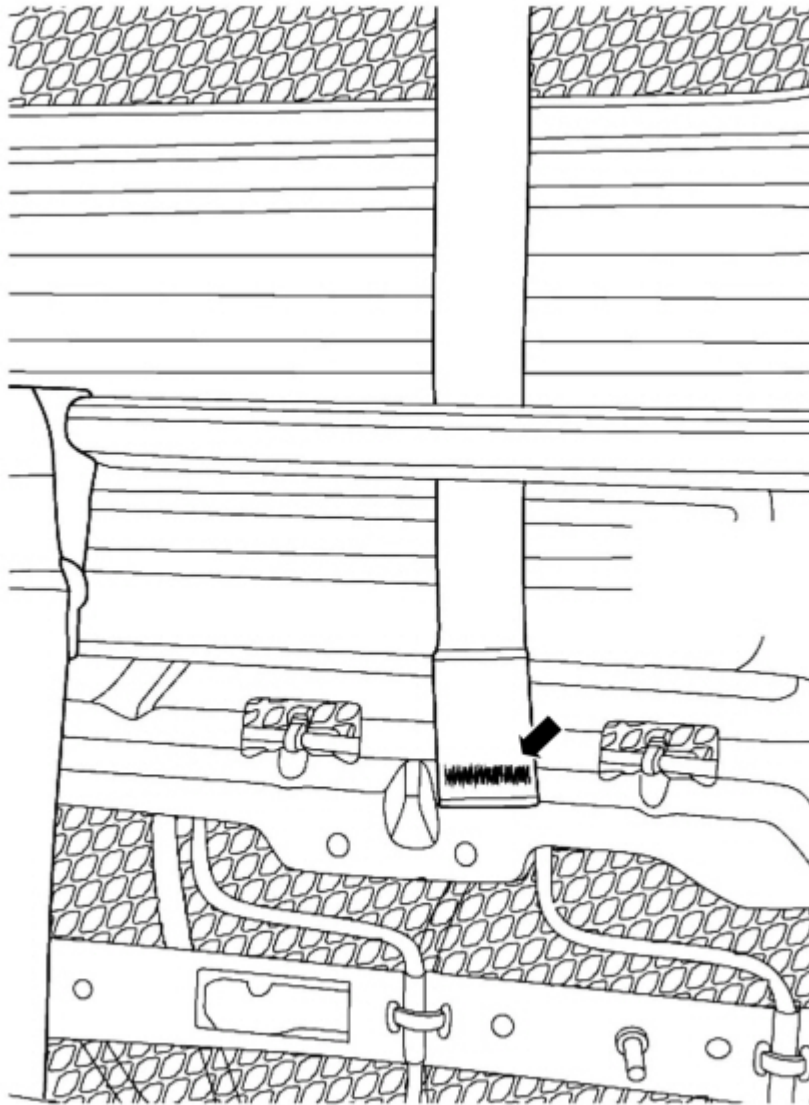
Figure 4

(1). With the red thread visible, route the end of the 1st webbing strap assembly without the metal ring between the cushion pan and the front cross-car tube. (Figure 4)

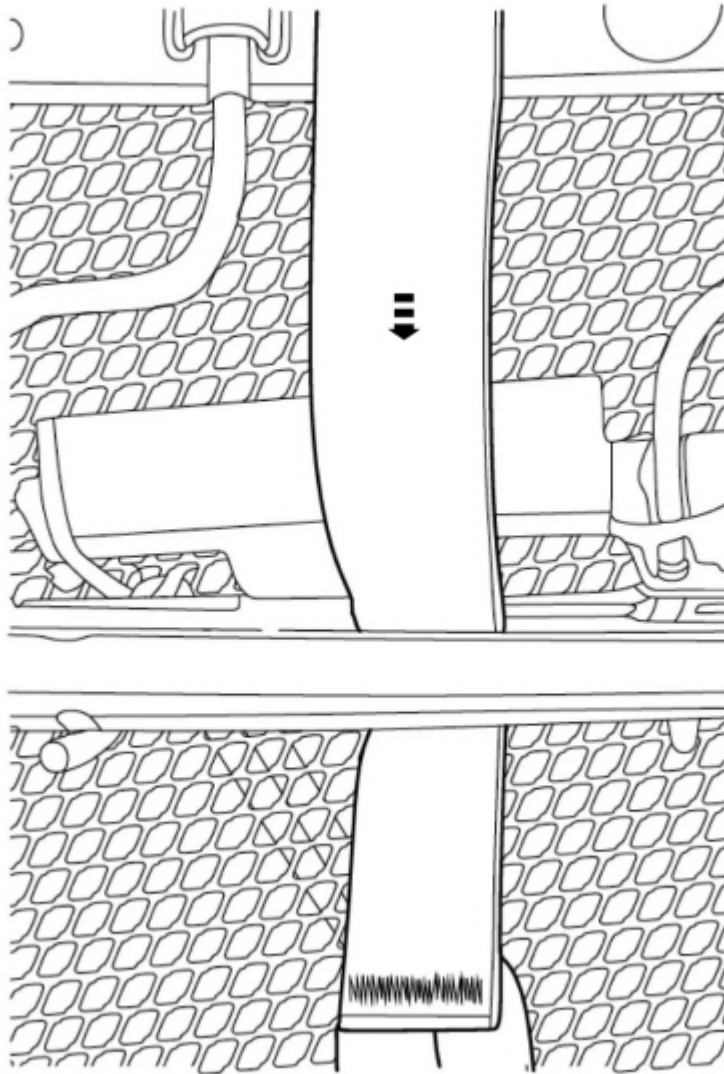
Figure 5

(2). Continue rearward and route the webbing strap assembly between the suspension mat assembly and the rear tube. (Figure 5)

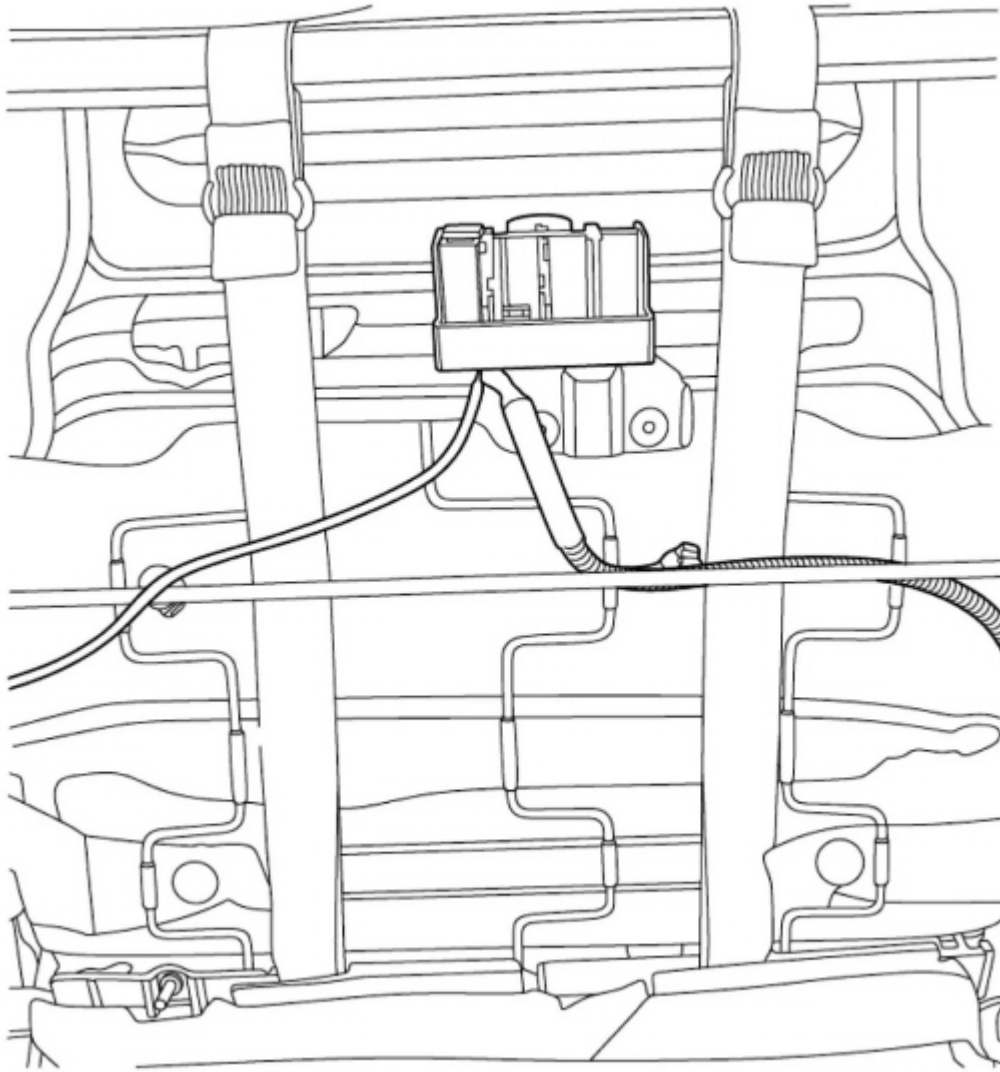
Figure 6

(3). Make sure all electrical harnesses are below the webbing. The final assembly will have the suspension mat on top (closest to the seat cushion), then the webbing straps, and then the wire harnesses on the bottom. (Figure 6)

**NOTE:** Make sure all electrical harnesses hang below the webbing and not between the webbing and suspension mat. When the final assembly is installed in the vehicle, it will have the suspension mat on top (closest to the cushion), then the webbing straps, and then the wire harnesses on the bottom. (Figure 6)

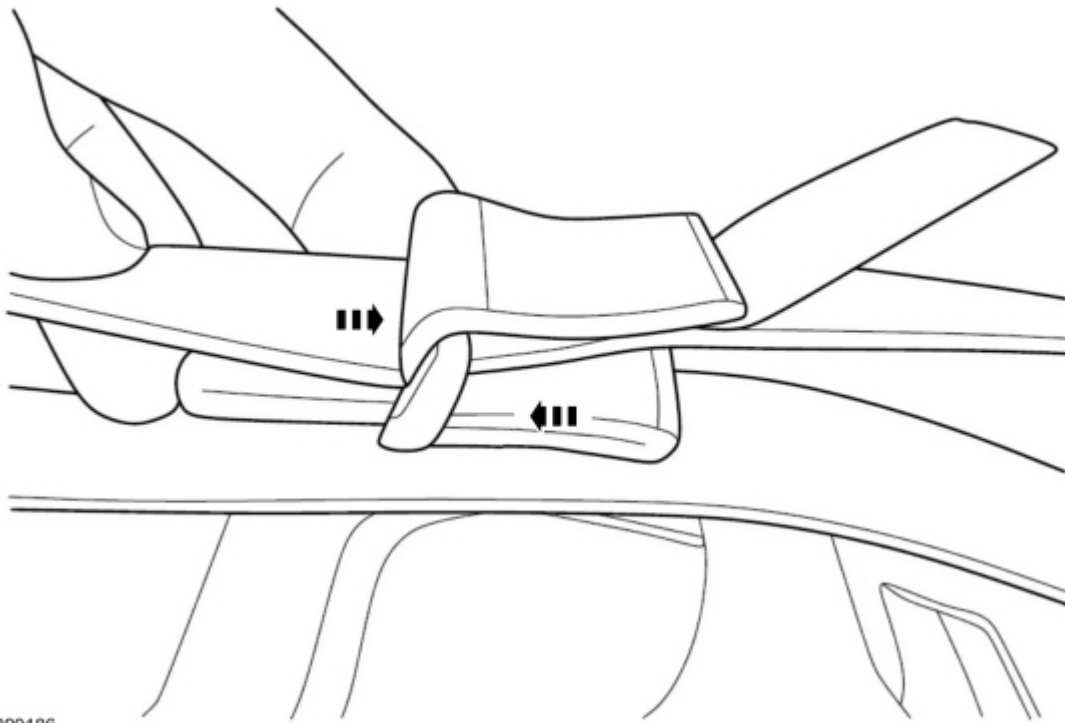
Figure 7

(4). Bring the webbing strap assembly to the metal ring and insert it. After the fold is all the way through the ring, pull the retention fold back and into position. (Figure 7)

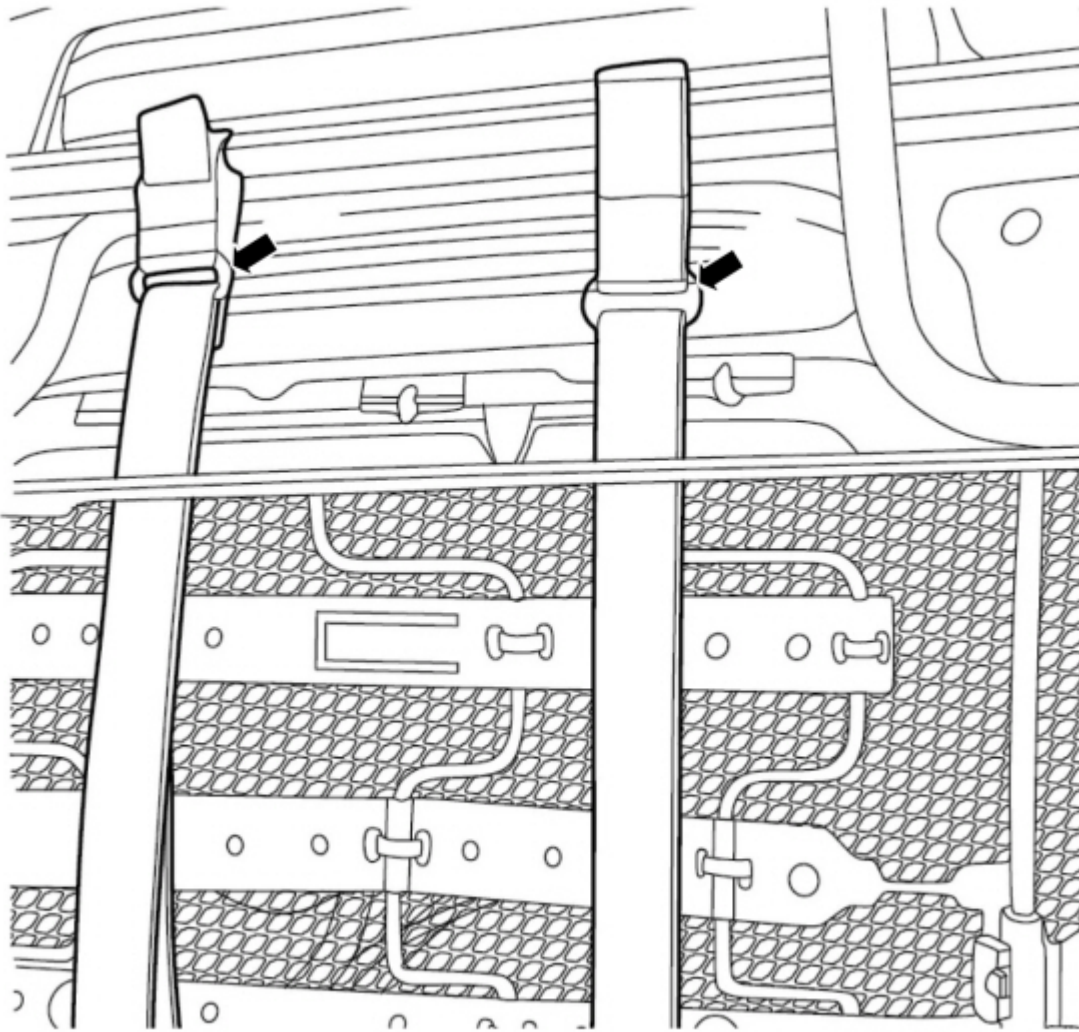
Figure 8

(6). The metal ring should be positioned forward in vehicle. (Figure 8)

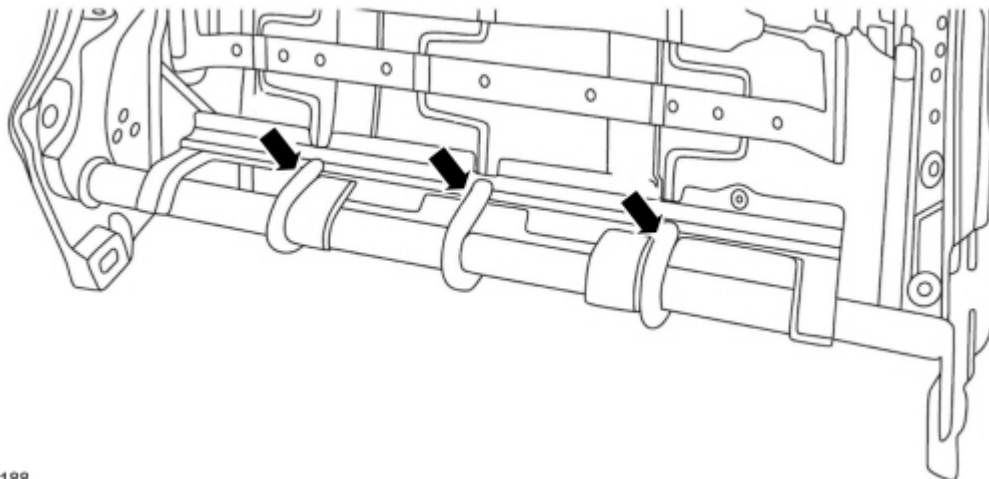
Figure 9

- (1). Locate the suspension mat to the cushion and webbing assembly.
- (2). At the rear tube verify one webbing is located between the left and center suspension attachment and the other is between the center and right suspension attachment. (Figure 9)

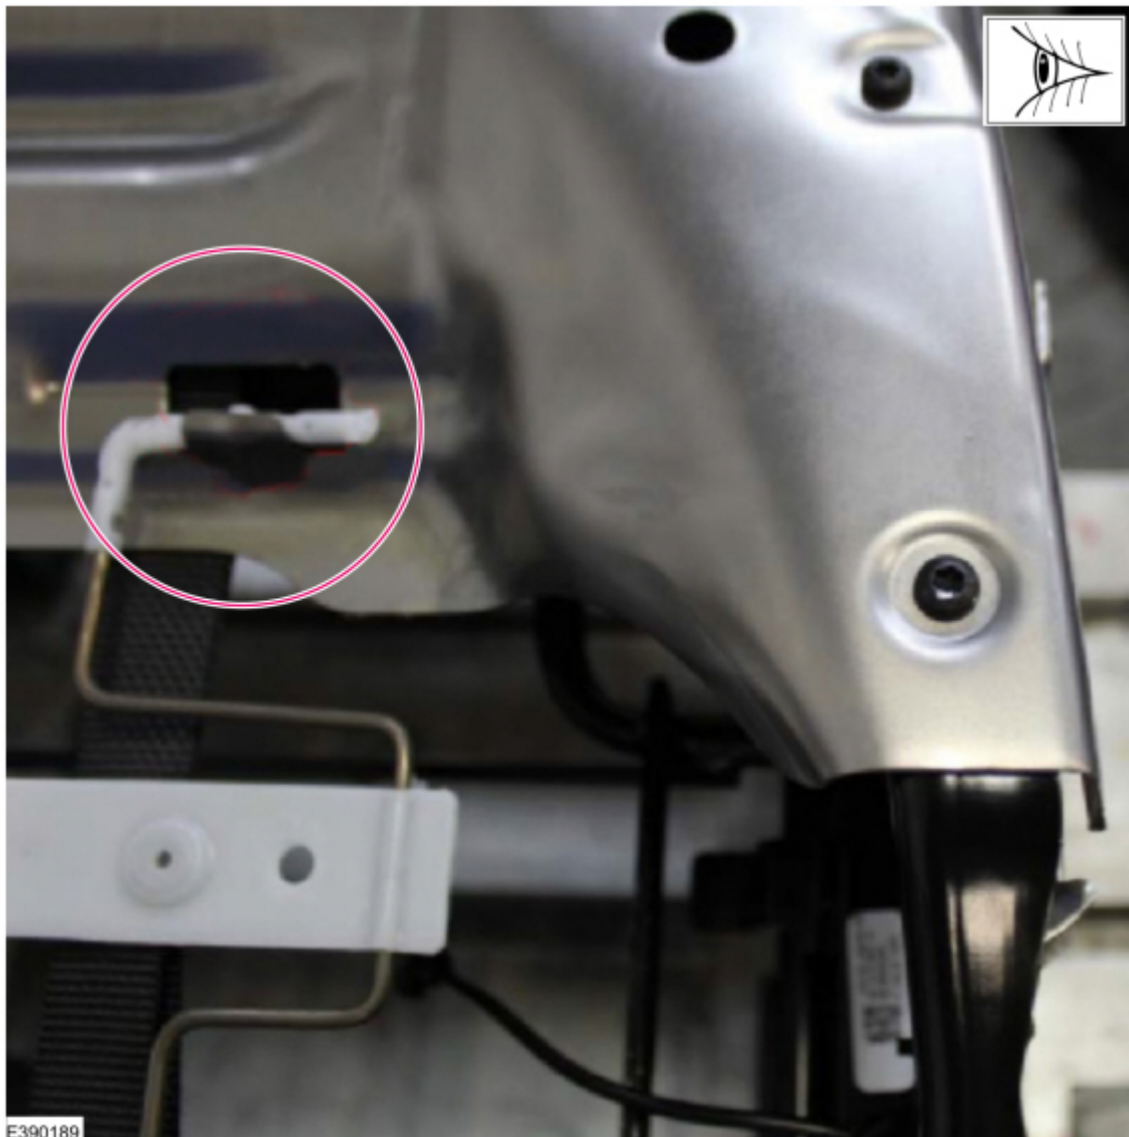
Figure 10

(4). Secure the front of the suspension mat to the retaining tabs on the cushion pan (no tools required). (Figure 10)

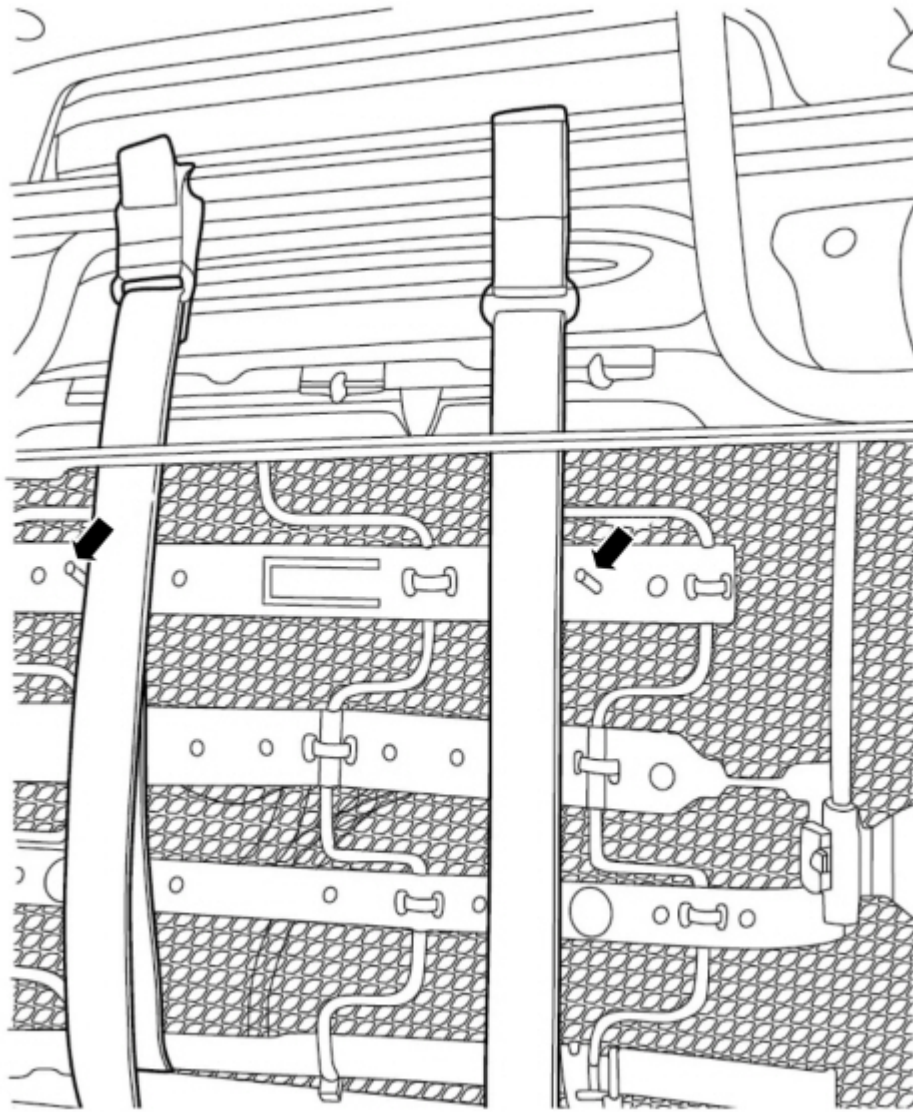
Figure 11

(5). Verify the cross-car position of the webbings. The position should be aligned with the stud on the suspension mat. (Figure 11)

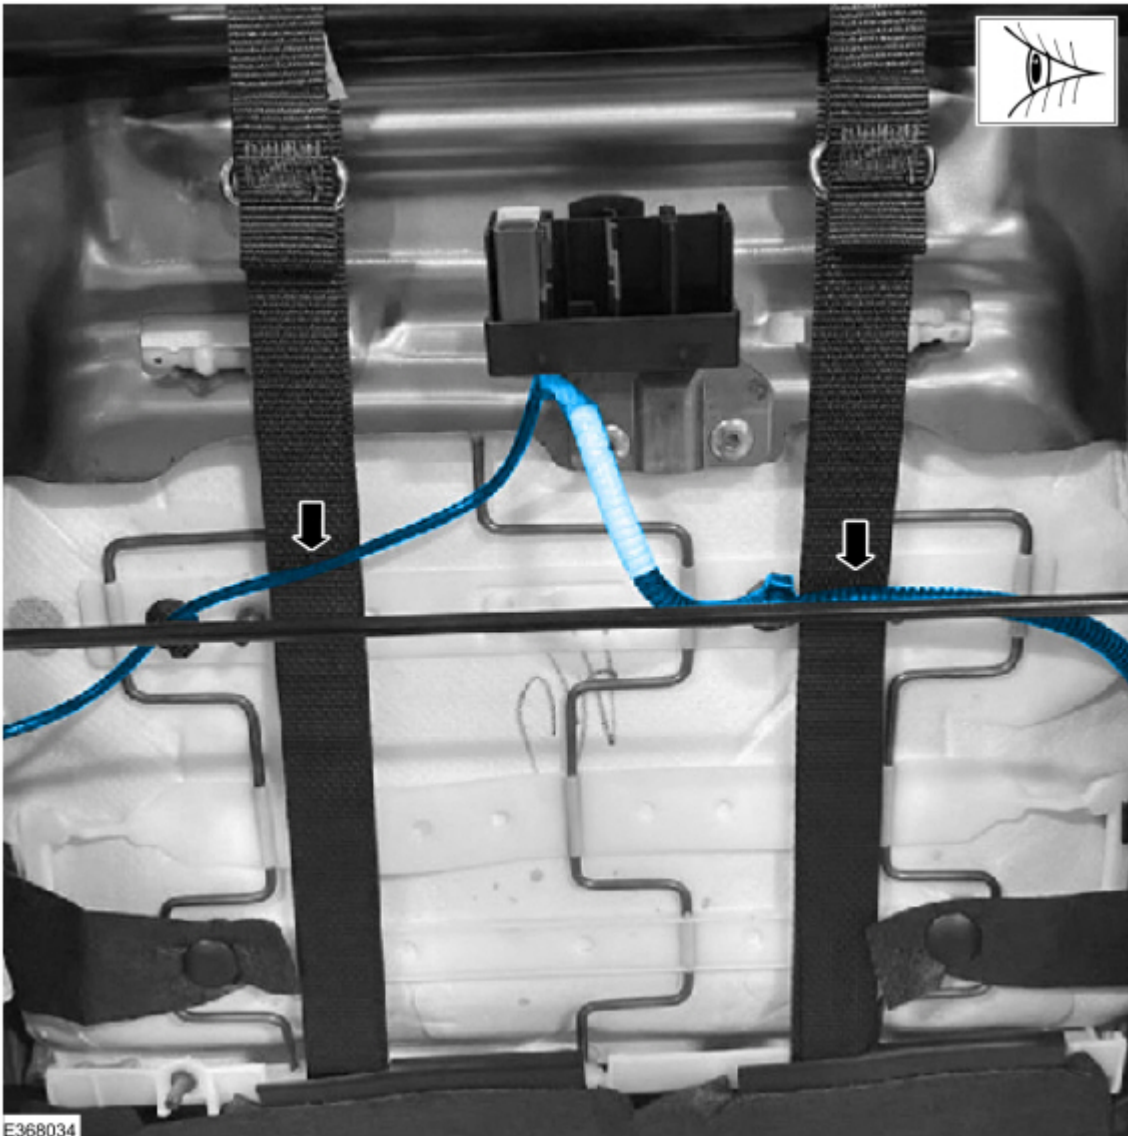
Figure 12

(6). Secure the wire harness(es) to the suspension mat. (Figure 12)

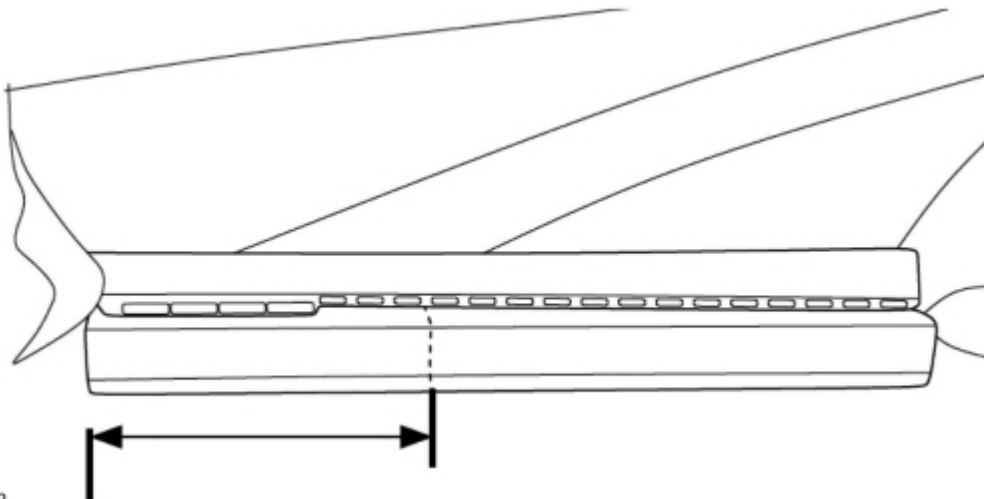
Figure 13

(1). Measure 1 3/4 in. (45 mm) and cut with a knife along the dotted line. (Figure 13)

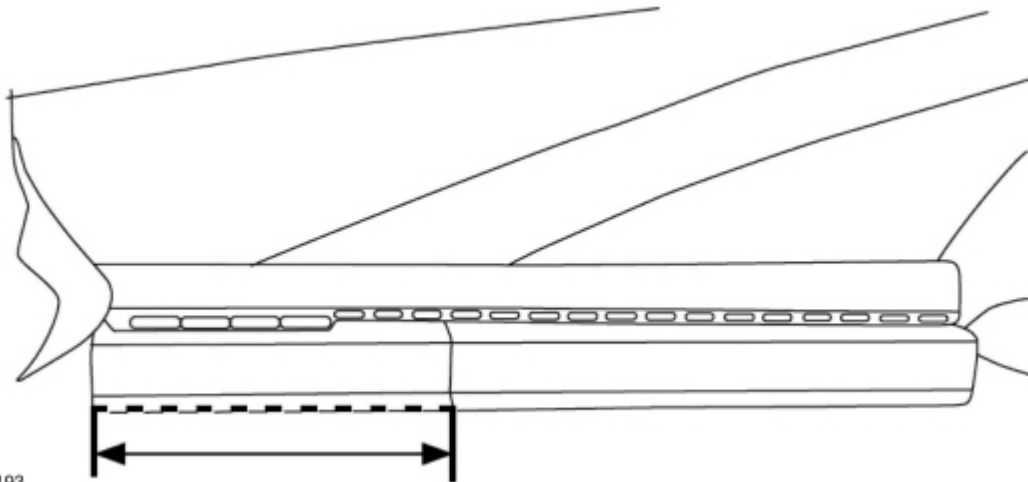
Figure 14

(2). Cut along the dotted line (Figures 14-15), perpendicular to the previous cut, so that the portion of the J retainer in Figures 16 and 17 can be removed.
