TECHNICAL SERVICE BULLETIN

Moan Noise In The Rear Brakes When Vehicle Is Driven In Reverse (R) In Cold Weather And/Or High Humidity

23-2308
09 October 2023

Ford
2021-2023 Bronco Sport
2020-2023 Escape

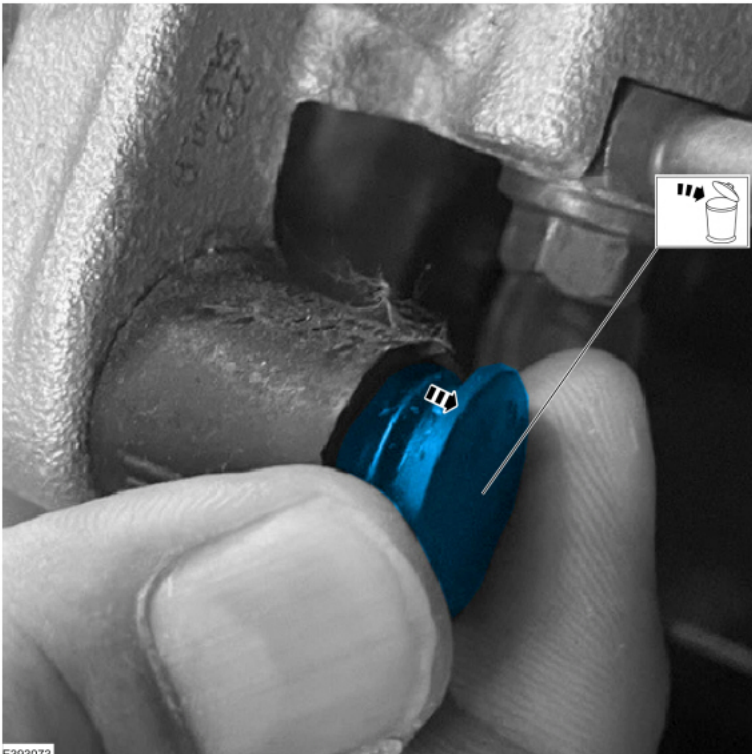
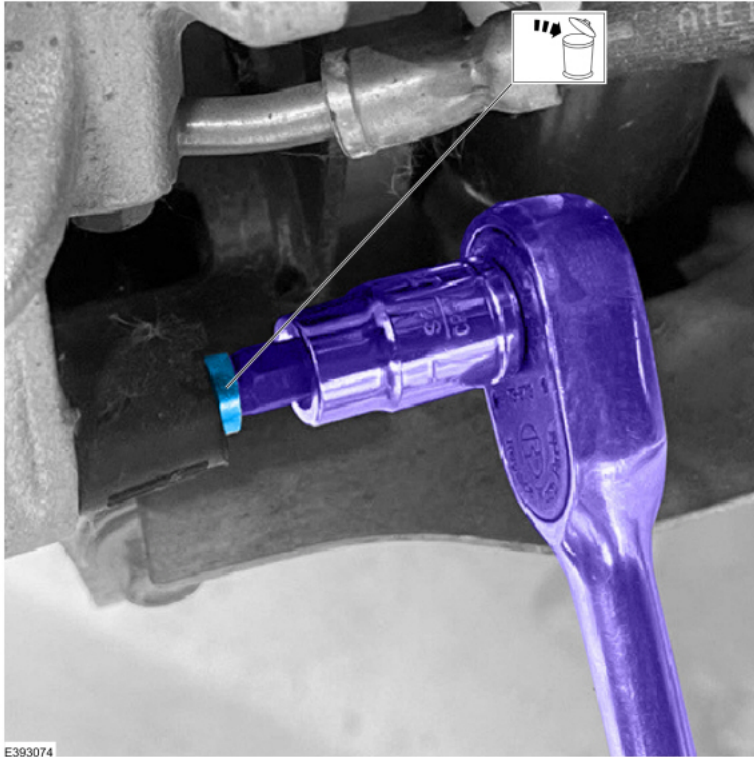
5. Remove and discard the brake caliper guide pin cap and guide pin on the opposite side of the bleeder. (Figures 3-5)
Figure 3

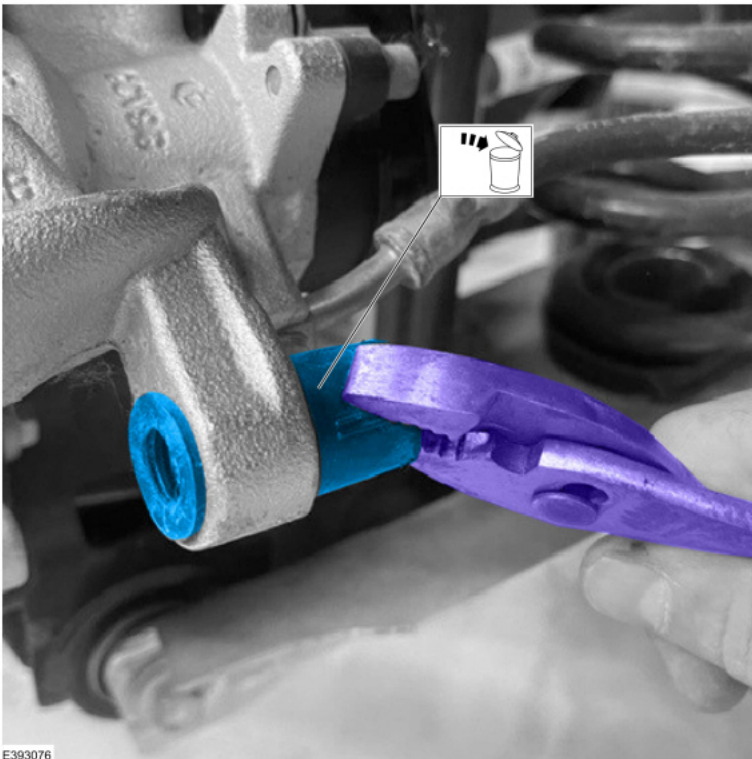
Figure 7

7. Using 6 inch slip joint pliers, remove and discard the standard bushing located on the opposite side of the bleeder. (Figure 7)

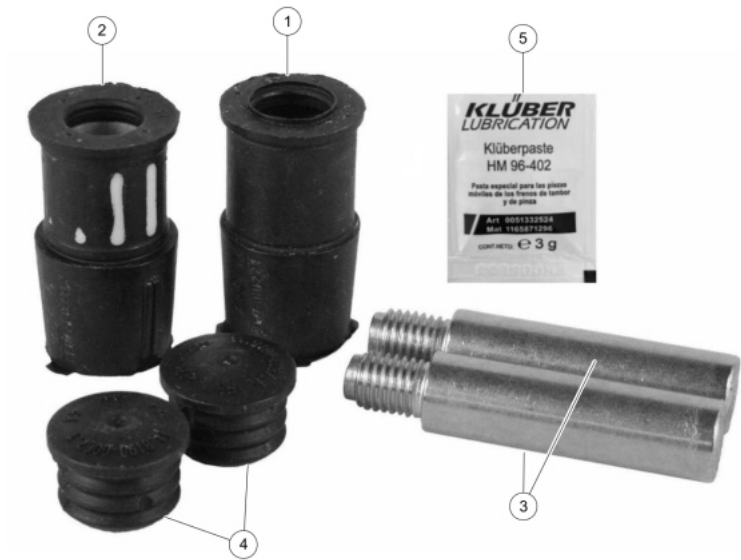
Figure 8

NOTE: The kit includes: 1 standard bushing (Figure 8, Callout 1), 1 reinforced bushing (Figure 8, Callout 2), 2 guide pins (Figure 8, Callout 3), 2 guide pin caps (Figure 8, Callout 4) and 1 packet of Klüberpaste® (Figure 8, Callout 5)

Item	Description
1	Standard bushing (1 piece)
2	Reinforced bushing (1 piece)
3	Guide pins (2 pieces)
4	Guide pin caps (2 pieces)
5	Packet of Klüberpaste®

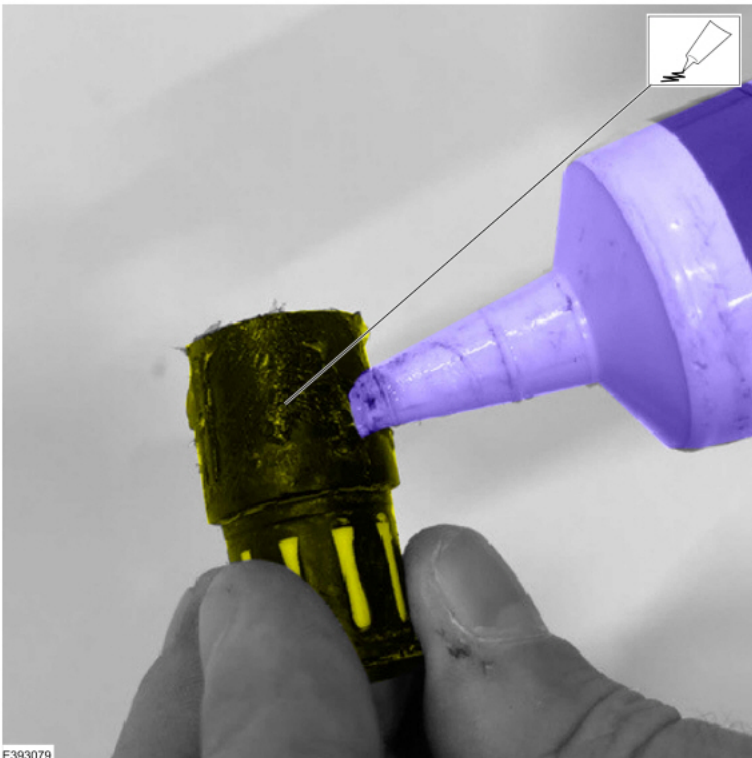
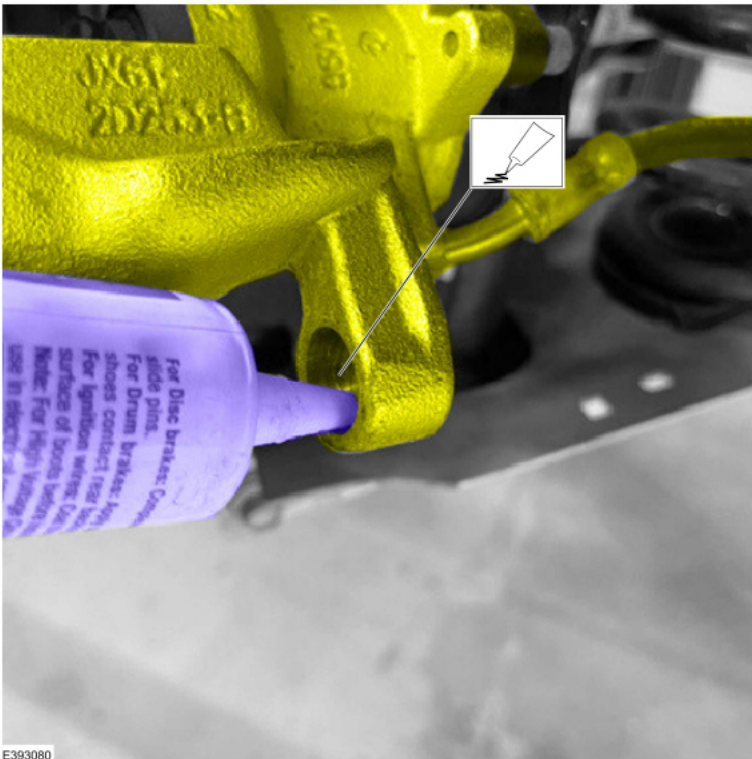
(3). Lubricate the bushing and bushing housing with Motorcraft® Silicone Brake Caliper Grease. (Figures 10-11)

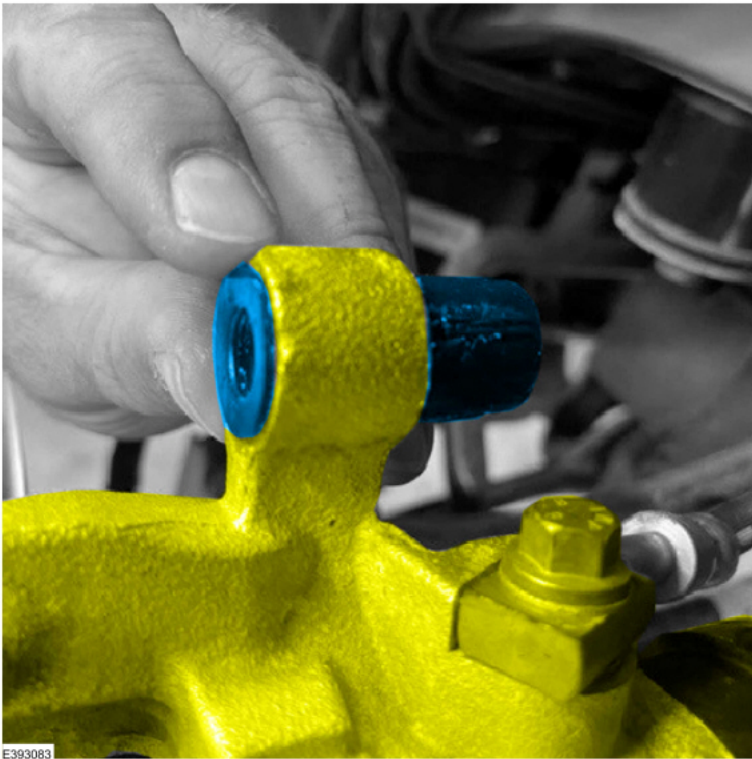
(4). Use an appropriate diameter socket, such as a 13 mm 3/8 drive chrome deep socket, to push the bushing into the caliper bushing housing. (Figures 12-14)

NOTE: Use a plastic trim tool to help guide the bushing into the housing.

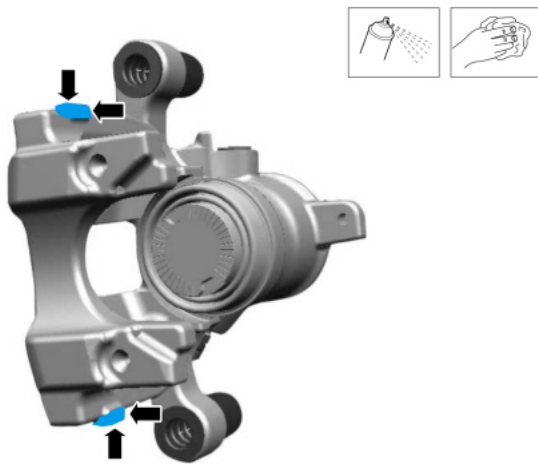
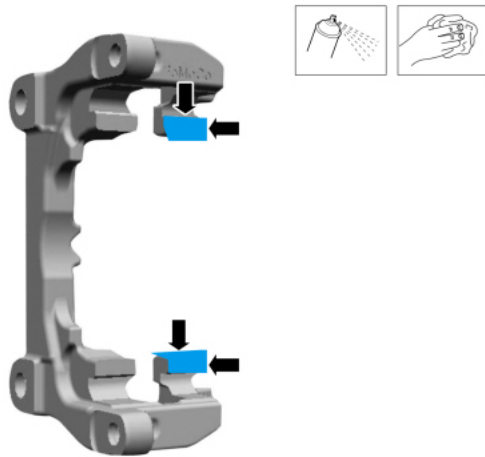
16. Use Motorcraft® Metal Brake Parts Cleaner and an abrasive pad (super fine grade) to clean the caliper housing at the machined brake pad backplate contact surfaces. (Figures 18-19)
