GROUP Body	MODEL All Models
	NUMBER PS290 (REV 1, 12/18/2015)	DATE January 2014

SUBJECT: SUCTION CUP RESIDUE ON WINDSHIELD

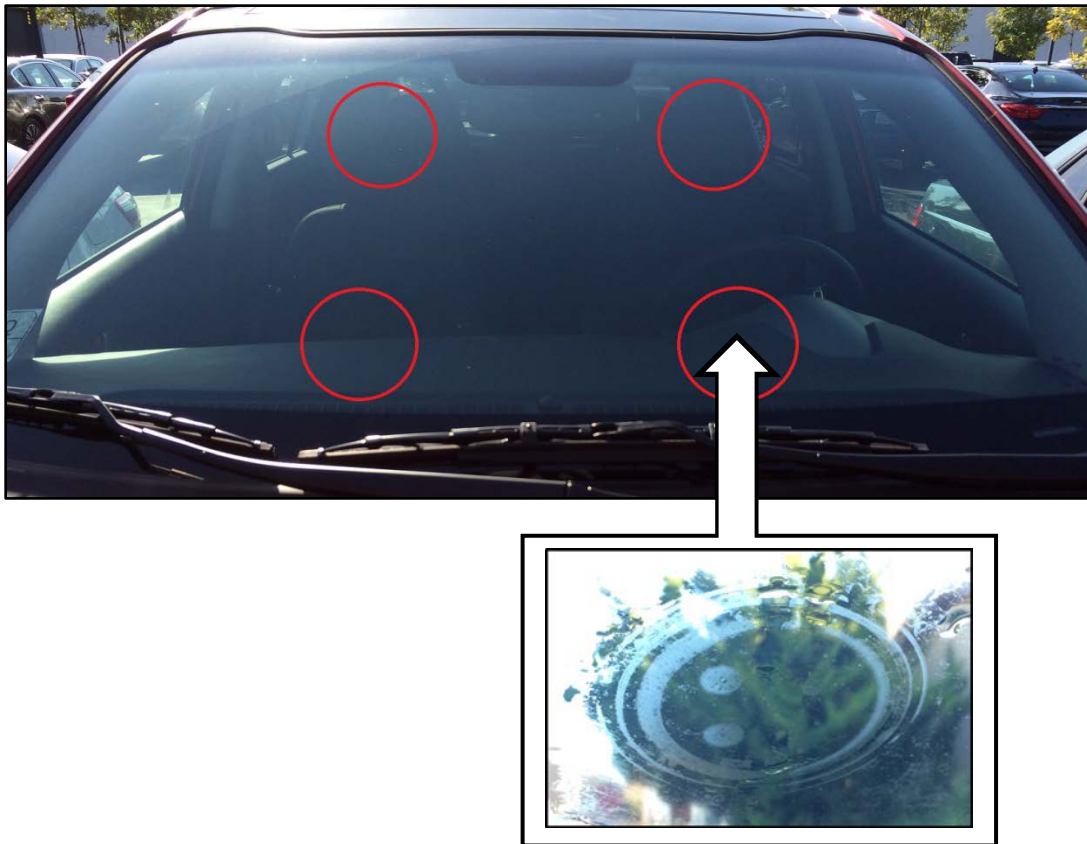
Residue from installation of the glass may cause the appearance of circular markings, in the shape of suction cups, to appear on the surface of the glass (example shown below). This condition is more apparent when condensation occurs on the glass and the moisture evaporates at different rates. To correct this condition, spray rubbing alcohol over the affected glass surface. Then, wipe the surface with a cloth. If the markings are still evident, continue spraying rubbing alcohol over the marking(s) and wiping with the cloth until all markings are removed from the surface. **NOTE: do NOT replace any glass surface over this concern.**
