MODEL  
2013-2014MY  
Optima (QF)

NUMBER  
PS297

**SUBJECT:** SQUEAKING NOISE FROM REAR OF VEHICLE

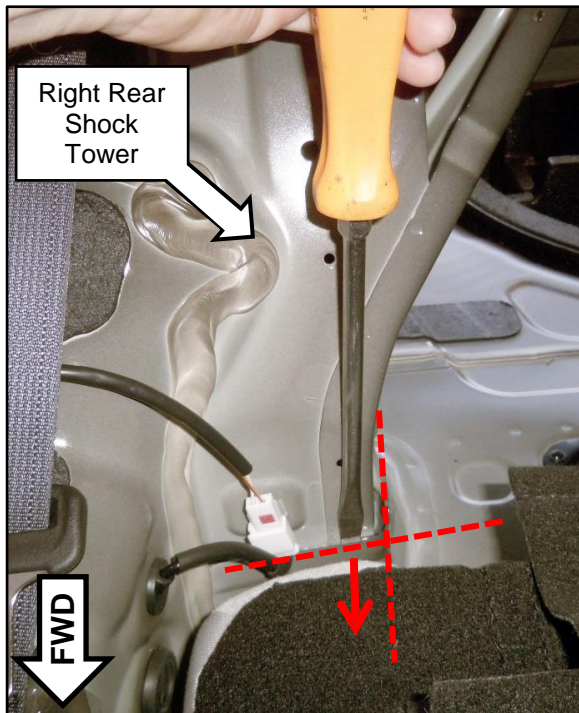
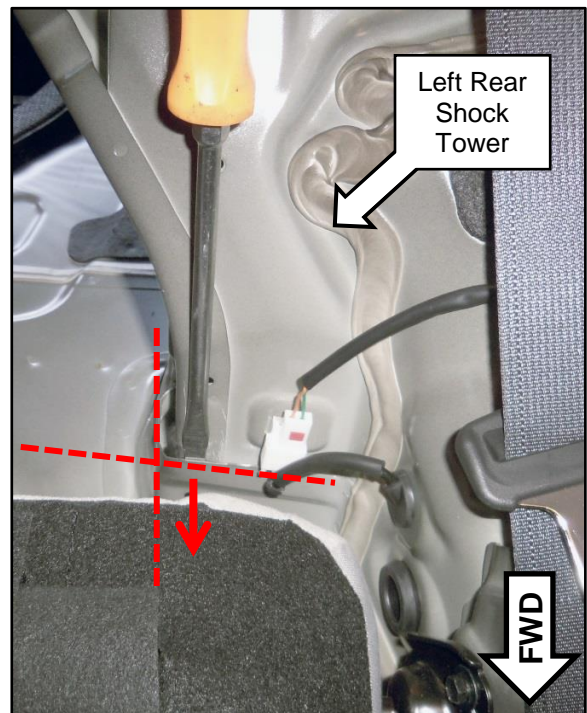
When addressing a customer complaint related to a squeaking sound emanating from the rear of the vehicle, and the noise can be isolated to the rear suspension, check the right and left rear shock towers as the most likely source of the noise. Once the noise has been isolated to either shock tower, use a large flat-head screw driver to provide extra clearance between the metal surfaces, at the locations shown in the images below. Make sure to only provide enough clearance to alleviate the noise concern. A sound file is available for reference by clicking on the attachment above.
