GROUP Body Electrical	MODEL 2014MY Optima (QF/TF) w/Base Audio
	NUMBER PS348	DATE September 2014

SUBJECT: DIM HEAD UNIT DISPLAY IN COLD WEATHER CONDITIONS

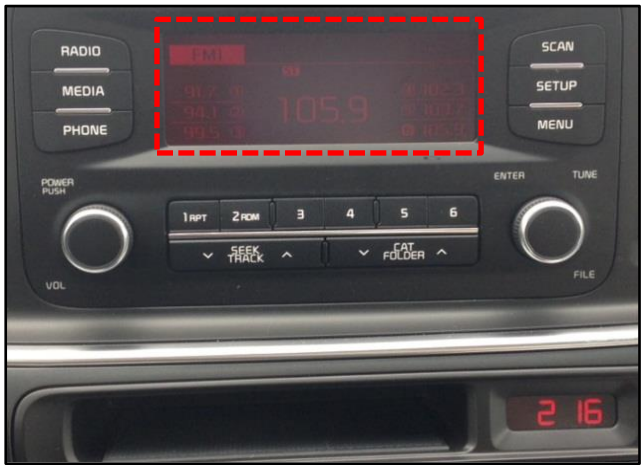
When addressing a customer complaint related to a Base Audio head unit display which appears to have no display or a dim display (see image below) at or below freezing conditions, pull the vehicle into a shop (warmer area) and check to see if full brightness is regained after a period of time. If full brightness is regained, the head unit should be replaced to resolve the concern. A countermeasure for this issue was applied to vehicles in production, on February 28, 2014 and to remanufactured units at the PDCs, beginning on May 1, 2014. If after replacement of the head unit the vehicle returns with the same concern, call Techline and open a case.
