# Service Bulletin

Bulletin No.: 12-09-41-001A

**Subject:** Information on Counterfeit Airbag Modules

**Models:** 2010-2011 Buick LaCrosse  
2006-2010 Chevrolet Aveo  
2011-2012 Chevrolet Camaro, Cruze, Volt

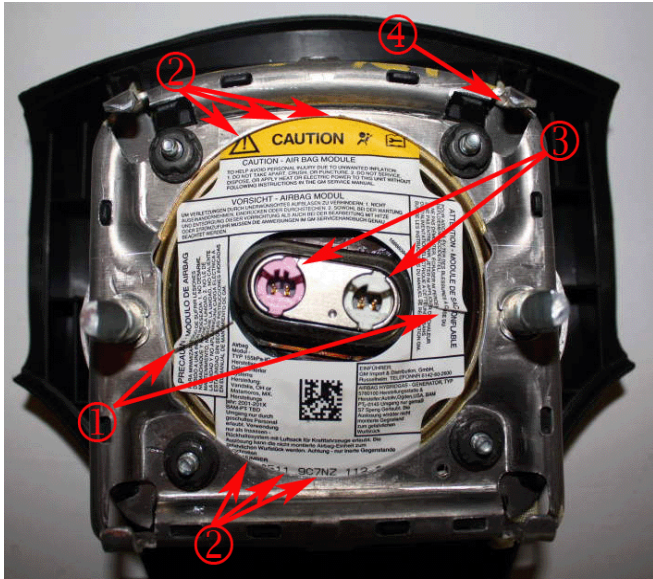
2918042

### Counterfeit Airbag Module

The pictured airbag module above is a confirmed counterfeit part. Please note the following:

- The caution label applied to the back of the module is the incorrect size and shape for the module. In order to place it in the intended location the label had to be folded over (1) in two places. Additionally, caution labels, will not be tucked under the backing plate (2) as shown.
- The electrical connectors (3) on the back of the airbag module will be color coded and match the connector color on the vehicle side. These connectors are keyed for each vehicle application and should not show any signs of being re-machined or tampered with.
- Examine the module for tool marks visible on the fasteners and/or grinder marks visible on the air bag backing plate. A counterfeit air bag may have numerous holes (4) drilled/cut into it, which allows the counterfeit air bag to be installed into a wider range of vehicles.

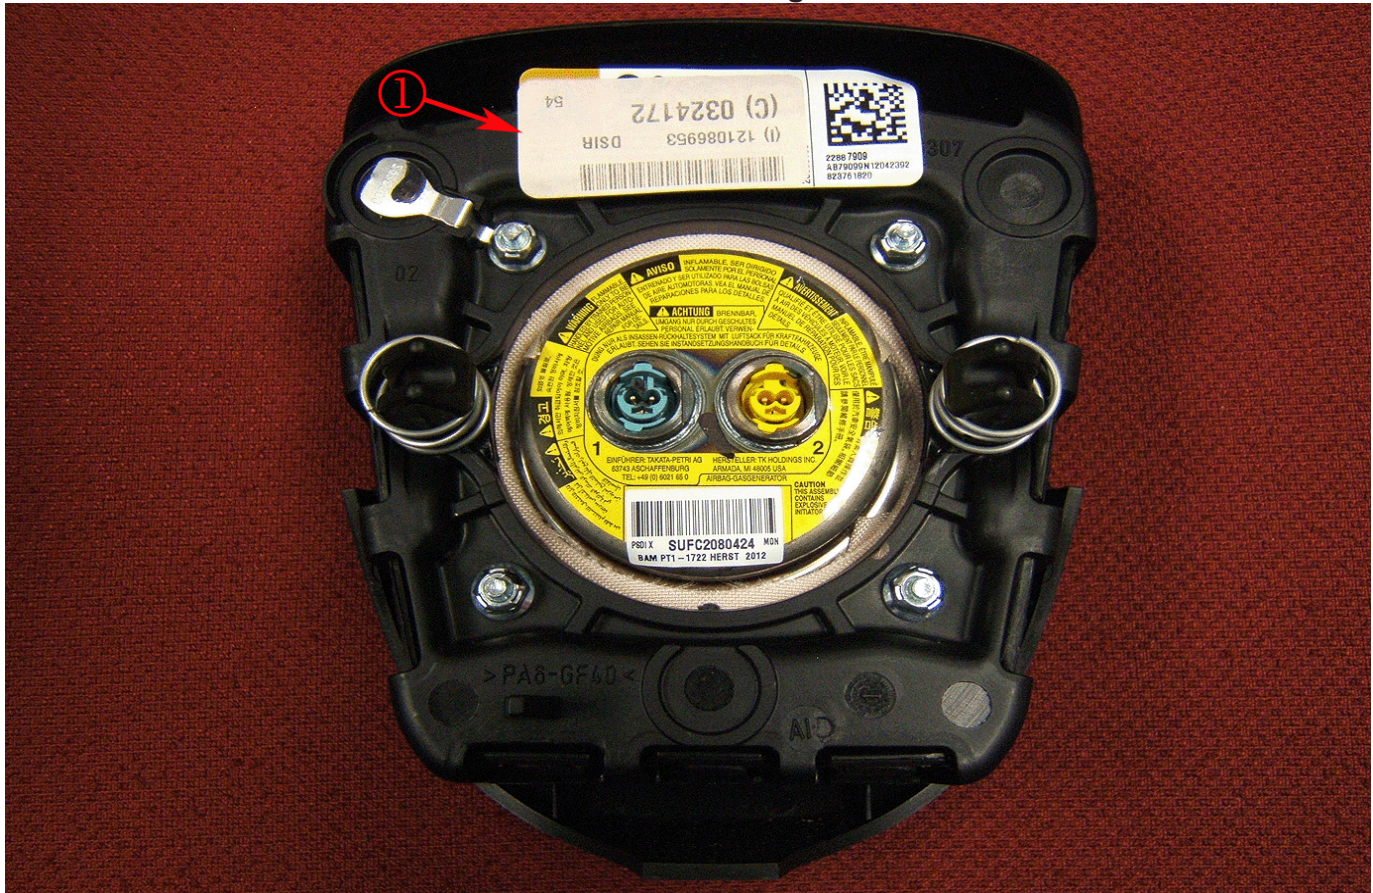
2918131

The Chevrolet Camaro uses a plastic backed airbag module black in color. The physical appearance of the module should exactly match the picture below.

**Genuine Camaro Airbag Module**

Look for inconsistent materials used, variation in the caution sticker, additional holes in the module, or any signs of tampering. The paper label (1) may be present, removed or placed at a different location on the module. This paper label should not be considered critical in validating the authenticity of this module.

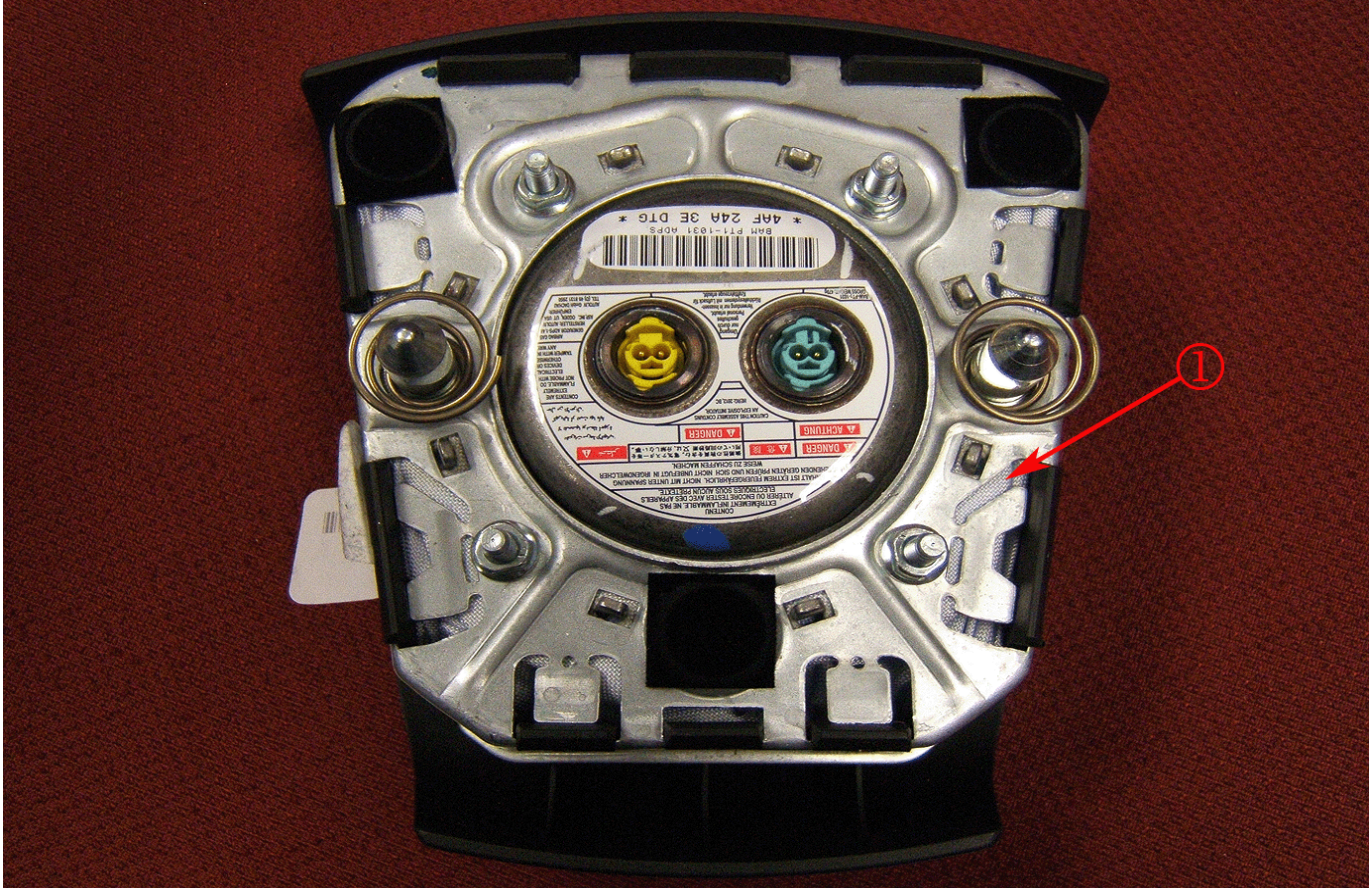
2918125

The Buick LaCrosse uses an unpainted metal backed airbag module. The physical appearance of the module should exactly match the picture below. Various part numbers are used for each application but the physical appearance is the same.

**Important:** This type of module allows the airbag (1) to be visible at several points around the edge of the module. Confirm the module has an airbag installed.

### Genuine LaCrosse Airbag Module

Look for inconsistent materials, stickers, additional holes in the module, or any signs of tampering.
