File in Section: -
Bulletin No.: PI0934
Date: March, 2013

Subject: Service Stabilitrak or Antilock Brake System Warning Lamp Illuminated

Models: 2013 Chevrolet Equinox
2013 GMC Terrain
All Built Prior to February 26, 2013

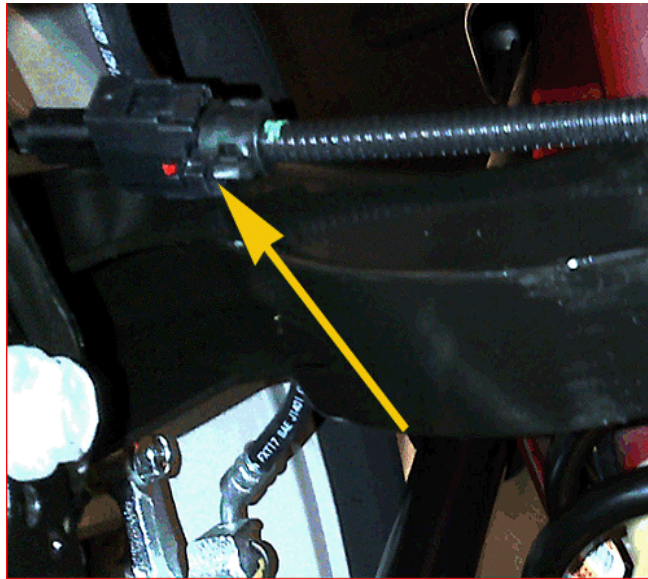
3329901

This condition may be caused by one or both of the rear wheel speed sensor (WSS) harness terminal(s) or connector(s) not being fully seated (connected).

Important: Do not attempt to re-seat the terminal into the connector. This will not be a permanent repair. If the terminal is out of position or not locked into the connector, the connector must be replaced.

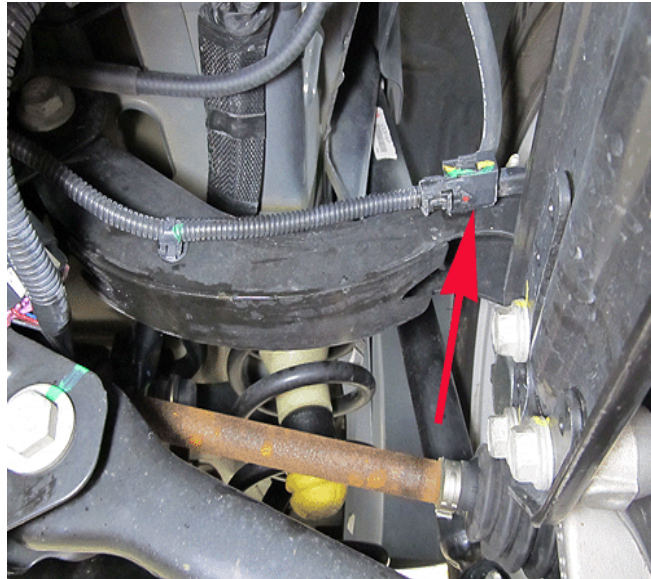
3344323

1. Locate the affected rear wheel speed sensor(s) (WSS) harness connector, located on the upper control arm.
2. Disconnect the harness from the wheel speed sensor lead.

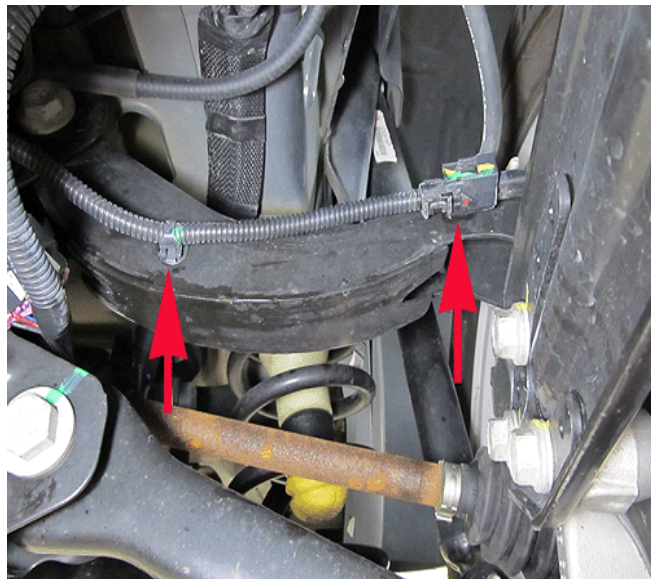
3344325

3. Release the two harness retainers from the control arm.

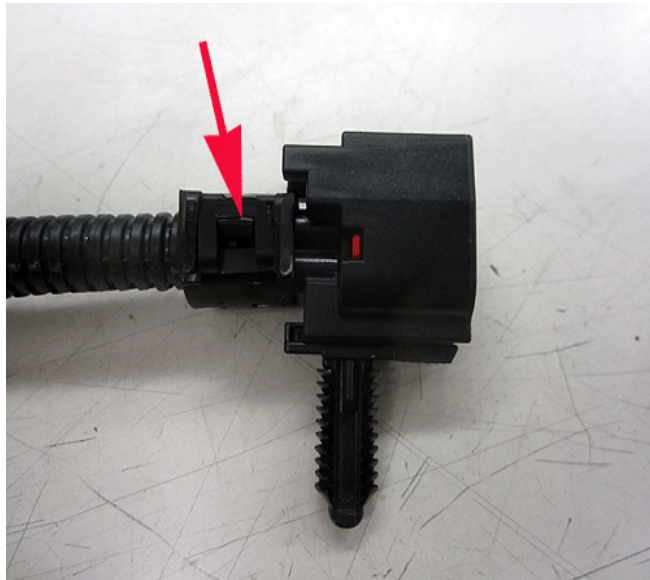
3344329

4. Remove the connector to conduit collar.

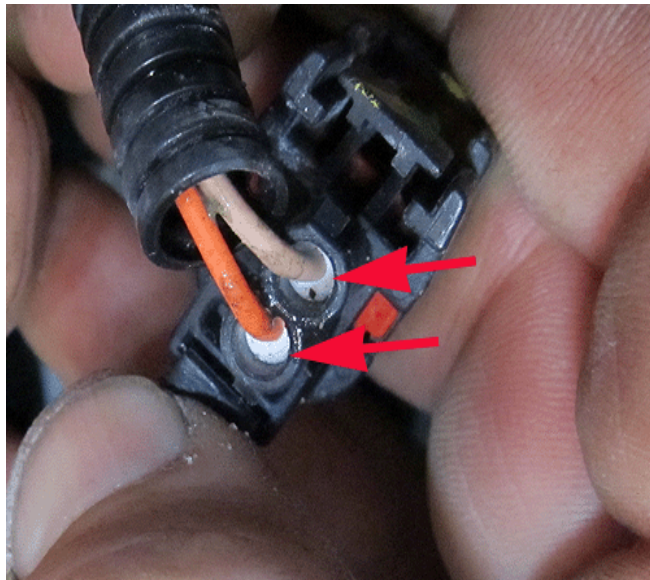
3344330

5. Inspect the wire side of the connector and ensure the grommets are fully seated in the connector.

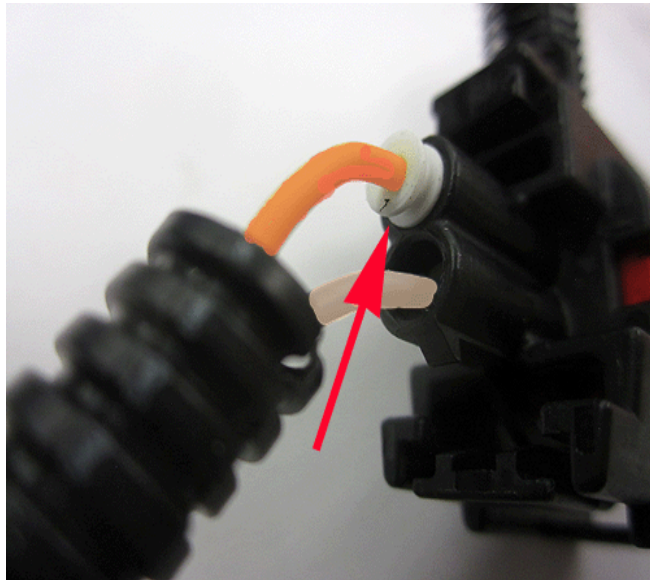
3344333

- If the wire is not fully seated, replace the connector.

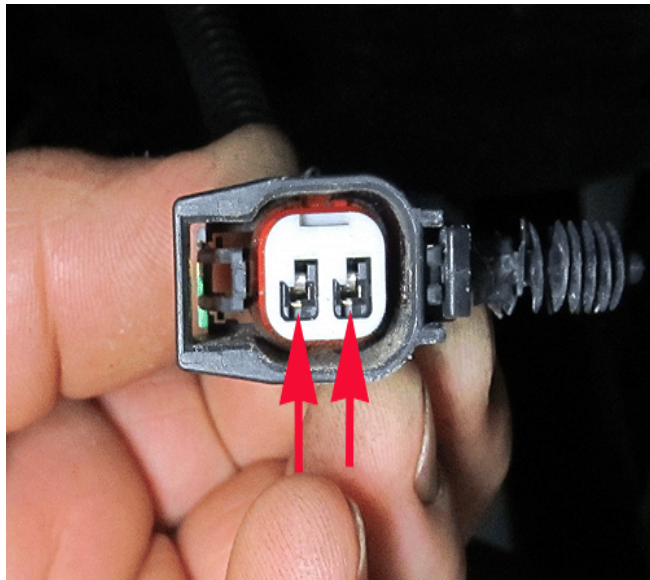
3344342

6. Inspect the terminals and ensure they are not damaged or pushing out of position in the connector.

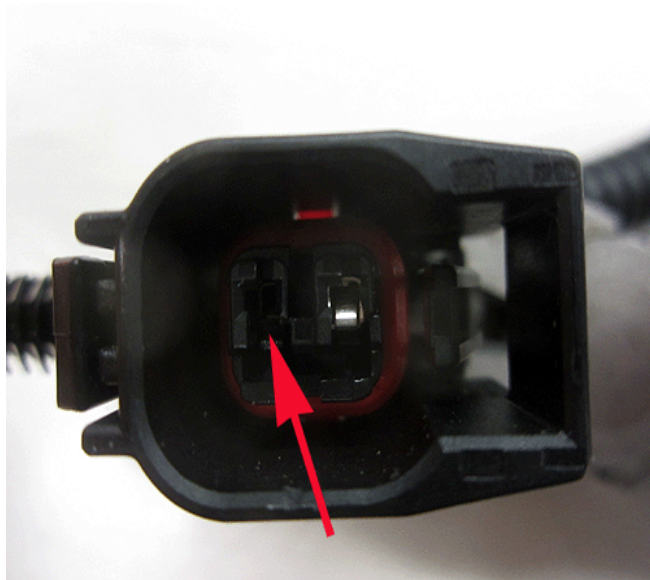
3344353

- If a terminal is out of position, replace the connector.
 - If a terminal is damaged, replace the terminal and the connector.
7. Reinstall the connector to conduit collar.
 8. Reconnect the harness to the wheel speed sensor.
 9. Reattach the harness to the control arm.
 10. Clear the DTCs as required.
