L83X-A.01.14

To: Official After Sales Network
Subject: Installation Of Rubber Boot Onto Alternator
Date: 14th/02/14
Pages: 4

Installation of rubber boot onto alternator.

All Lamborghini Model Aventdor MY 12, 13 and 14 Coupe And Roadster from VIN CLA00091 to VIN ELA02542.

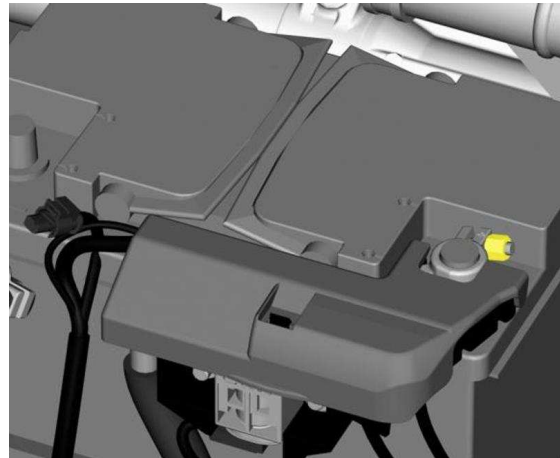
2. Remove trunk pool to get access to battery.
3. Unscrew fastener bolt onto positive pole

Torque: **6 Nm**

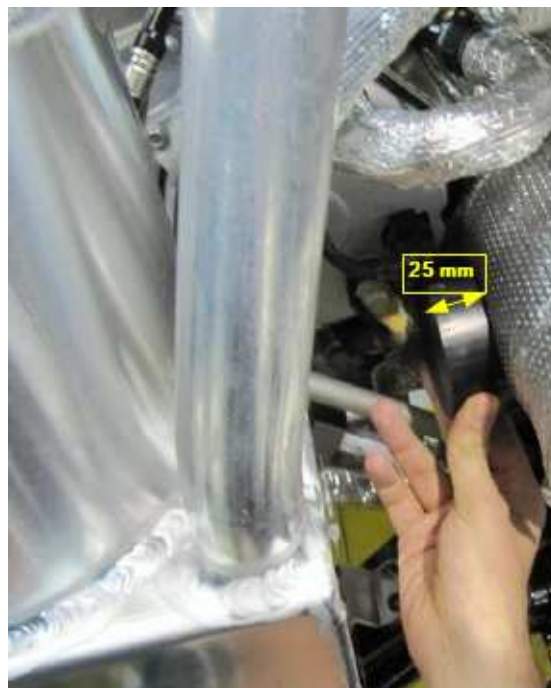
8. Check the distance between firewall and positive cable is 25 mm.
