# Service Bulletin

Bulletin No.: PIT5224

**Subject:** Updated Left and Right I/P Fuse Block Labeling

**Models:** 2014 Chevrolet Silverado 1500  
2014 GMC Sierra 1500  
Built Prior to July 26, 2013 in Silao (11th Vin Position = G)

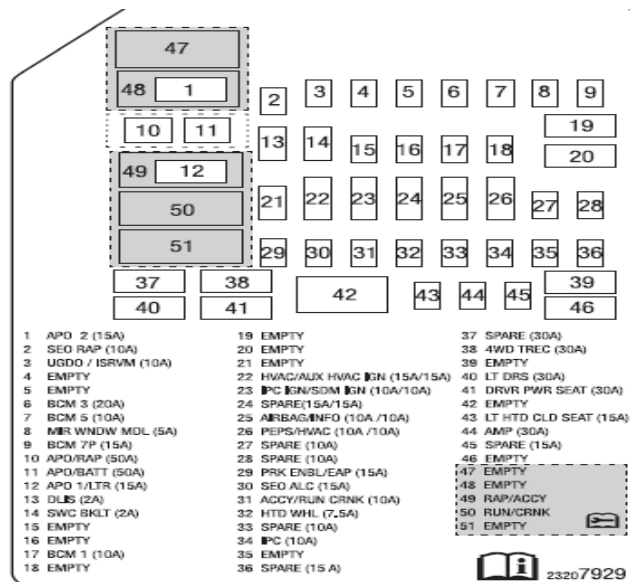
3600974

After inspecting the Left and/or Right I/P Fuse Block Labels, it may be noted the numbering is incorrect.

Inspect the lower right corner of each label for P/N 23114670 (Left) and/or P/N 23114671 (Right). If these part numbers are found, replace the label(s) with updated label(s): P/N 23207928 (Left) and P/N 23207929 (Right). See photos below of the updated labels.
