Service Bulletin

Bulletin No.: 12-09-41-001A

Subject: Information on Counterfeit Airbag Modules

Models: 2010-2011 Buick LaCrosse
2006-2010 Chevrolet Aveo
2011-2012 Chevrolet Camaro, Cruze, Volt

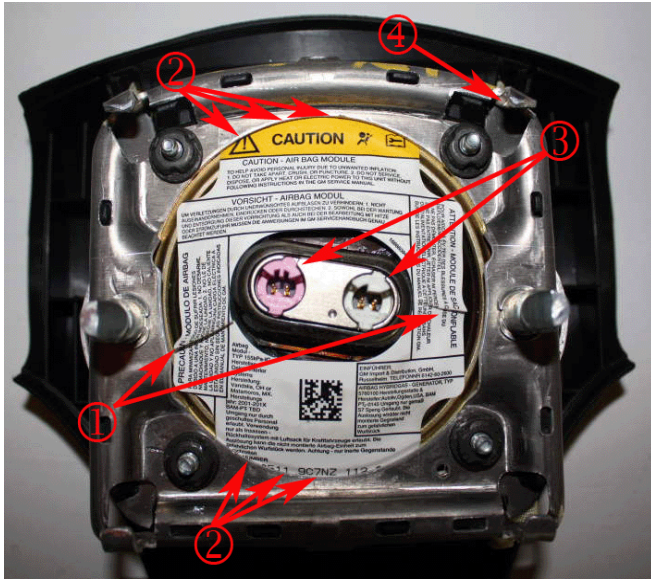
2918042

Counterfeit Airbag Module

The pictured airbag module above is a confirmed counterfeit part. Please note the following:

- The caution label applied to the back of the module is the incorrect size and shape for the module. In order to place it in the intended location the label had to be folded over (1) in two places. Additionally, caution labels, will not be tucked under the backing plate (2) as shown.
- The electrical connectors (3) on the back of the airbag module will be color coded and match the connector color on the vehicle side. These connectors are keyed for each vehicle application and should not show any signs of being re-machined or tampered with.
- Examine the module for tool marks visible on the fasteners and/or grinder marks visible on the air bag backing plate. A counterfeit air bag may have numerous holes (4) drilled/cut into it, which allows the counterfeit air bag to be installed into a wider range of vehicles.

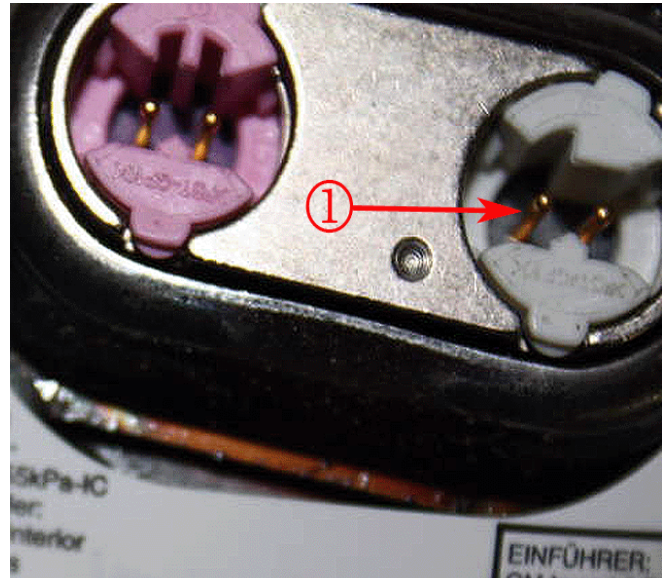
2918044

Vehicles that are the subject of this service information all have airbag modules equipped with “shorting bars” (2) incorporated in the electrical connectors. Grounding terminals or “shorting bars” on the inflator wire connectors prevent the air bag from deploying when disconnected from the vehicle system are missing this counterfeit airbag.

Shorting Bars Missing

In the photos above you can identify the grounding terminals or shorting bars (2). In all cases the shorting bars appear as a gold plated U-shaped piece of metal on genuine GM airbags. Counterfeit modules (1) often omit these secondary contacts.

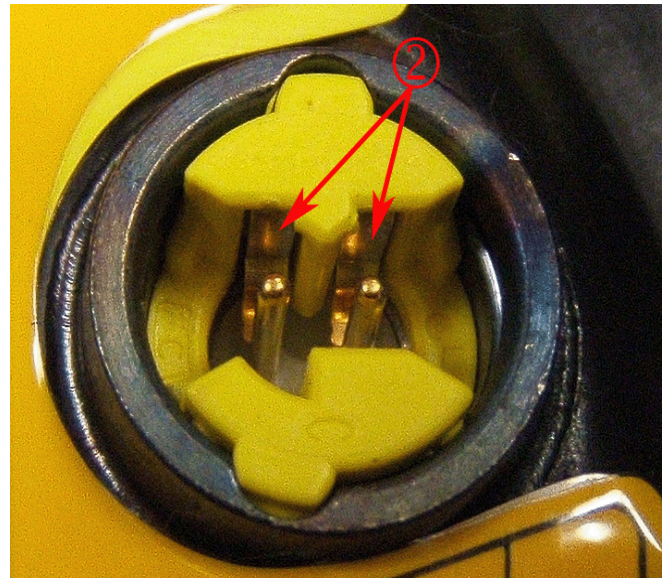
2918141

Shorting Bars Present

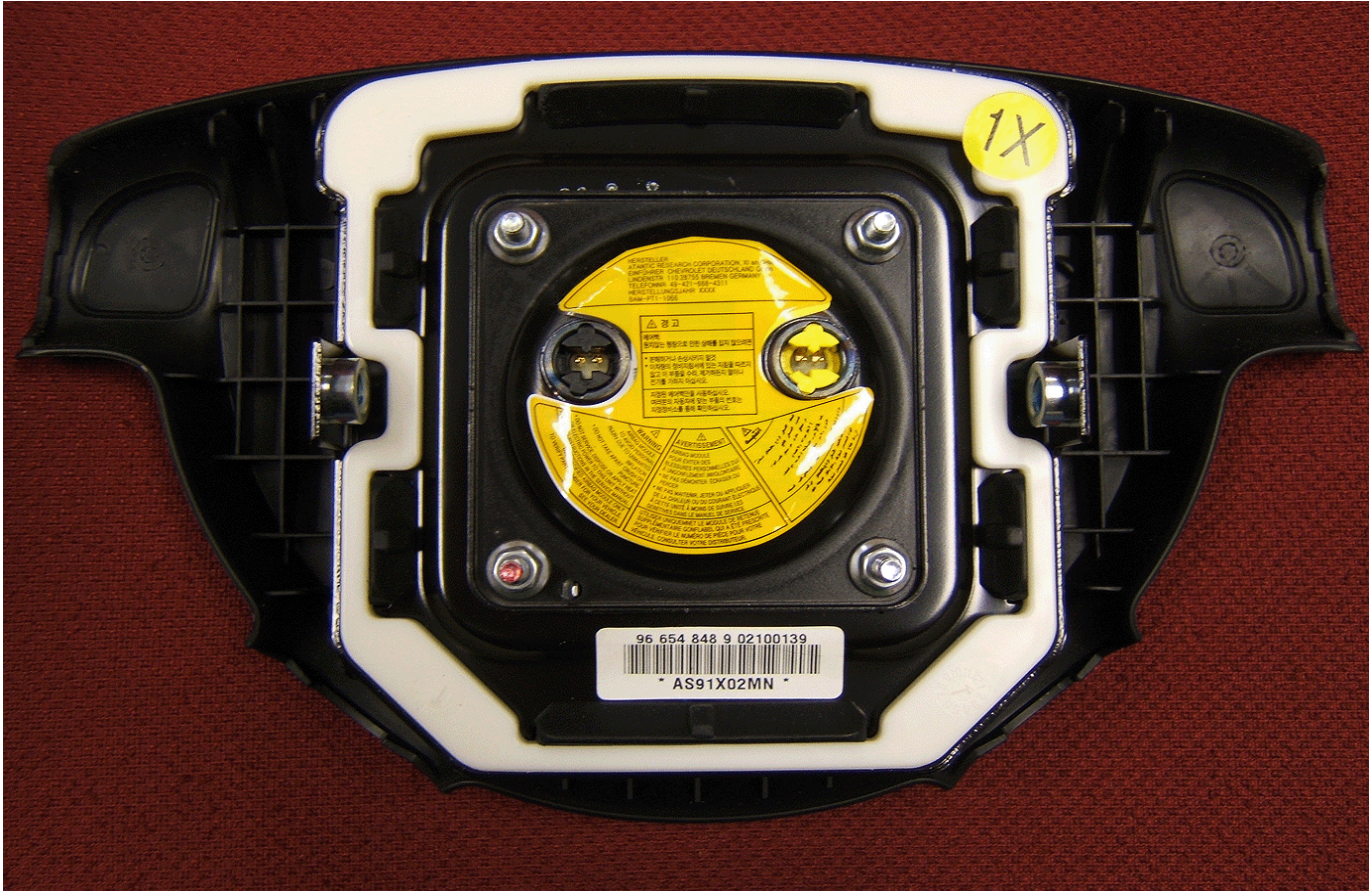
2918128

The Chevrolet Aveo uses a metal backed airbag module that is painted black. The physical appearance of the module should exactly match the picture below.

Genuine Aveo Airbag Module

Look for inconsistent materials, stickers, additional holes in the module, or any signs of tampering.

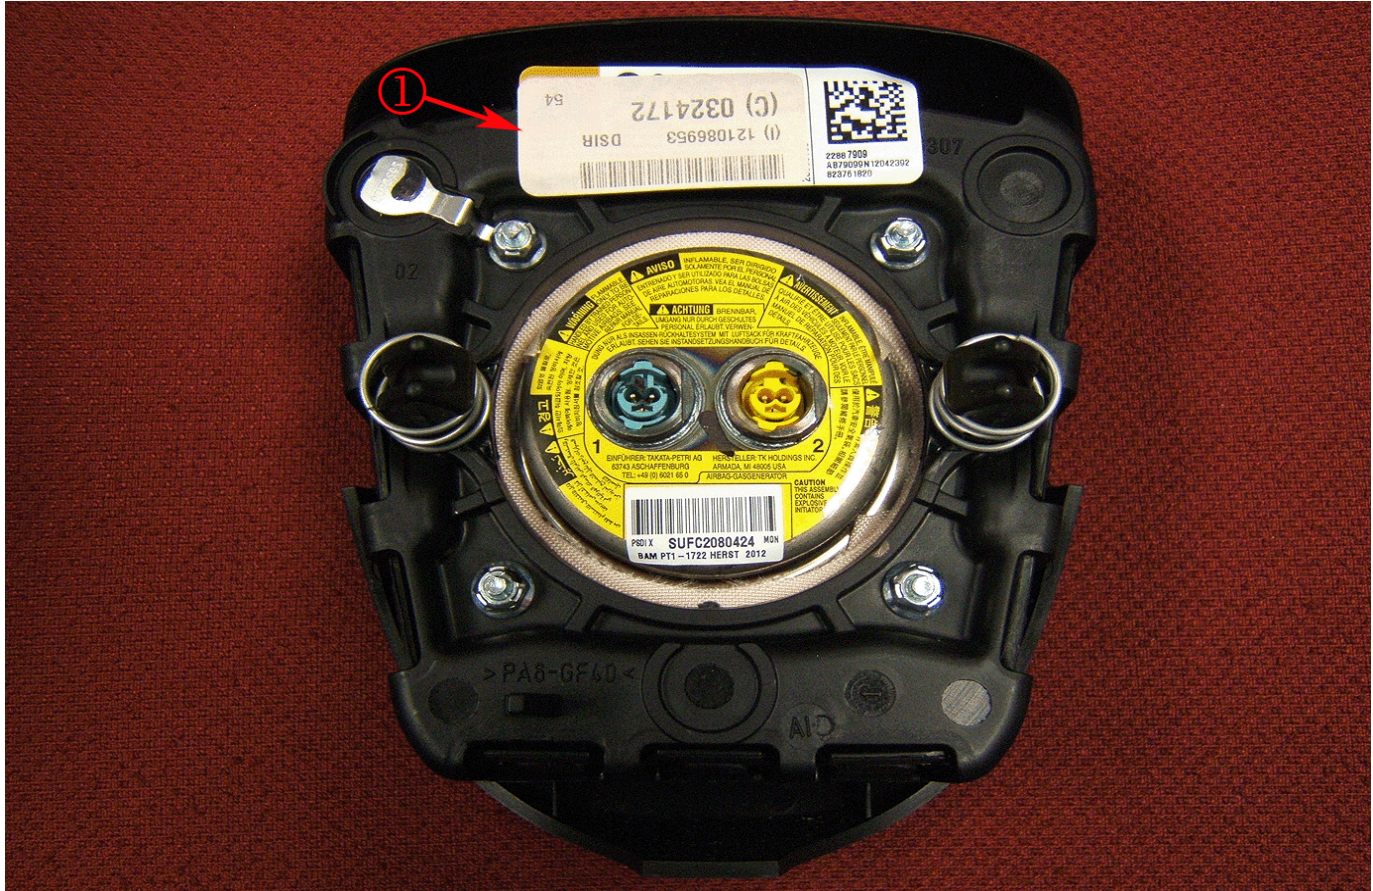
2918131

The Chevrolet Camaro uses a plastic backed airbag module black in color. The physical appearance of the module should exactly match the picture below.

Genuine Camaro Airbag Module

Look for inconsistent materials used, variation in the caution sticker, additional holes in the module, or any signs of tampering. The paper label (1) may be present, removed or placed at a different location on the module. This paper label should not be considered critical in validating the authenticity of this module.

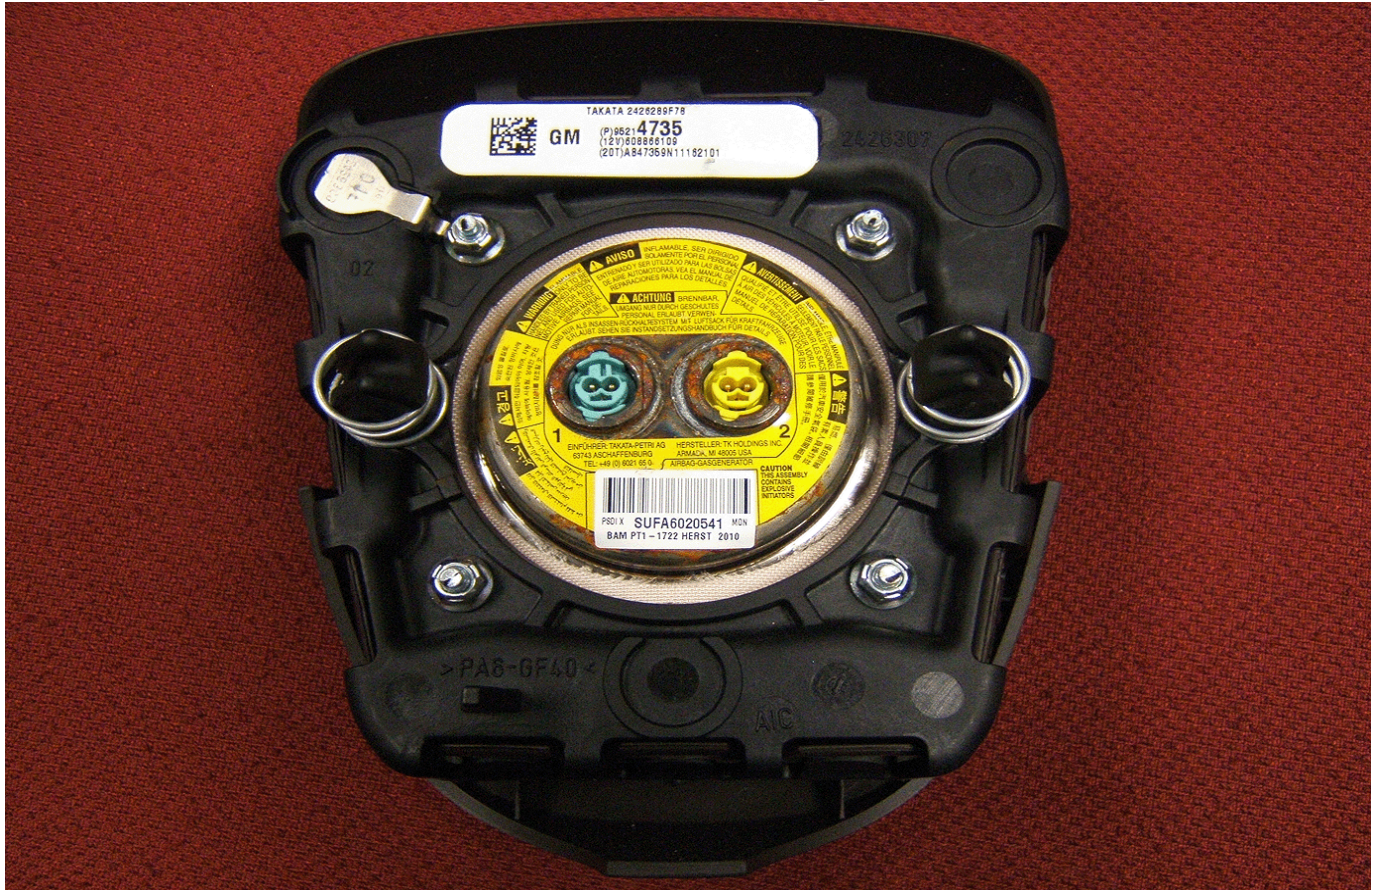
2918132

The Chevrolet Cruze / Volt uses a plastic backed airbag module black in color. The physical appearance of the module should exactly match the picture below. One example is shown for both vehicles. Various part numbers are used for each application but the physical appearance is the same.

Important: This example shows corrosion on the bare metal near the electrical contacts. This is a normal condition you may encounter, and is not an indication of counterfeit, remanufactured or reclaimed parts. The corrosion does not affect operation of the airbag module.

Genuine Cruze / Volt Airbag Module

Look for inconsistent materials, stickers, additional holes in the module, or any signs of tampering.

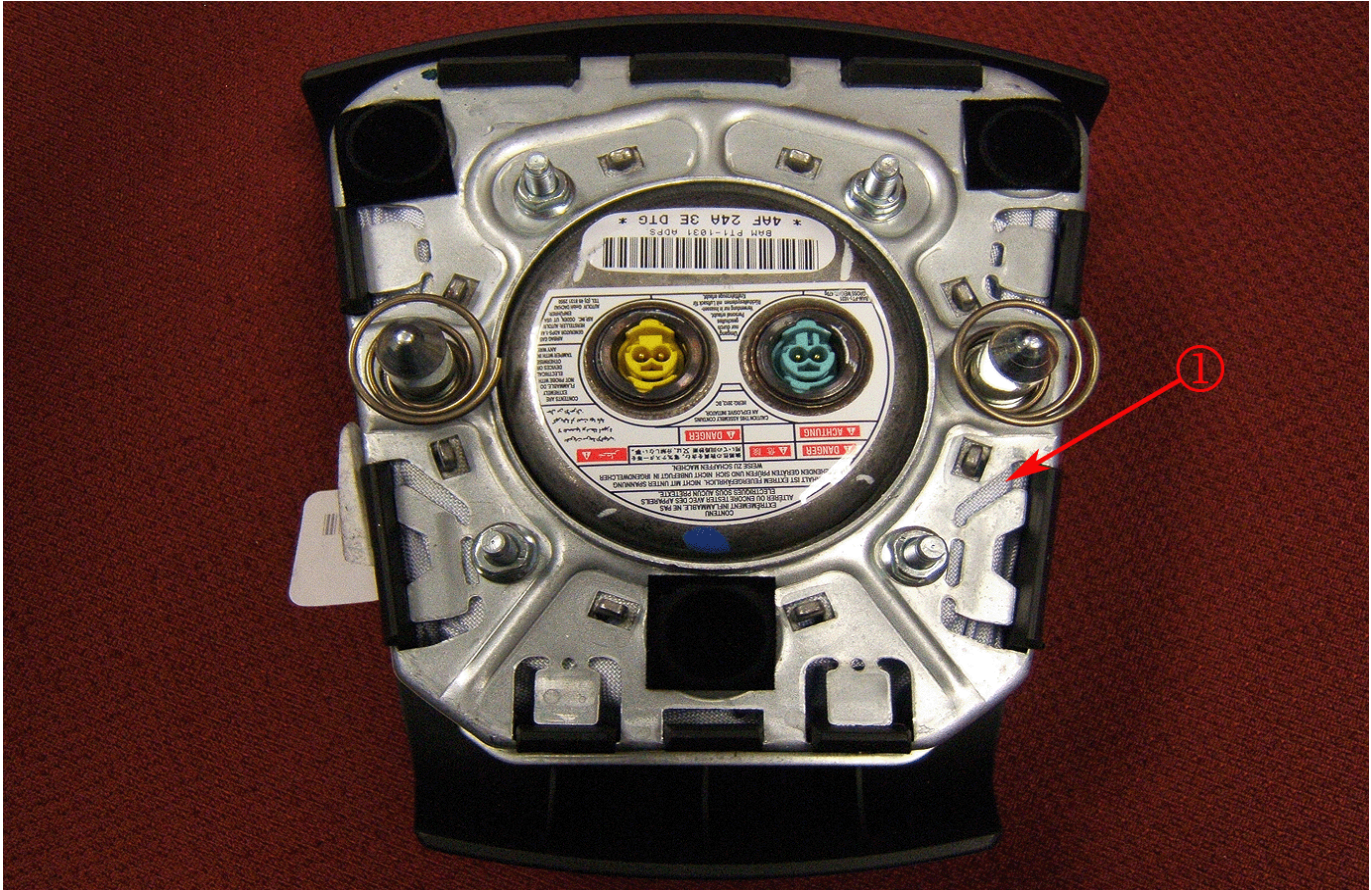
2918125

The Buick LaCrosse uses an unpainted metal backed airbag module. The physical appearance of the module should exactly match the picture below. Various part numbers are used for each application but the physical appearance is the same.

Important: This type of module allows the airbag (1) to be visible at several points around the edge of the module. Confirm the module has an airbag installed.

Genuine LaCrosse Airbag Module

Look for inconsistent materials, stickers, additional holes in the module, or any signs of tampering.
