Service Bulletin

Bulletin No.: PIT5278A

Subject: Power Liftgate Erratic Operation Will Not Power Close DTC B153A And/Or Motor Running But Does Not Move

Models: 2015 Cadillac Escalade Models
2015 Chevrolet Tahoe, Suburban
2015 GMC Yukon Models

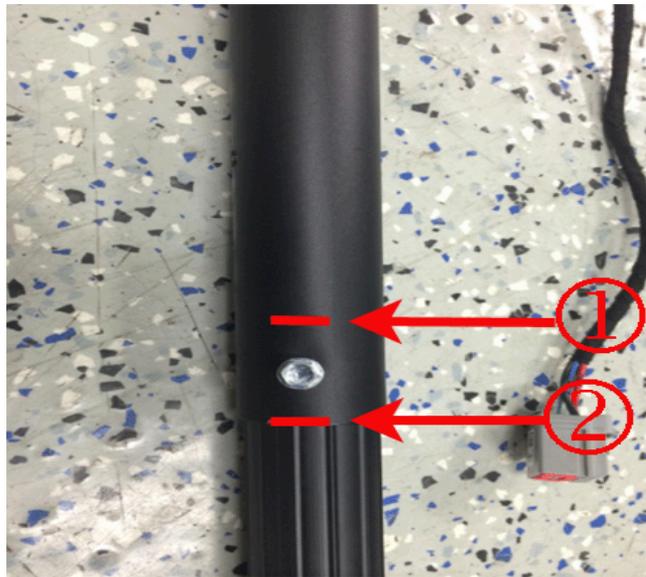
3825803

1. Obtain one #8 self-tapping screw 1 1/2 inches long.
2. Fully open the liftgate.
3. Install the self-tapping screw any place in the 30 mm space (from the bottom of the smooth tube) between location 1 and 2. As reflected below, a location of 20 mm (approximately 3/4") is ideal to secure the tubes.

Note: The screw will hold the strut together for removal.
