Service Bulletin

Bulletin No.: PIT5318A

Subject: Wind Buffeting Droan Type Noise And/Or Body Pressure Booming And/Or Water Leak

Models: 2015 Cadillac Escalade Models
2015 Chevrolet Suburban, Tahoe
2015 GMC Yukon Models

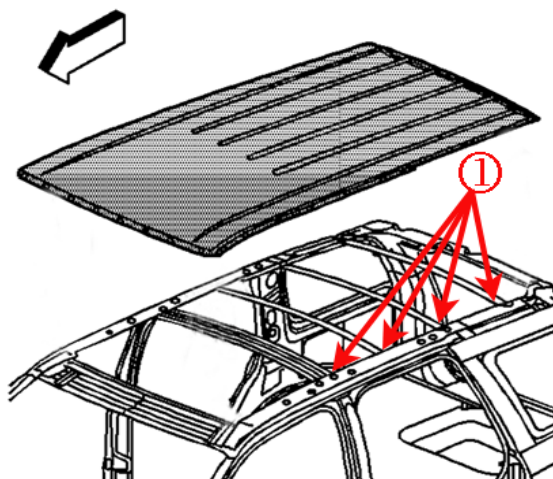
These concerns could be caused by the roof sheet metal no longer being attached fully to the roof bows (1). On trucks with a sunroof, it may be noticed that the rear edge of the sunroof glass is considerably lower than the roof (2). This is due to the roof sheet metal being detached from the roof bow directly behind the sunroof opening (3).

To correct this concern, apply panel vibration control material between the roof bow and roof sheet metal, along with foam shim material when necessary.
