Service Bulletin

Subject: Water Leak In Rear Floor Area

Models: 2011 - 2015 Chevrolet Camaro Convertible

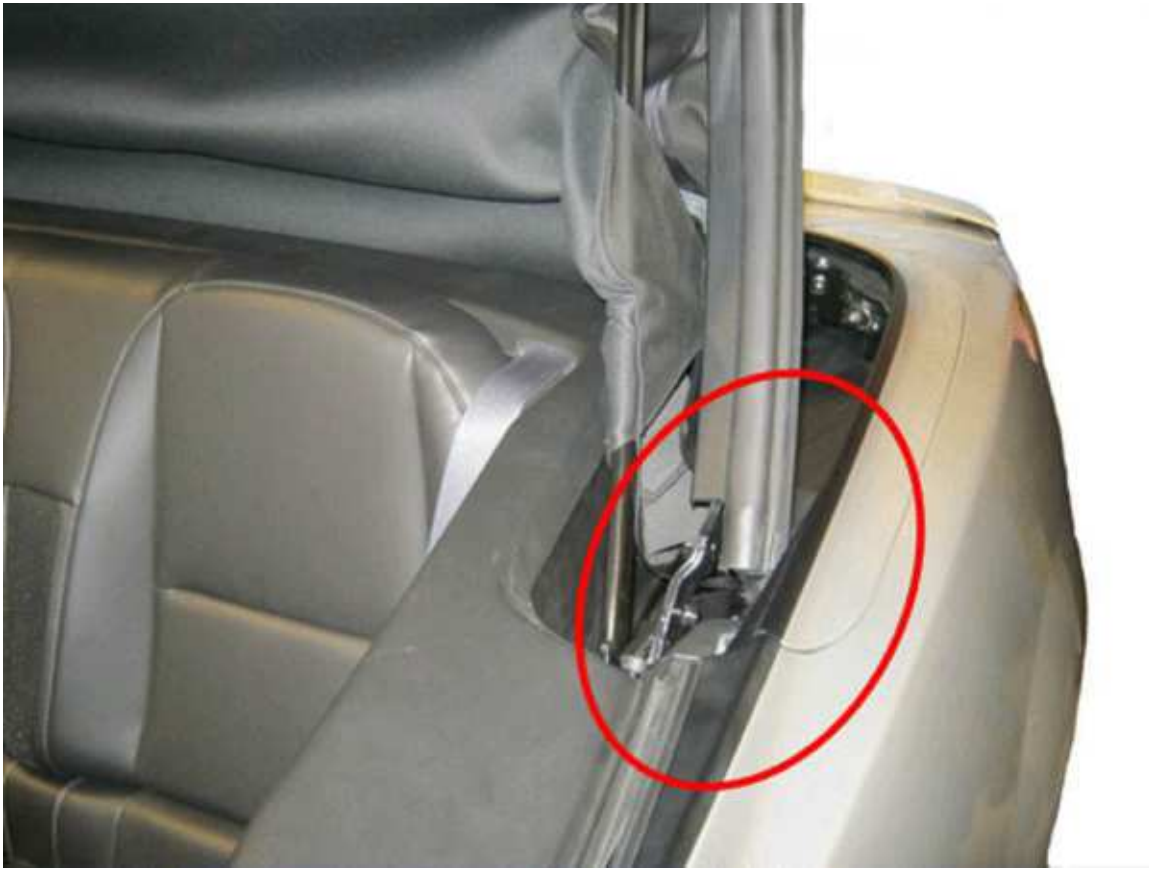
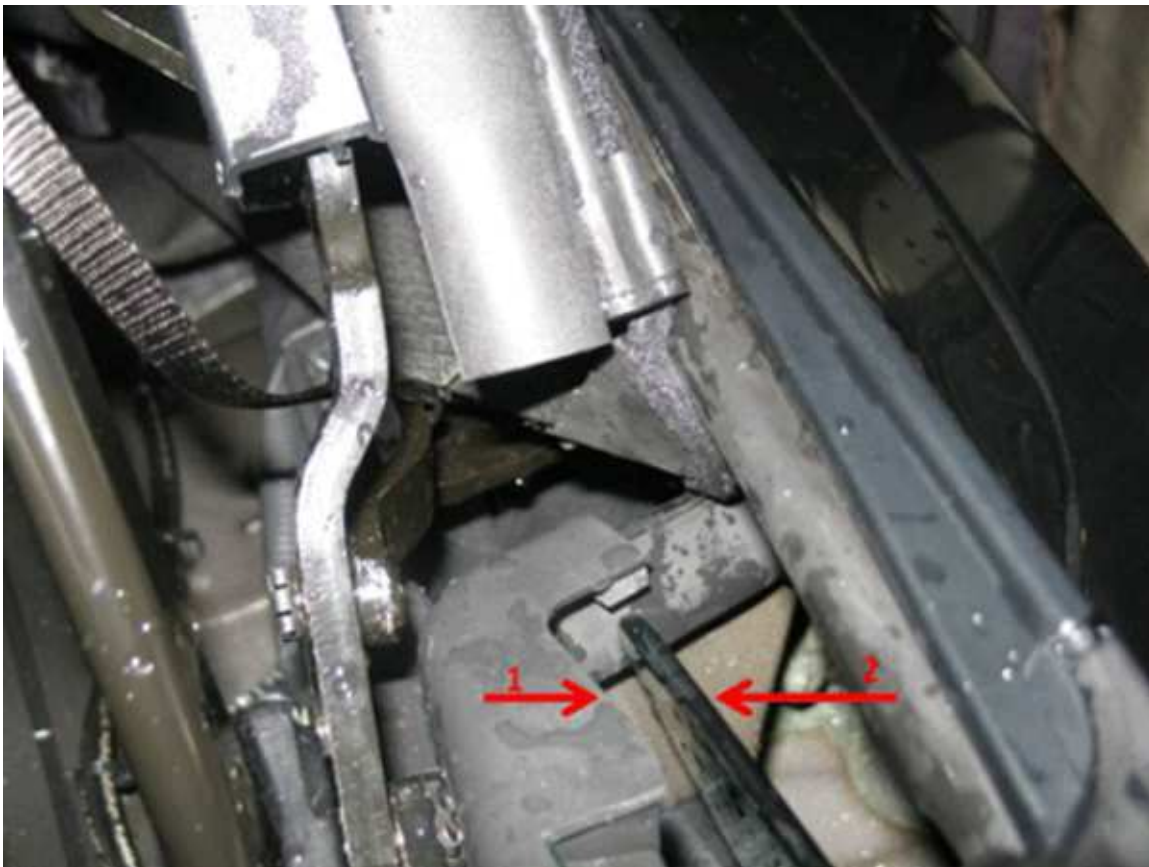
Everything to the inboard side of the rear quarter glass is considered a dry area; water should not be in the "dry area" (1). Everything to the outboard side of the rear quarter glass is considered the "wet area" (2). It is acceptable and by design that water is present on the outboard side of the rear quarter glass and in the area of the quarter glass regulator that the front drain spills into.

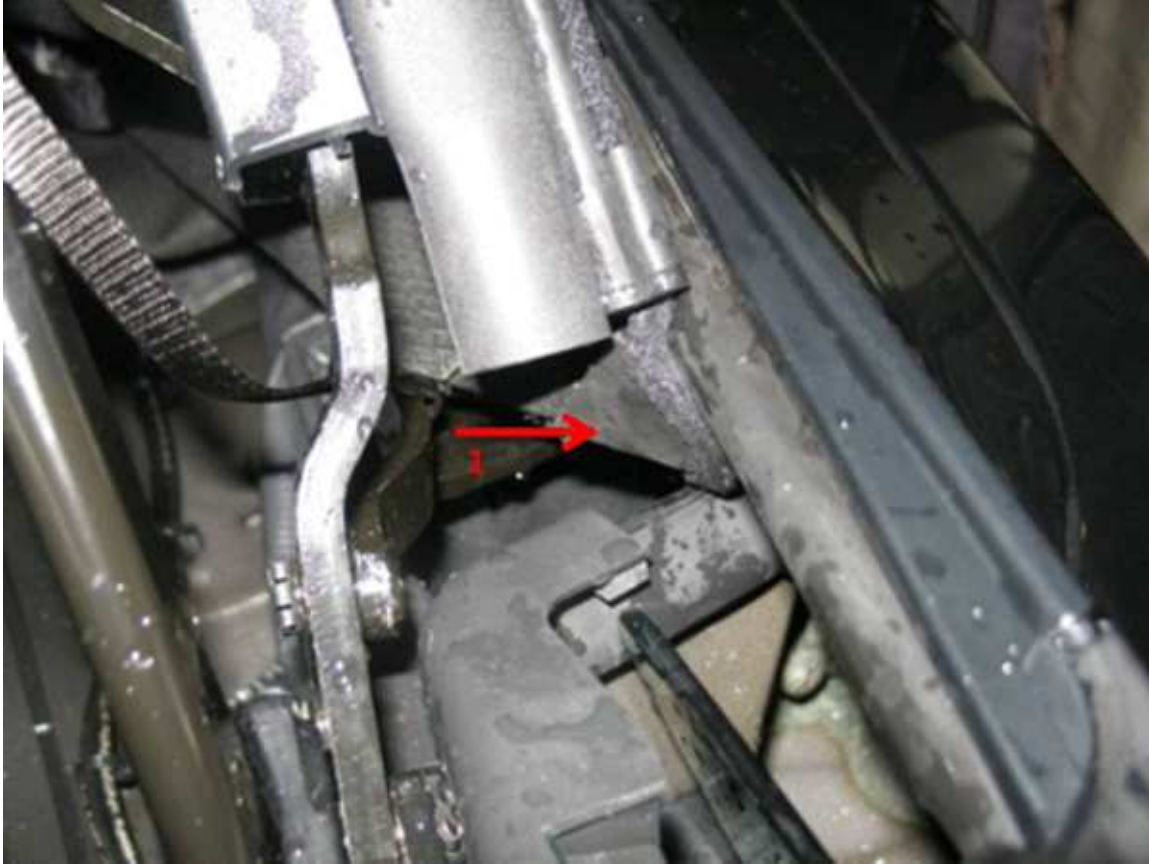
Correct Position

management bag. If the water doesn't drain into the water management bag verify that the plastic water diverter (1) that is sewn into the top is on the "wet side" of the trim. The two pictures below show this plastic diverter in both the correct and incorrect positions.

With the top in the closed and latched position, have an assistant stand outside of the vehicle and run water over the top of the car. While sitting in the back seat, lift the headliner up in the area behind the quarter window. With the water running, look past the headliner to confirm the water is draining into the water

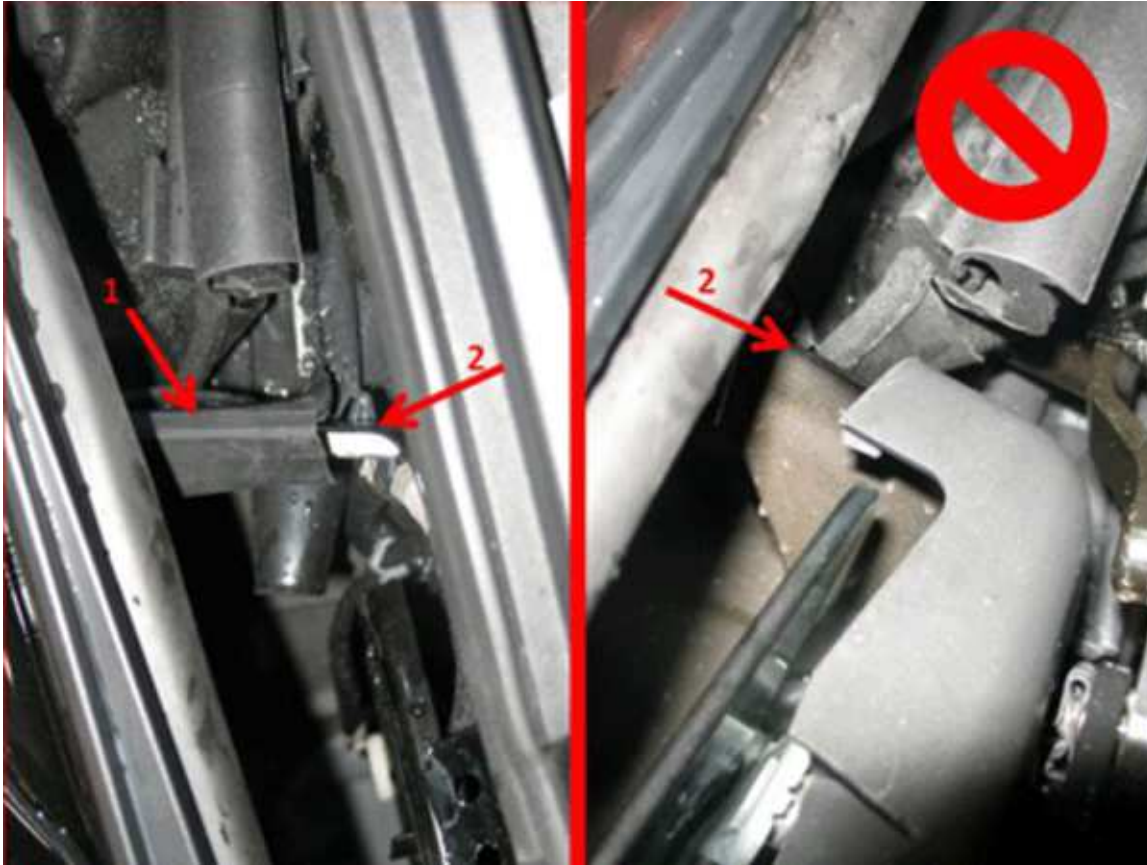
Verify the front of the water management bag is properly attached to the body sheet metal panel. In the photo below, the water bag (1) is correctly positioned and attached to the vehicle's sheet metal (2) in the LH photo. The RH photo shows the bag where it is not attached (2) to the sheet metal of the vehicle.

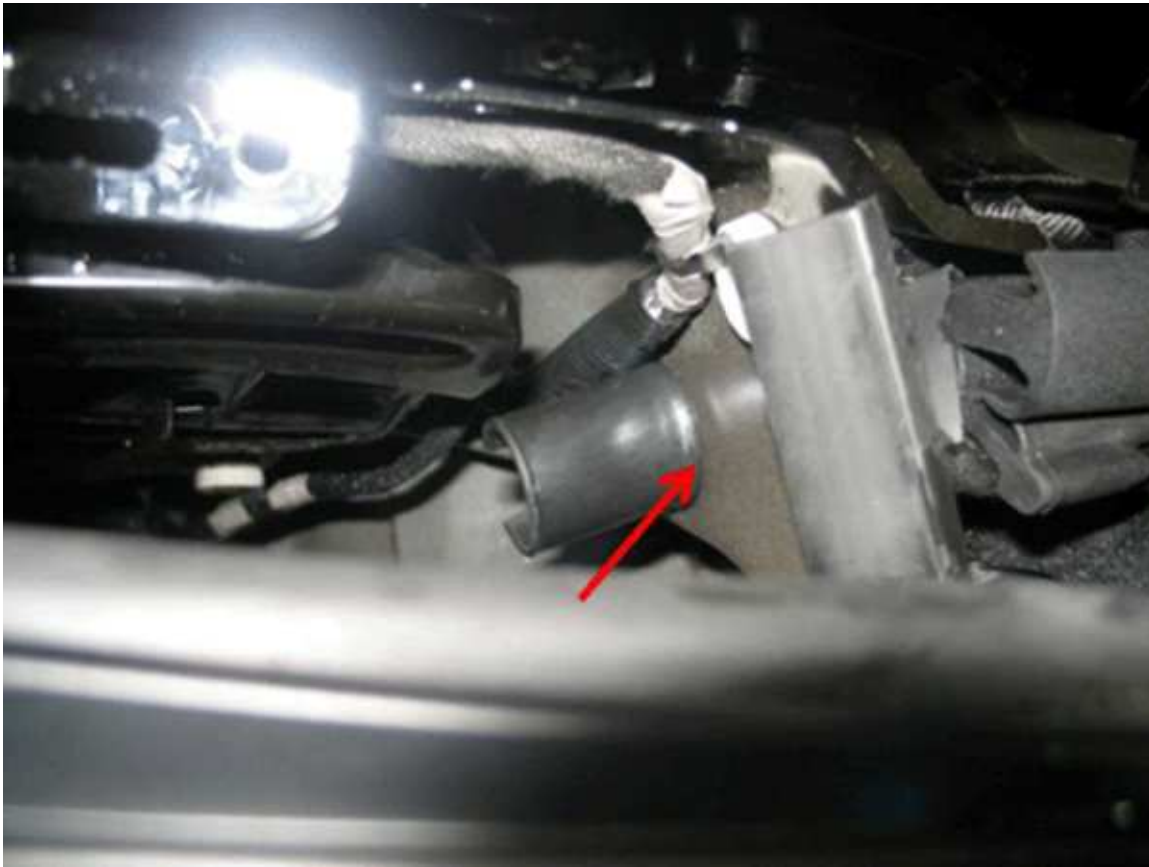
Inspect the front drains for proper installation. This can be difficult to confirm due to the limited space and limited visibility in this area. The following picture illustrates a drain that is not fully seated in position. The front drains are difficult to install and may not be fully seated in the body sheet metal panel. If the front drains were previously dislodged, it is possible that the drain may have taken set and will not remain in place. Replace the water management bag ONLY if the drain will not stay in place. Water management bag replacement can only be performed after removing the top from the vehicle.

Important: It is normal for the quarter glass window to make light contact with this drain when the window is rolled down. Modifications to the upper lip of the drain can be made if cycling the window results in the drain tube being pushed out of the sheet metal. An opening on the top of the drain tube that resembles the opening on the bottom of the tube can be made for this condition. The drain will not fall out of the body sheet metal unless the drain is not fully seated.

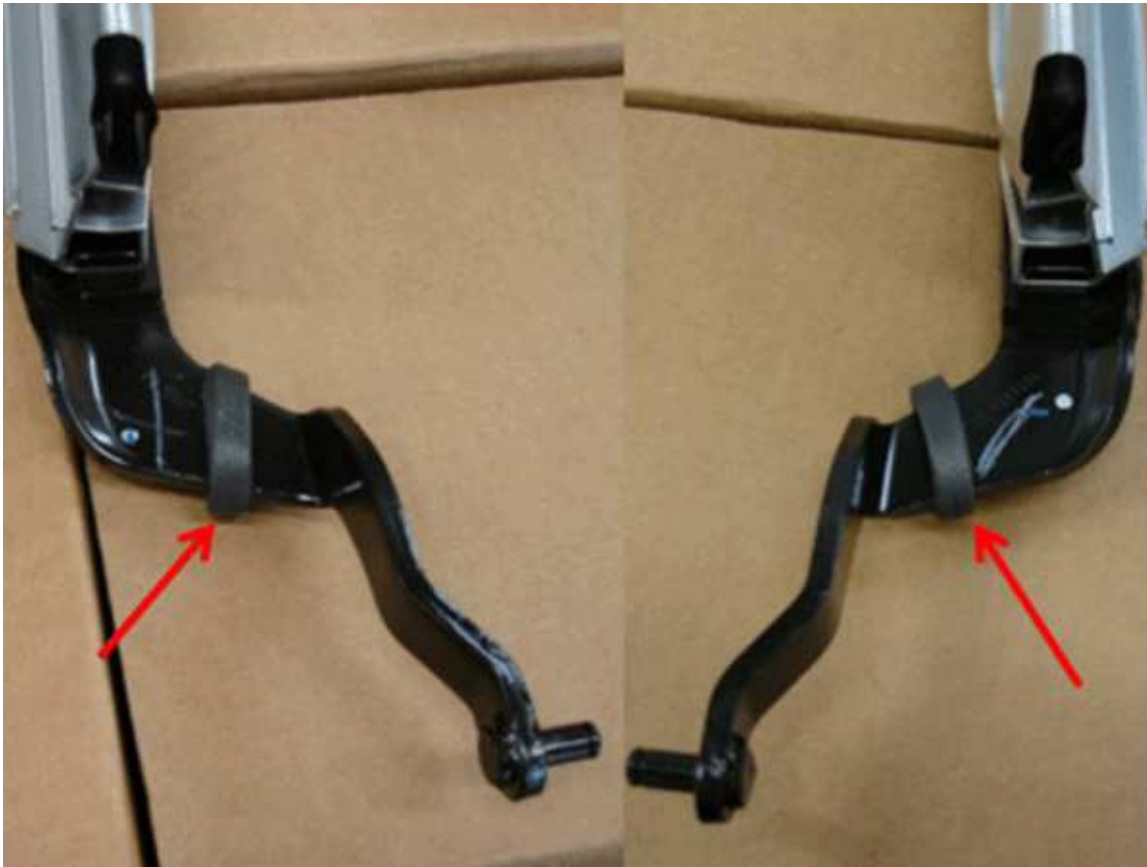
Verify the presence and proper location of the foam tape on both the left and right side 5 bow brackets, as shown in the following photograph.

By design, water runs along the folding top and down to the 5 bow and 5 bow brackets. It runs down until it hits the pieces of foam. Once it reaches this foam, it can no longer wick down the brackets and into the vehicle. Instead, the water drips off the brackets, directly into the water bag located directly below these foam pieces. If the foam pieces are damaged or missing, they will need to be replaced. If the foam pieces are still present, an additional layer of foam tape may be added on top of the existing foam pieces. This will make the foam stand taller, preventing water from overcoming the height of the foam. This peel-and-stick foam tape can be purchased at any local home improvement or hardware store.

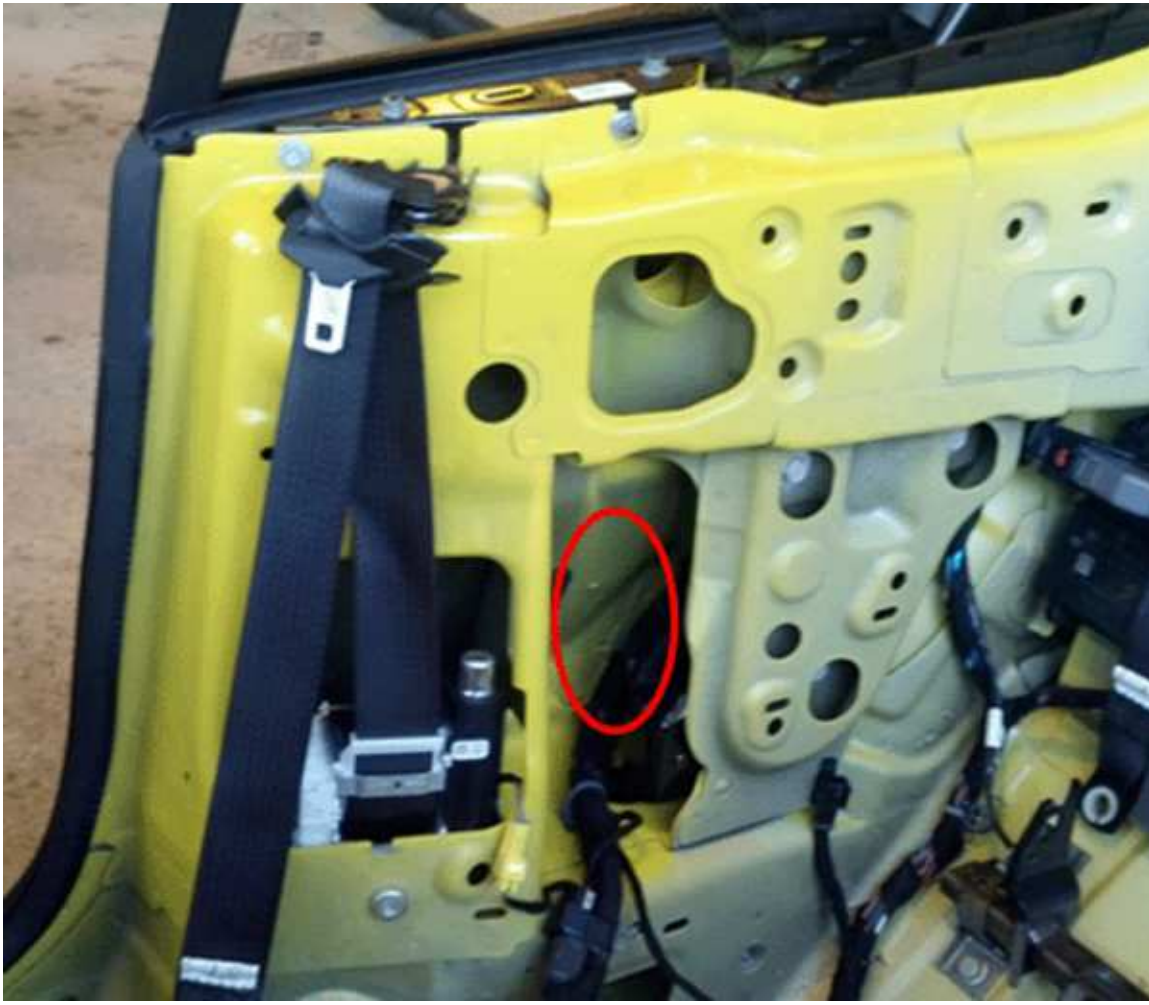
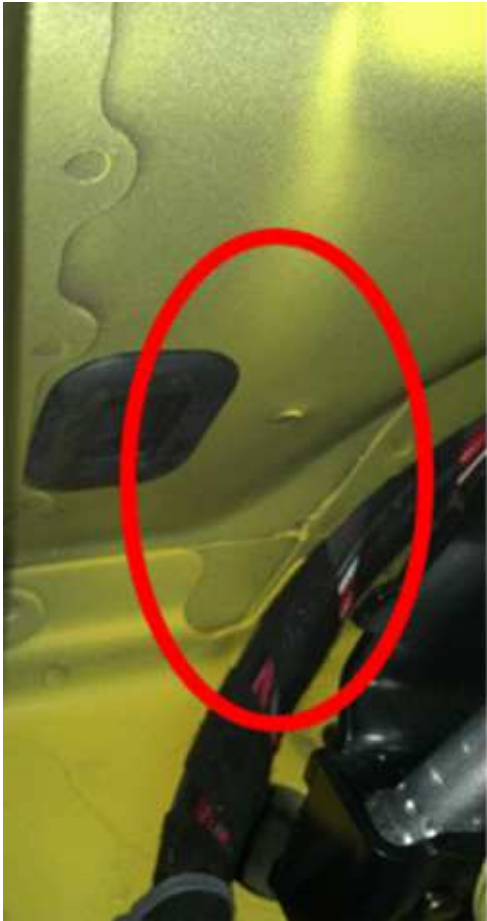
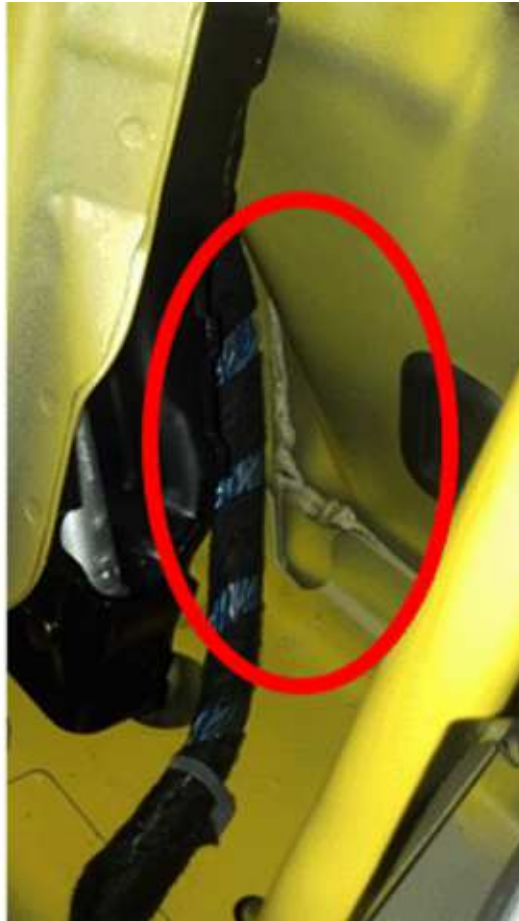
Inspect the area of the vehicle where the folding top frame is fastened in place. There may be water leaking into the vehicle between 2 pieces of sheet metal in the quarter panel area. When comparing the body seams on both RH and LH sides of the vehicle, it may be noticed that there is visible seam sealer protruding from the body seams on only one side of the vehicle. If there is no visible seam sealer on the side of the vehicle that has the leak, this may be the cause for the concern. The first photograph below shows the area in question. The second photo shows a close up view of the circled area and the potential leak in the body seam. The LH side of the photo shows a body seam that has not been properly sealed. The RH side of the photo shows a body seam that has been properly sealed.
