Service Bulletin

13-080

May 18, 2016 52148-02140 Version 6

Warranty Extension: MIL Comes On With DTCs P0301 thru P0304

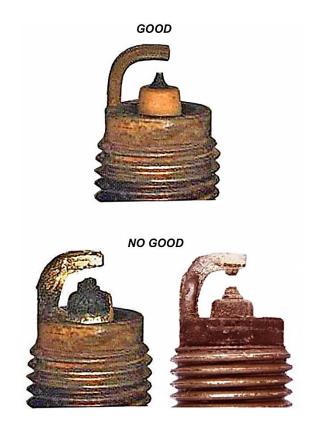
2. Remove and check the spark plug(s) on the affected cylinders (example: if P0301 is stored, check the spark plug on cylinder No. 1).

Are the spark plug(s) fouled?

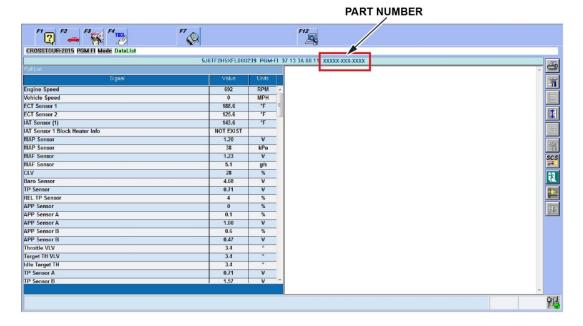
3. Check the PCM software version P/N located above the PGM FI Data List.

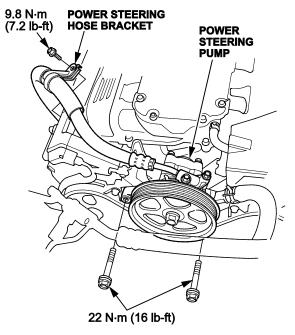
- 20. Remove the drive belt.
- 21. Remove the drive belt auto-tensioner.
- 22. Remove the power steering pump bolts, the power steering bracket then secure the power steering pump out of the way.

NOTE: Do not remove any of the hoses.

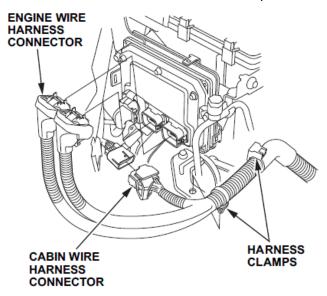
31. Remove the PCM connectors and harness clip. Remove the battery cables from the underhood fuse bo

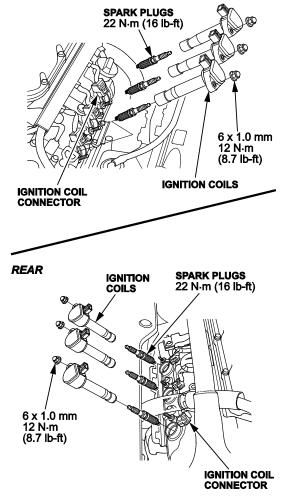
FRONT

32. Remove the appropriate Ignition coils based on the diagnosis.

NOTE: Depending on the diagnosis, you will either have to remove the rear bank ignition coils or both ignition coil banks.

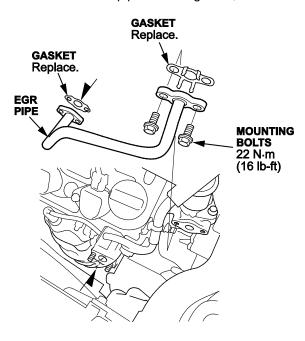
37. Remove the EGR pipe mounting bolts, then remove the EGR pipe.

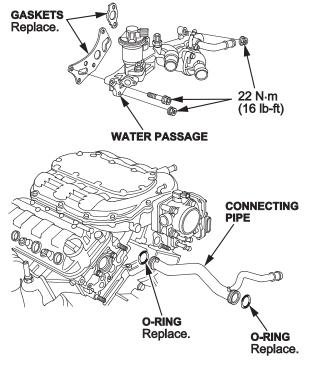
38. Separate the water passage from the heads.

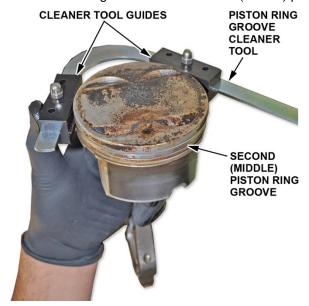
- 2. Spray the piston head and piston ring grooves thoroughly with Honda throttle plate cleaner.
- 3. While holding the piston upright in your left hand, take the piston ring groove cleaner tool in your right hand and line up the cleaner tool guides with the second (middle) piston ring groove.

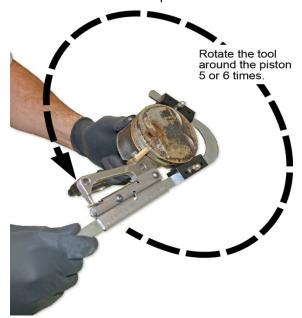
6. Hold the piston steady and rotate the tool counter-clockwise five to six times to remove any carbon deposits in the piston ring grooves. **Do not** rotate the tool clockwise.

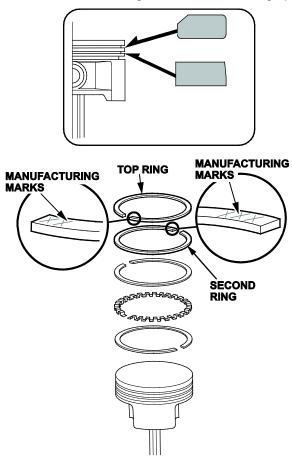
9. Install the piston rings as shown.

NOTE: The first (top) ring has a **1D** manufacturing mark and the second (middle) ring has an **SPR** manufacturing mark. The manufacturing marks must be facing upward.

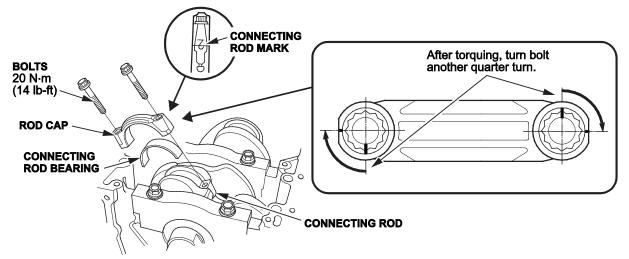
14. Apply new oil to the connecting rod bolt threads and flanges. Torque the bolts to **20 N•m (14 lb-ft)** then tighten the connecting rod bolts an additional **90 degrees**.
