APPLICABILITY: 2005 - Current MY Legacy and Outback
 2008 - Current MY Impreza, WRX, STi and Crosstrek
 2003 - Current MY Forester
 2006 - 14MY Tribeca
 2013 - Current MY BRZ

NUMBER: 02-162-15R
DATE: 09/10/15
REVISED: 09/11/15

SUBJECT: Change to Engine Oil Pressure Switch

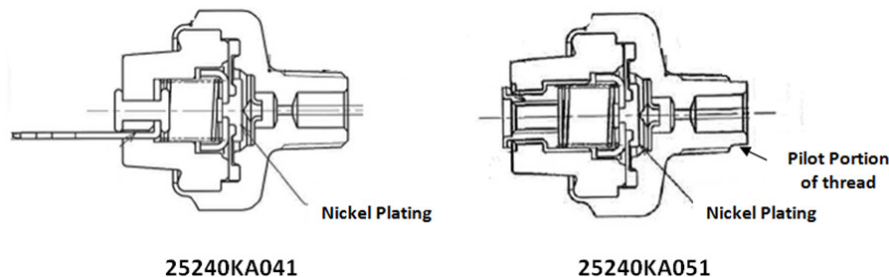
This Service Information bulletin announces a design change to the oil pressure switch assembly. Nickel plating has been applied to the internal switch contacts to enhance their durability and reduce the possibility of poor contact which could affect operation or cause improper illumination of the oil pressure warning lamp. A small pilot portion was added to the threaded area on p.n. 25240KA051 as shown in the illustration below.

NOTE: The oil pressure switches shown below supersede part numbers 25240KA040 and 25240KA050 respectively.

Whenever replacement of the oil pressure switch is required, follow the procedure outlined in the applicable Service Manual. After installation, always run the engine and recheck for leaks and proper operation of the warning lamp before releasing the vehicle.
