Service Bulletin

PRELIMINARY INFORMATION

Subject: Buzz / Rattle Noise From Right Rear Of Vehicle

Models: 2015 - 2016 Cadillac Escalade Models
2015 - 2016 Chevrolet Tahoe and Suburban
2015 - 2016 GMC Yukon Models

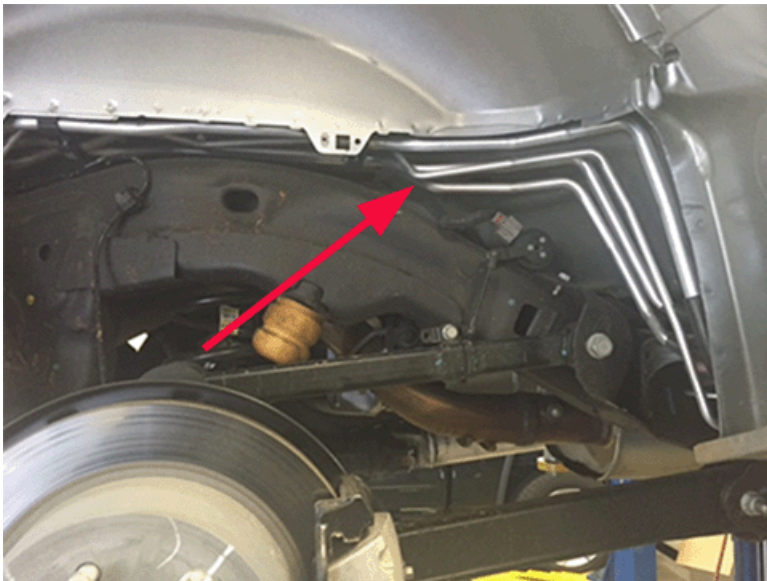
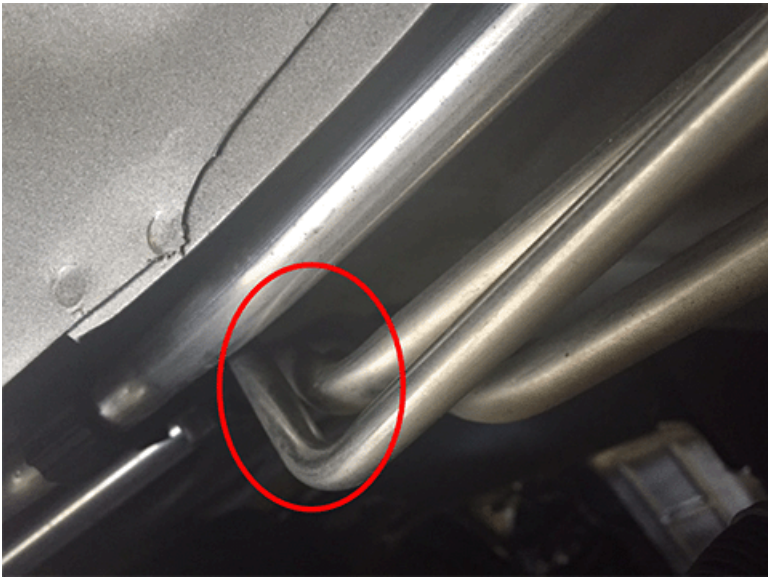
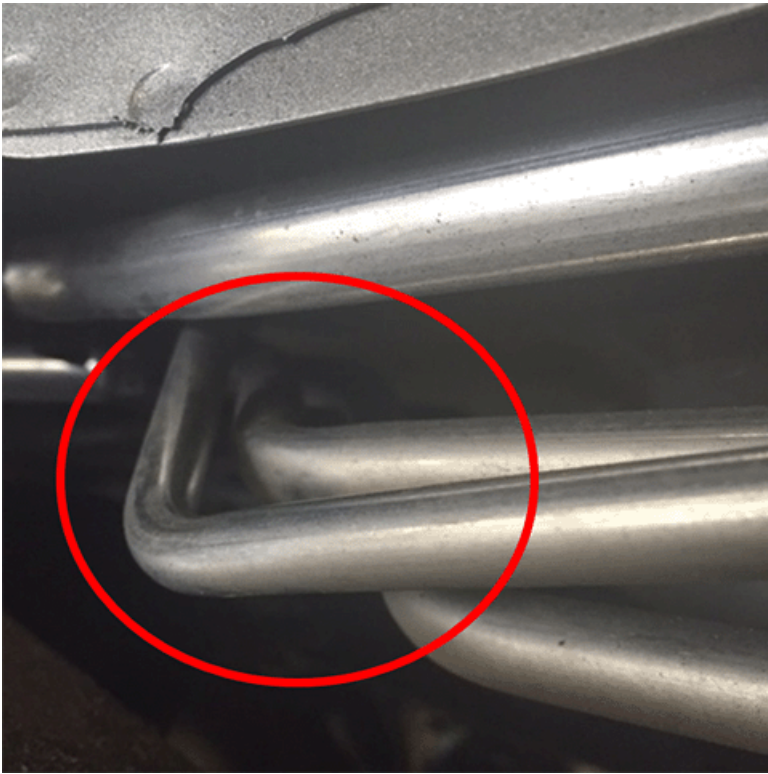
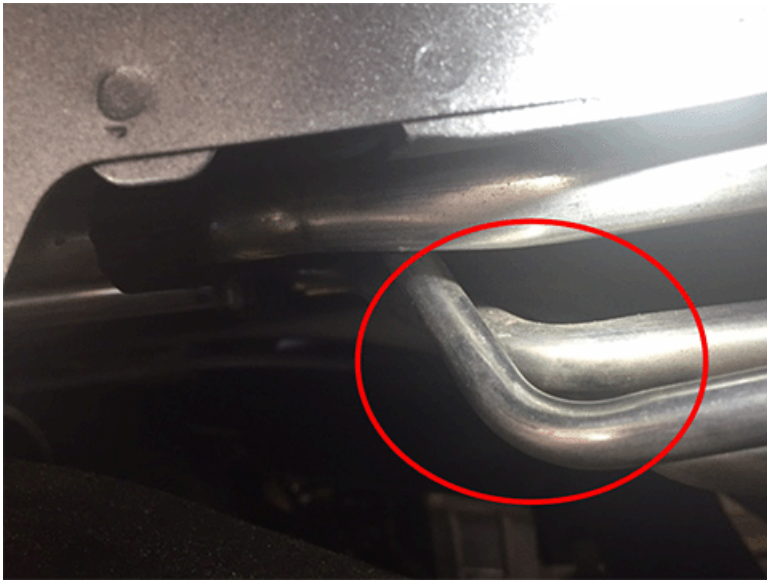
Road test vehicle to get it up to operating temperature so concern can be duplicated. Remove right rear inner fender well and inspect the rear auxiliary heater / evaporator lines for contacting each other.

If the lines are found to be contacting each other, loosen the retaining clamps and reposition lines to gain clearance, then retighten retaining clamps.
