Subject: SQUEAK NOISE FROM FRONT BRAKES AND/OR GROOVE MARKS ON FRONT DISC PLATE	Bulletin No: 04-004/15
	Last Issued: 10/07/2015

2014-16 Mazda3 with VINs starting with JM1

2016 CX-3

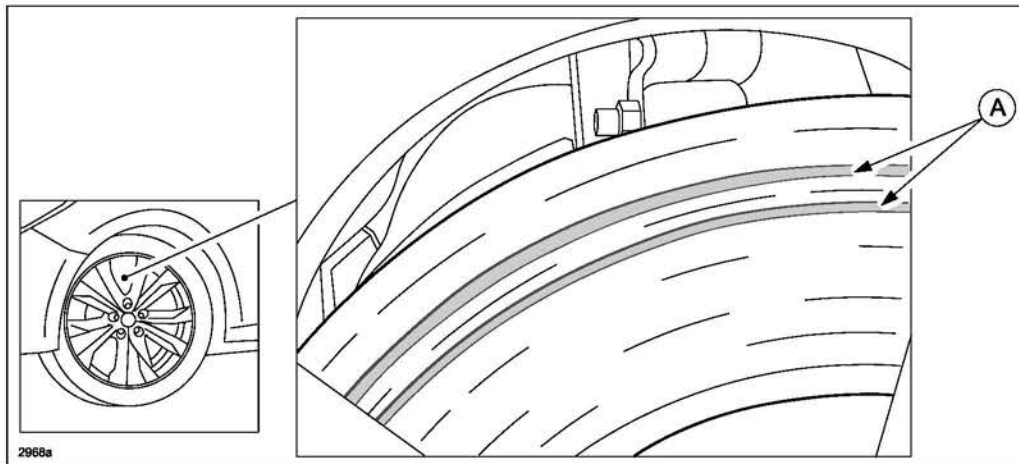
Some vehicles may exhibit a squeak noise when applying the brakes and/or groove marks (A) on the front disc plates. This is caused by abrasive metal from the front disc plate sticking to the brake pad, which damages the disc plate over time. To correct the problem, a modified brake pad is being used.

Customers having this concern should have their vehicle repaired using the following repair procedure.

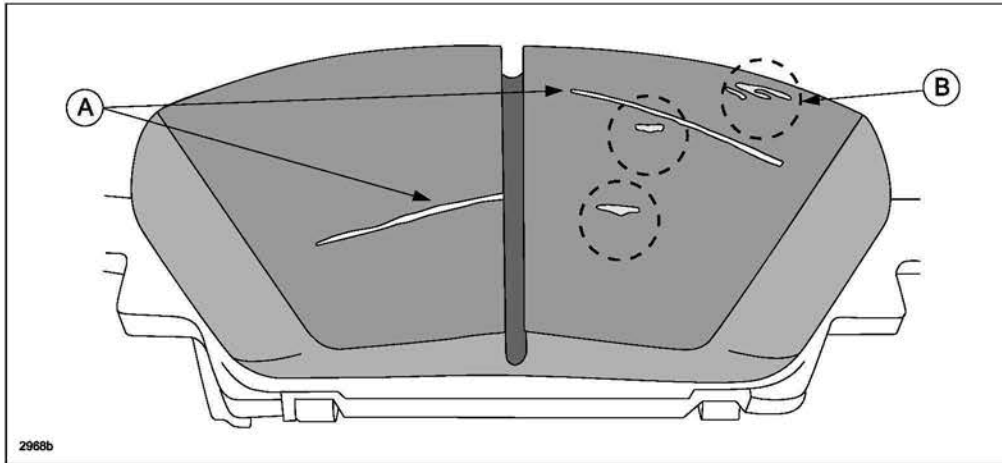
Front Brake Pads

Visually inspect the front brake pads surface for pieces of metal.

- If metal pieces (silver or white in color) are found in a line (A) or cluster form (B) on the surface, replace the front brake pads with a modified service set.

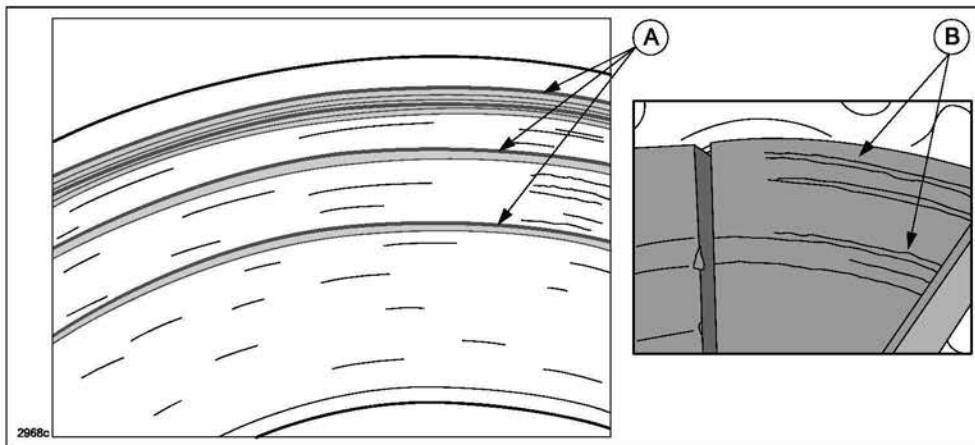
Front Disc Plates

Visually inspect the surface of the disc plate(s) for damage.

- If groove damage is found on a disc plate (A) and brake pad (B), replace the front brake pads with a modified service set and ONLY the damaged disc plate(s).

NOTE: Metal may have dropped off the brake pad, and groove damage will be found on the brake pad in the same position as damage on the disc plate.
