MEDIC UPDATE
TECHNICAL SERVICE BULLETIN

SUBJECT: STEERING COLUMN NOISE WHEN TURNING			No: TSB-05-54-007
			DATE: September, 2005
			MODEL: See below
CIRCULATE TO:	<input type="checkbox"/> GENERAL MANAGER	<input checked="" type="checkbox"/> PARTS MANAGER	<input checked="" type="checkbox"/> TECHNICIAN
<input checked="" type="checkbox"/> SERVICE ADVISOR	<input checked="" type="checkbox"/> SERVICE MANAGER	<input checked="" type="checkbox"/> WARRANTY PROCESSOR	<input type="checkbox"/> SALES MANAGER

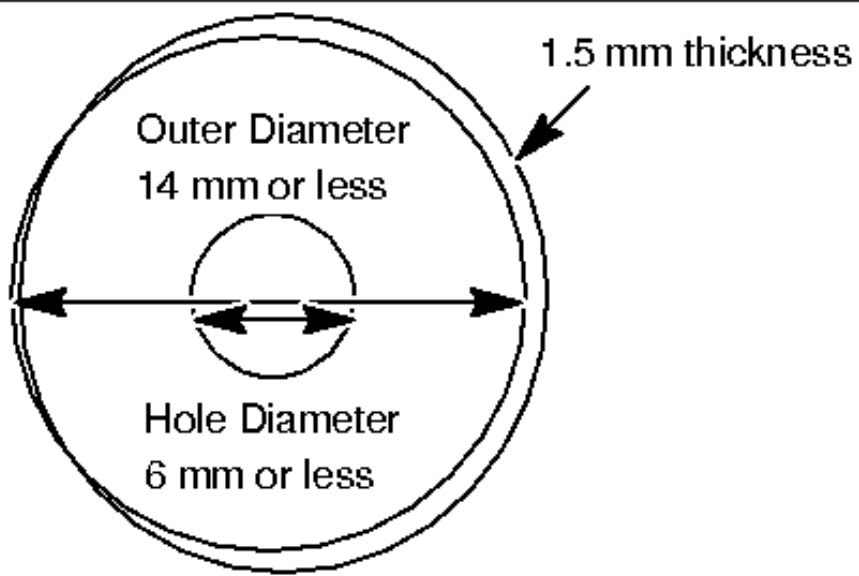
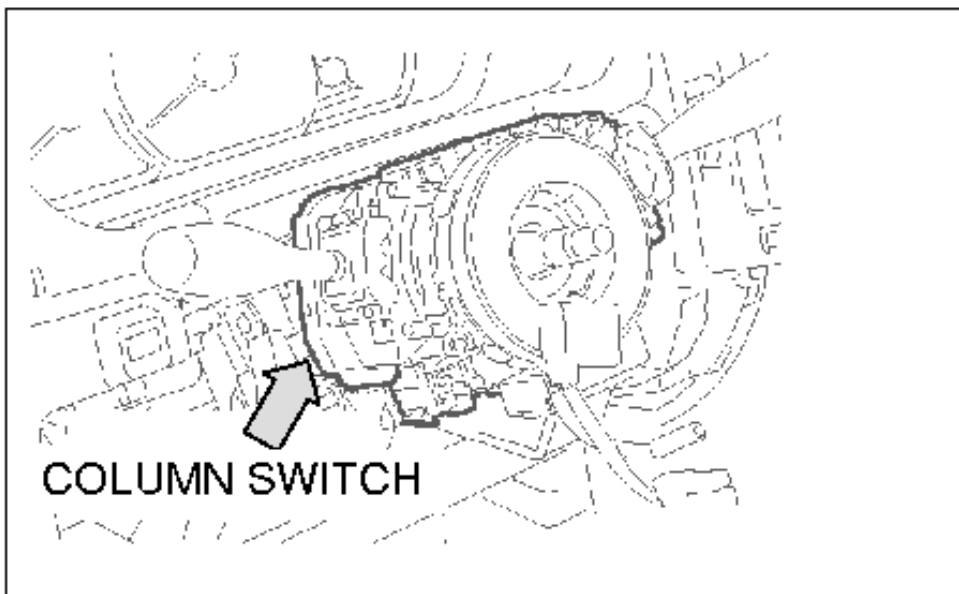
1. Obtain a **1.5 mm thick washer:**

Outer diameter = 14 mm
or smaller
Hole diameter = 6 mm or
smaller.

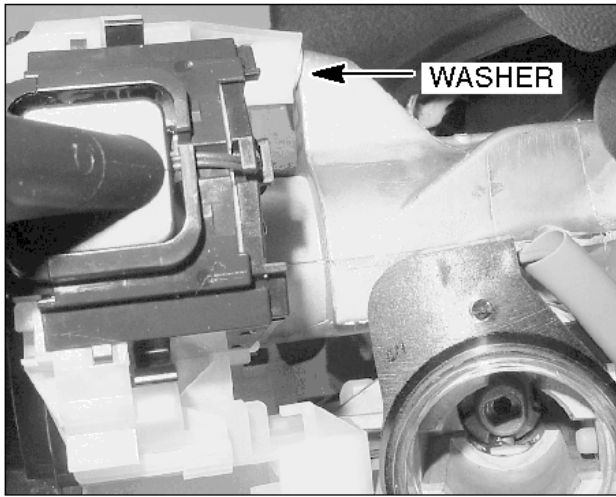
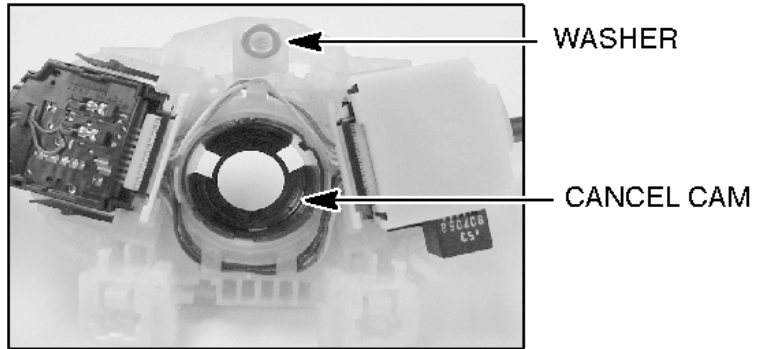
3. Insert the washer over the top mounting screw as shown.

Install a washer between the steering column and the switch mounting screw as described in this bulletin. The washer will change the position of the cancel cam, and eliminate the noise.
