Intermittent Cluster, Radio and HVAC

Subject: Display Resets on Snow Plow Trucks

Models/Years 2014 Chevrolet Silverado 1500

Page 1 Bulletin #124h January 29, 2018

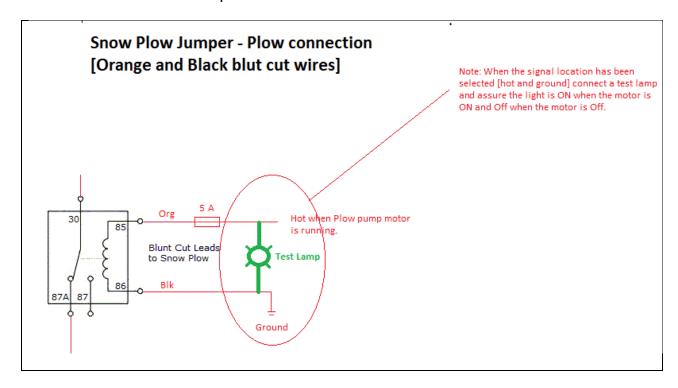
Note: To identify the signal needed by the jumper harness perform the following test. Any connection point that passes this test can be used. The best case is a signal from the wiring that remains with the truck but if that is not found then the signal must be found out on the plow itself.

- a) An operating signal must be identified to operate the small relay in the jumper harness. This signal should go ON and OFF with the plow pump motor. The relay requires low power < 1 amp so most any signal will do without loading issues. The schematic shows the control terminals on the motor solenoid which is the most common connection point.
- b) Using a test lamp try various connection points on the plow control wiring to identify a signal that will illuminate the test lamp only when the motor is running.

- Some plows will present hot [B+] to both motor solenoid control terminals until one side goes to ground. As long as the lamp works right the jumper can be connected the same way. Connect the blunt cut red and black wires across the same signal source as was used to operate the test lamp. Normally the red wire will go to B+ and black to ground. [If both connection points are at B+ when the motor is at rest then put the black wire to the side that goes to ground when the motor runs and the red one to the constant B+ connection.]

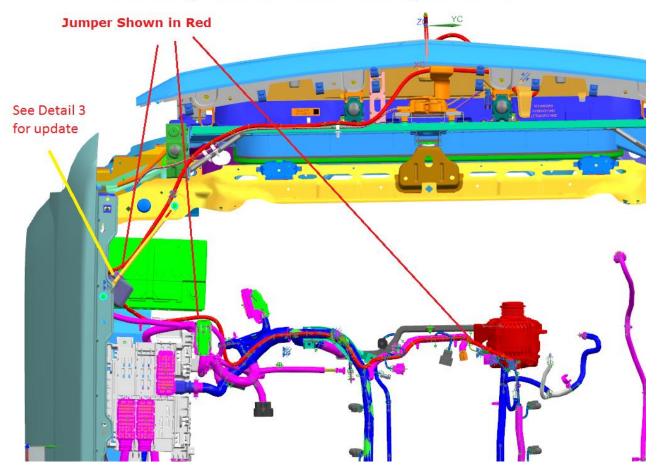
Fig: 3a Jumper Harness Layout – single alternator [see detail 3 for updated relay mounting]

VYU Single Alternator - Jumper Harness

1) Single alternator systems:

- a) Unplug the 2-way connector on the alternator.
- b) Identify the master alternator connector [at the very tip of the harness when it is fully extended]. Insert it in the alternator.
- c) Take the original alternator connector and plug it into the mating jumper harness connector.
 Note: In this case the second alternator connector will be unused and will remain capped and tied to the harness bundle.

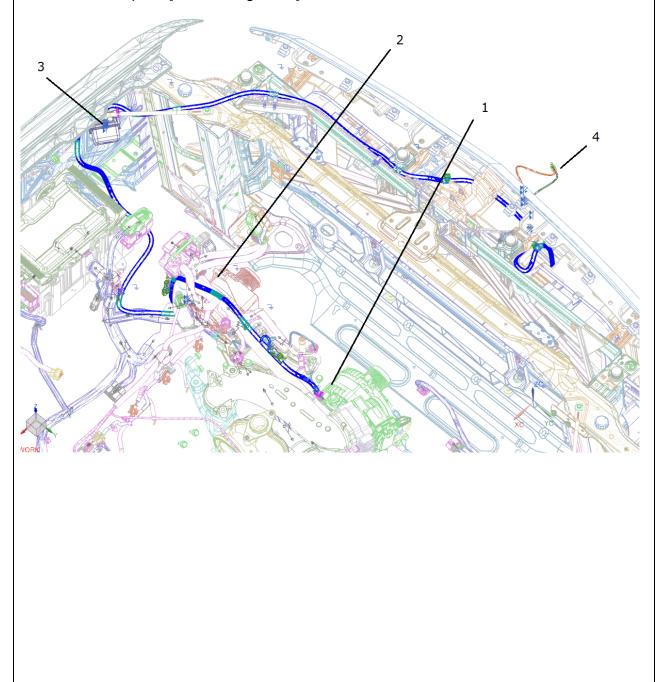
Layout Details

- 1. Primary Alternator
- 2. Slave Alternator
- 3. Relay Center and [new] corner brace
- 4. Wires to plow [fused + & ground]

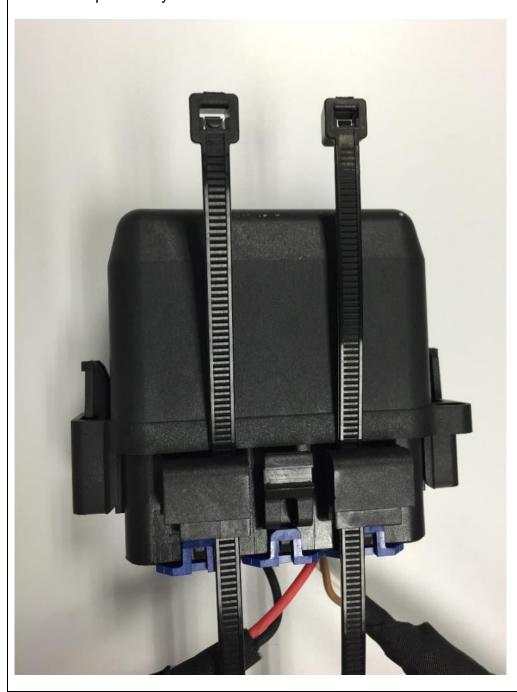
Detail 3.1.1

Details 3.1.1-3 apply to service part and not the factory included [loose shipped] part.

Add tie straps to relay

i) Route the snow plow jumper harness along the existing harness routing where possible and secure the relay center with tie straps as shown in Details 3.1.1-3. Allow slack for engine roll and upright orientation of the relay center to prevent water intrusion/collection.

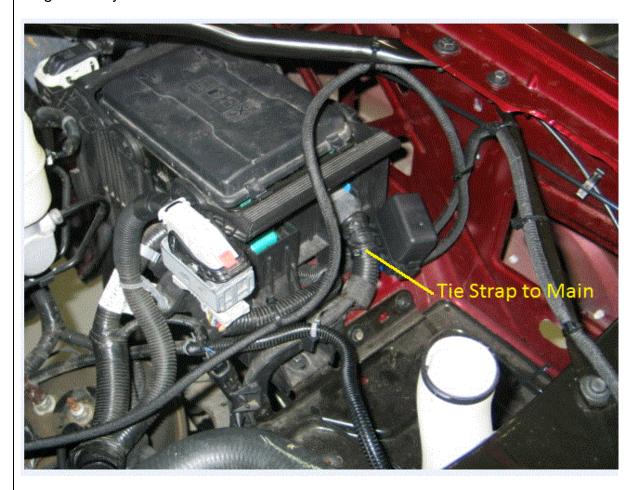
Detail 3.1.2

Single Battery Trucks

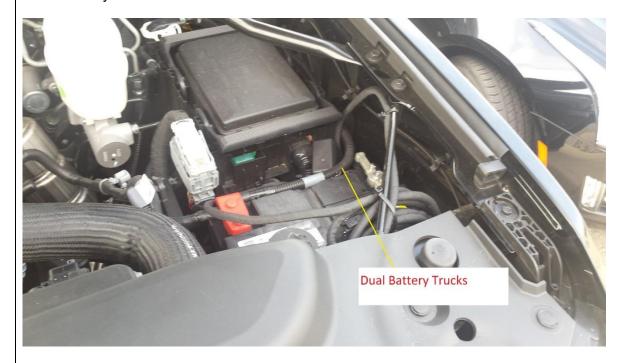
Detail 3.1.3

Dual Battery Trucks

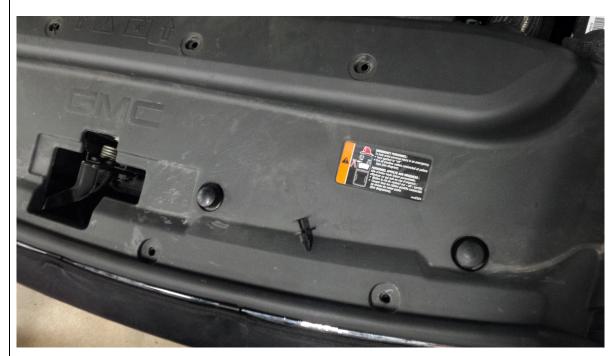
Detail 3.2.1

The following details 3.2.1 – 7 apply only to trucks that came with harness components [loose shipped] from the assembly plant.

Remove the Radiator Air Upper Baffle and Deflector.

- i) Remove the harness and loose parts from the shipping bag/container. Locate the new corner brace pn 84234282 [it should be painted black but our pictures are of an unpainted part] and the nuts and bolts that will be used to attach the relay center portion of the harness.
- ii) For a complete picture book sequence for the installation see Details 3.2.1-7.
- iii) Route the snow plow jumper harness along the existing harness routing where possible and allow slack sufficient to secure the relay center to the [new flat] corner brace with the nuts and bolts included in the parts bag.
- iv) Remove the Radiator Air Upper Baffle and Deflector by unclipping it from the radiator.
- v) Remove and discard the LH front pencil brace as shown and install the new flat corner brace.
- vi) Attach the relay center to the corner brace and the brace top the truck as shown.

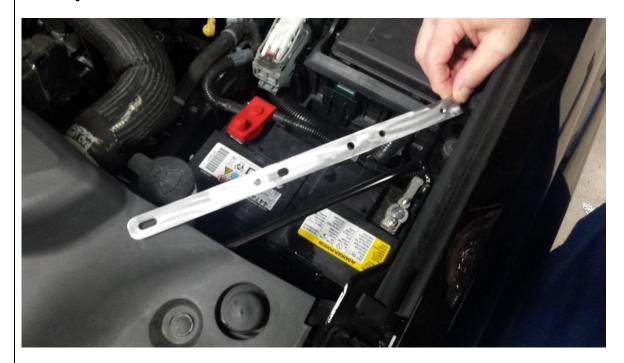
Detail 3.2.2

Identify the new flat painted corner brace pn 84234282. [unpainted version shown]

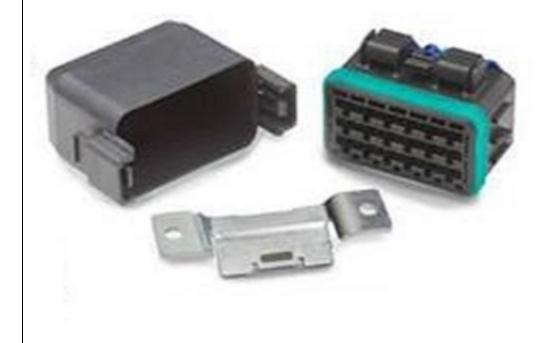
Detail 3.2.3

Relay center and bracket details.

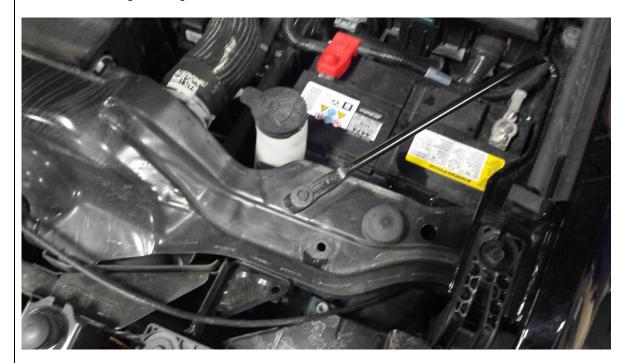
Detail 3.2.4

Remove the [round] left front corner brace shown here.

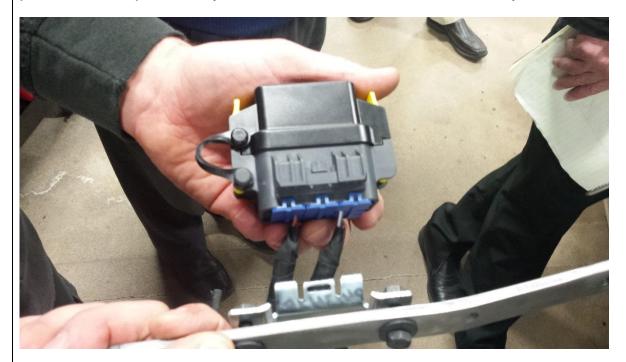
Detail 3.2.5

Assemble the relay bracket to the flat corner brace using hardware provided. Snap the relay bracket into the feature on the relay center.

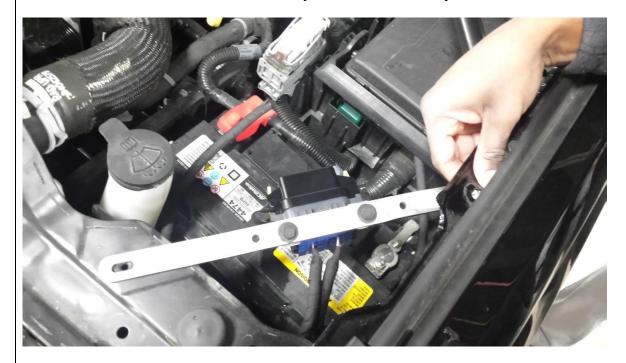
Detail 3.2.6

Position the corner brace and relay center assembly.

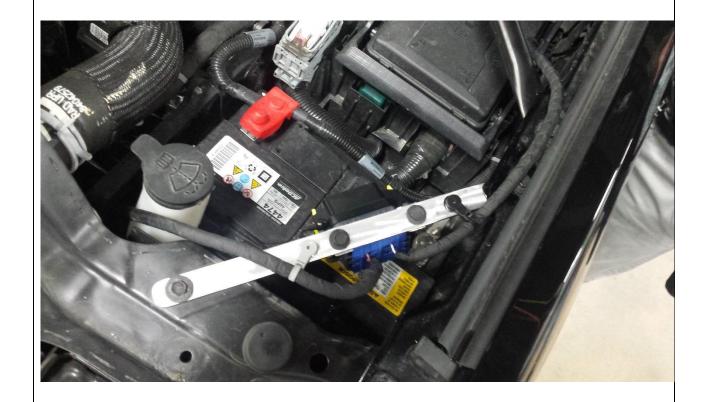
Detail 3.2.7

Mount the flat corner brace assembly as shown.

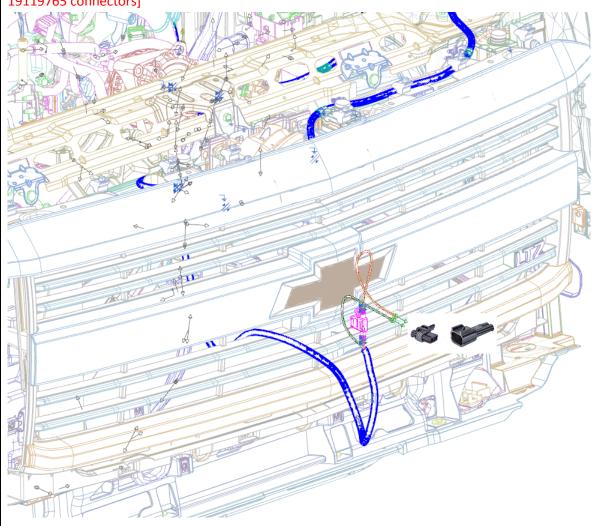
Detail 4

On units were the control signal must be obtained out on the plow wiring. **Two sets of 2-way sealed connectors** will be required as shown here. Extra mating halves can be used to fashion tethered caps. [Order GM service kit, 2 each M 2W 19119346 and 2 each F 2W

19119765 connectors

- c) If the operating signal must be obtained outside of the engine compartment [on the plow itself] then <u>two sets</u> of inline connector will be required. [Order GM service kit, 2 each M 2W 19119346 and 2 each F 2W 19119765 connectors] Using 2 sets of connectors will allow tethered caps to be fashioned for when the plow is disconnected. Secure the wires and caps appropriately to assure durability. See figure 4.
