ARTICLES CONTAINED IN THIS ISSUE

15 DAMAGED USB PORTS

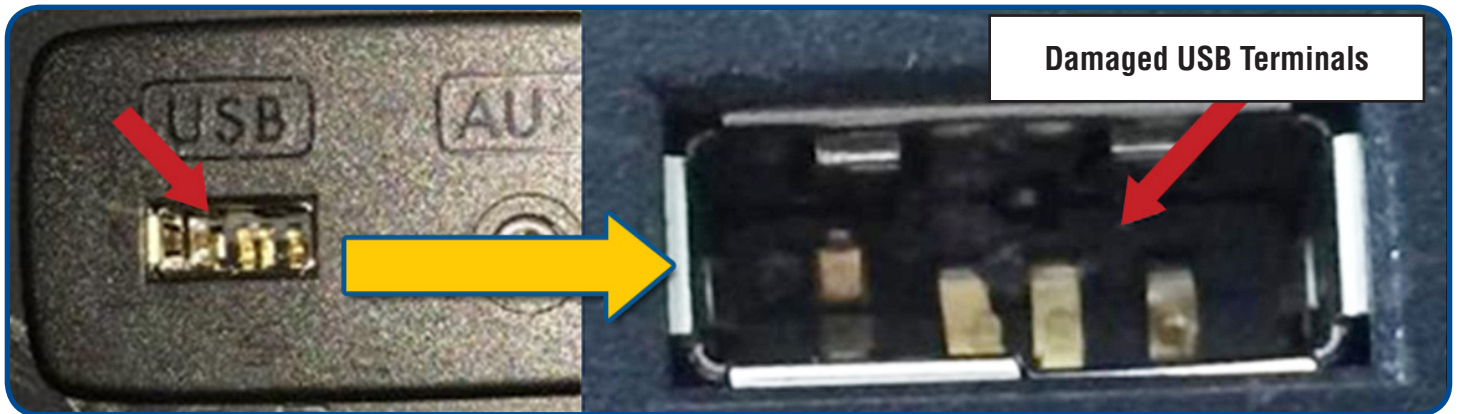
As part of a regular review of USB port quality, a number of parts were collected for review. Upon inspection of these collected parts, a large percentage have been physically damaged as shown in the example photos below. This type of damage often results when the device being connected is plugged in with its connector either upside-down, forced / twisted into or forcibly removed from the USB port.

An easy way to prevent this type of damage is to make sure the USB icon

which is usually found on the body of the device connector always points upward. The USB connector inside the console box can be difficult to see, especially at night. In that case, make sure the USB icon faces toward the molded-in "USB" when connecting the device. Never force any device when connecting or disconnecting it to or from the USB port.
