ARTICLES CONTAINED IN THIS ISSUE

12 2015 LEGACY / OUTBACK, RATTLING SOUND FROM FRONT OF VEHICLE

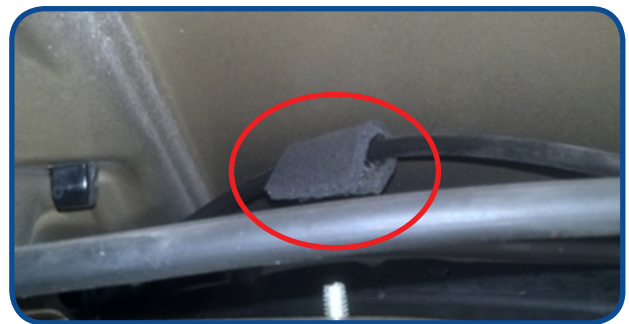
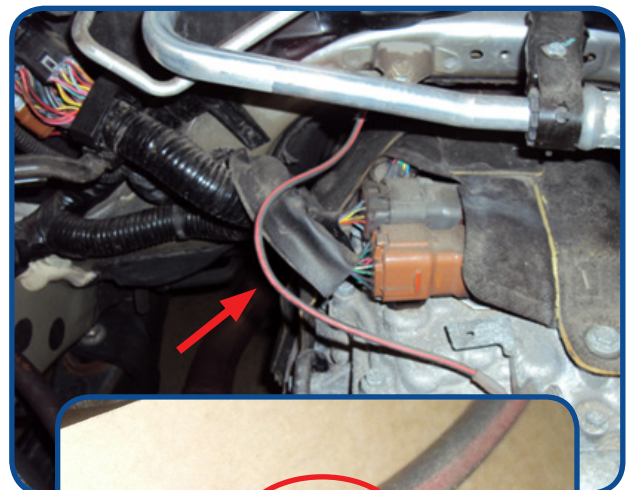
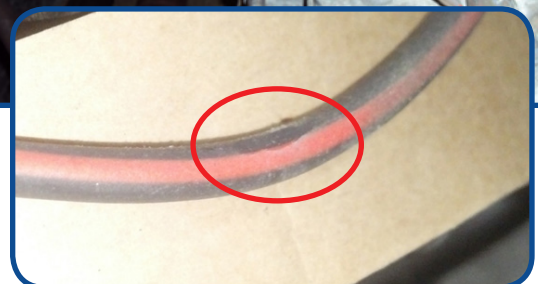
The first repair resulted after the sound was traced to the left fender area. The Technician removed the fender inner liner and saw where the hood release cable was contacting the inside of the fender. The contact point left a witness mark making it easy to identify where to simply add some foam tape to eliminate the sound.

The second involved the BR auxiliary chassis ground wire which runs to the CVT underneath the air box ductwork. A rub mark on the wire insulation and a corresponding witness mark on the air box duct were also identified here. The contact and rattling sound were eliminated by a slight "repositioning" of the BR wire.
