ARTICLES CONTAINED IN THIS ISSUE

SUBARU OF AMERICA

01 IMPORTANT REMINDER: WQK-47R EQUIPMENT CLEANING PROCEDURE

03 AT LEARNING CONTROL INFORMATION

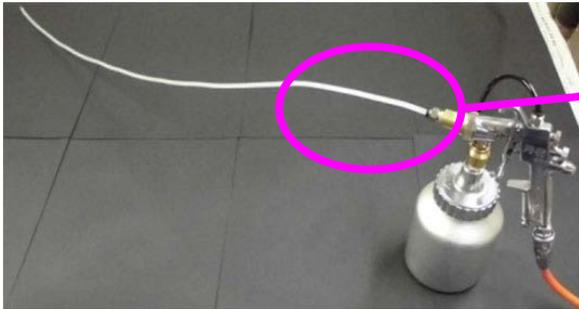
Close the discharge knob then clear the residual wax in nozzle with air pressure and wipe the tip clean.

Insert nozzle into waste container and close the discharge knob.

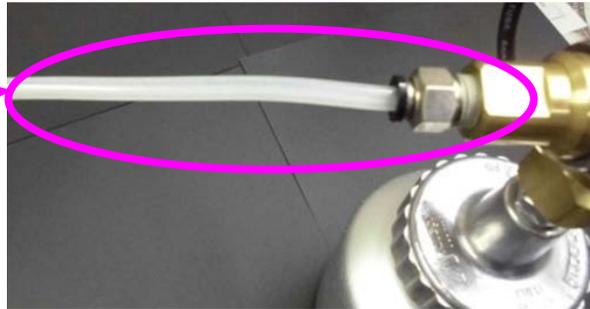
Residual wax visible inside nozzle

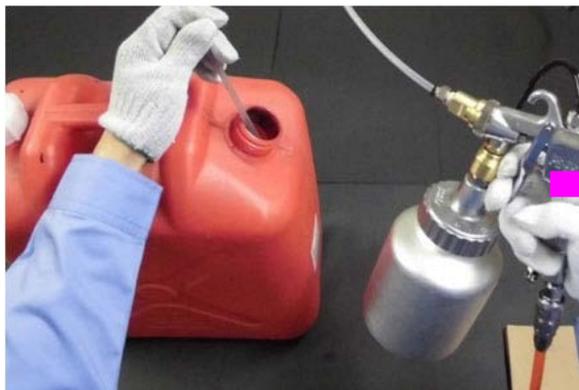
Pull the gun trigger half way and hold for about 20 seconds until the tip is clear.

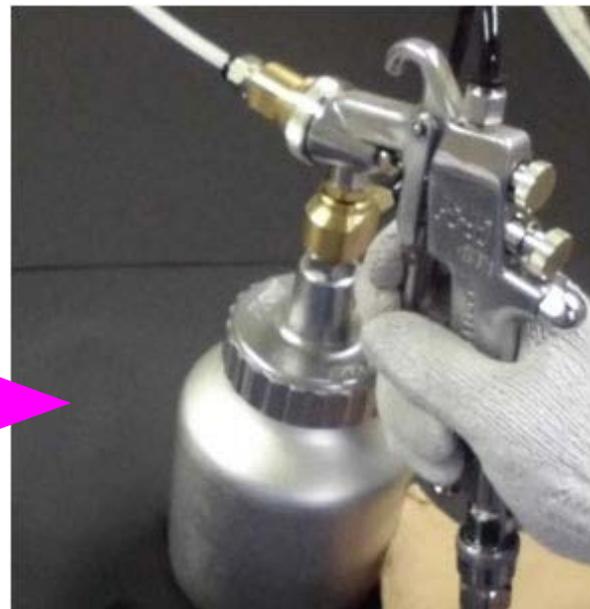
Confirm the nozzle and tip are clear.

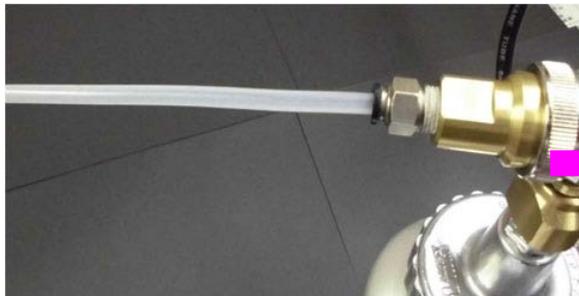
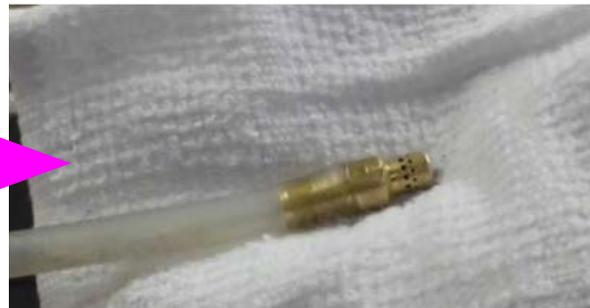
Wipe the tip with a clean cloth.

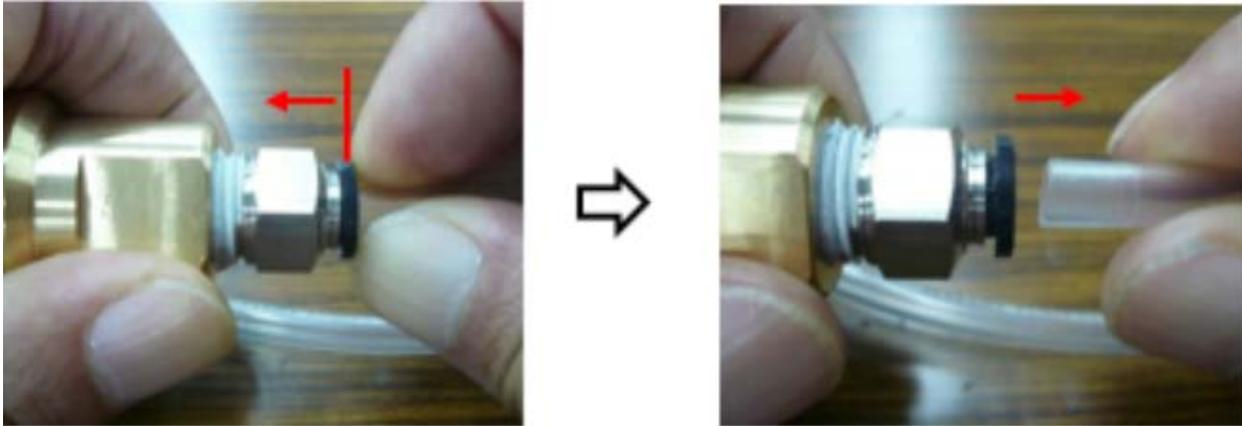
- Remove the tube / nozzle from the gun assembly and clean by applying compressed air.
- Release the plastic tube from the gun by pressing down on the black collar of the connector.
- Pull out the tube while holding the black collar portion down.

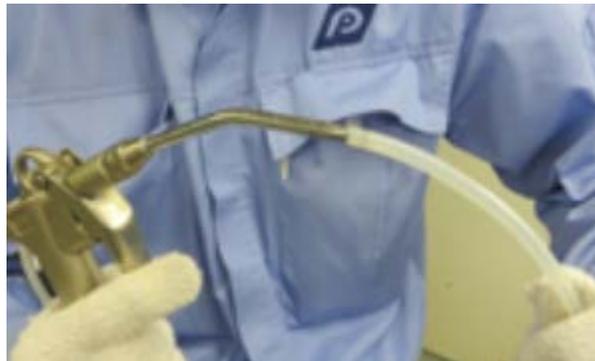
- **CAREFULLY** apply compressed (regulated, “shop”) air to the removed tube to clear the restriction from the tip.

- After cleaning, reinstall the tube / nozzle back into the connector.
- Make sure to push the tube all the way into the fitting until it stops then pull on it slightly to make sure it locks in place.

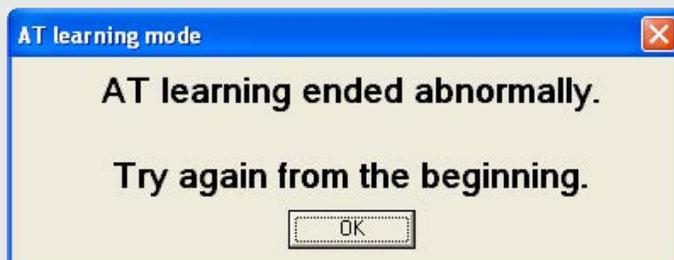
Figure 1 Error Messages and Explanations

Main causes of the contents shown	Remedy
Detection of DTCs	Correct the DTCs and then perform the AT learning procedure again.

Main causes of the contents shown	Remedy
Detection of DTCs	Correct the DTCs and then perform the AT learning procedure again.
<ul style="list-style-type: none"> • Un-instructed operations were taken during the AT learning process. • Depressing the brake pedal is not enough • Pulling the parking brake lever is not enough • Abnormal Idle Up 	Execute the [AT learning mode] again from the beginning

When performing the Learning Control procedure, be aware of items such as:

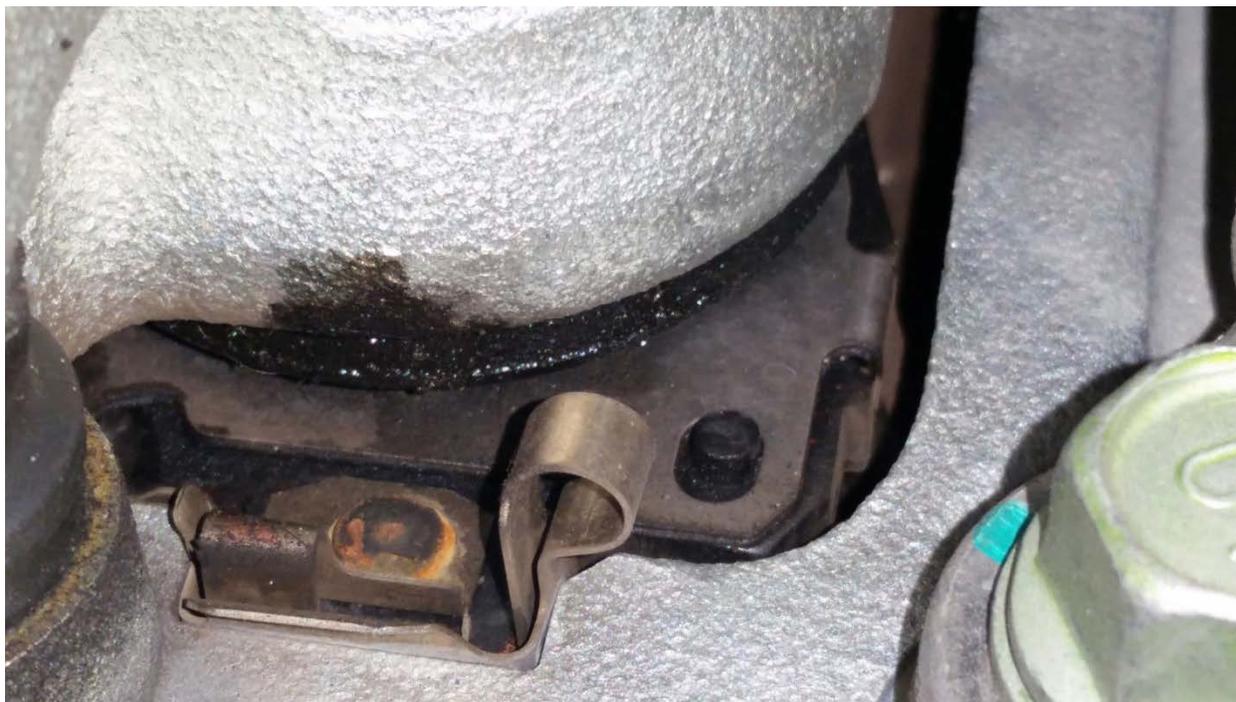
There have been reports from some retailers indicating possible brake fluid leaks from the front brake calipers on a some 2017 Imprezas. After investigation, it was determined there was no brake fluid leaking from the brake caliper and the fluid found was residue from an assembly oil. Should you encounter this condition, clean all affected components with an appropriate parts cleaner and confirm the brake fluid level in the master cylinder reservoir. If the fluid level is full and there are no signs of any contamination or any other concerns, test drive the vehicle making several stops. After the test drive, check the brake calipers again along with the balance of the brake system for any leakage and the brake fluid level for any decrease. If there is no leakage, brake caliper replacement is not necessary.
