ARTICLES CONTAINED IN THIS ISSUE

01 G TYPE, H TYPE, AND I TYPE IMMOBILIZER REGISTRATION

01 IMPORTANT BATTERY SENSOR PROCEDURES- 2019MY CROSTREK PLUG-IN HYBRID (PHEV) MODEL

01 MELTING PLASTIC PARTS

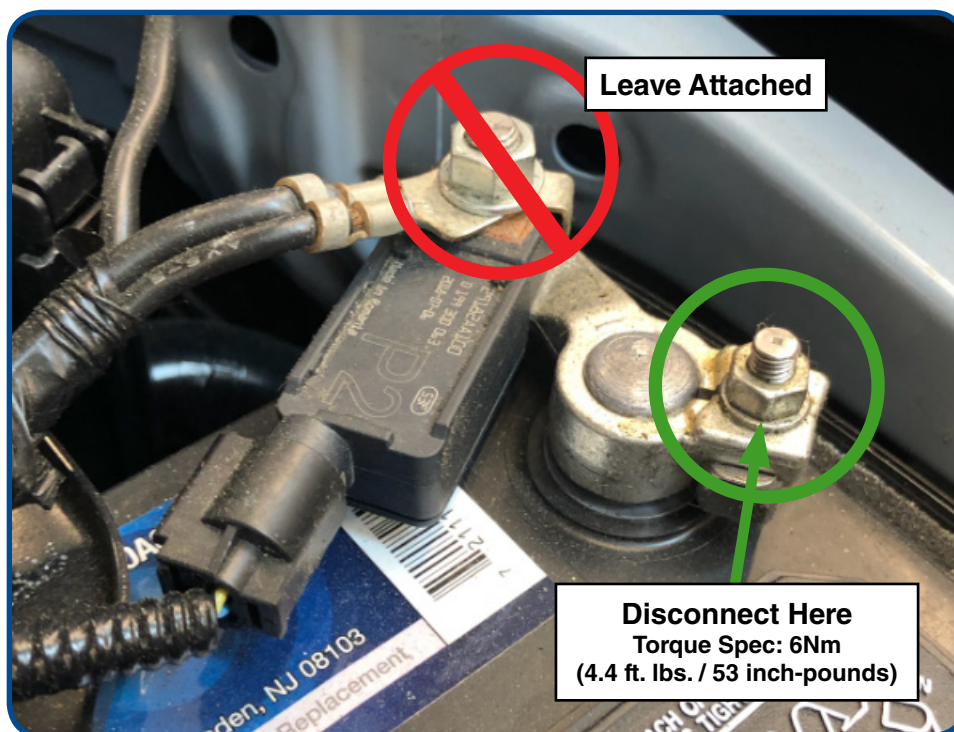
The new 2019MY Crosstrek PHEV is equipped with a new-style battery sensor connecting the negative (-) battery cable to the negative battery post. In the past, the recommended procedure has been to disconnect the negative cable from the battery sensor leaving the sensor attached to the battery post. This new-style sensor requires the negative cable to stay attached and the cable / sensor “assembly” be removed from the battery post as shown below.

VERY CRITICAL: Never over-tighten the 10mm hex nut at the battery terminal connection beyond the torque specification of 6 Nm (4.4 ft. lbs. / 53 inch-pounds).

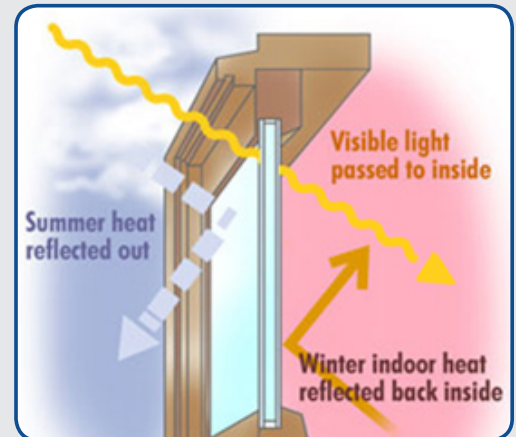
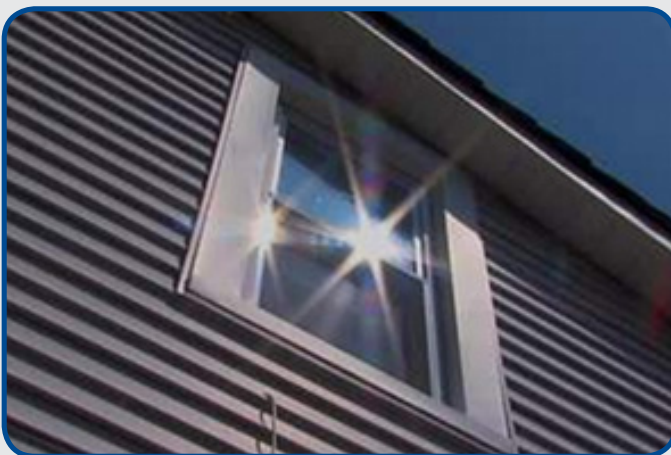
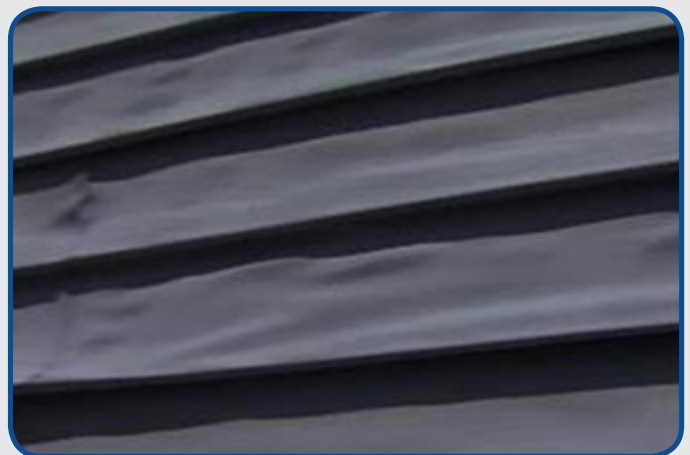
Have you had a customer come into your dealership and report they have plastic parts on their car that look like they are melting? The customer may be correct but this kind of damage, is not a defect with their car's plastic exterior parts. During the warmer months, the sun's ultraviolet rays are stronger than at other times. If their vehicle is parked near a house or building which utilizes "Low-E" glass windows, sunlight reflection from this type of glass can actually direct enough heat to damage plastic parts. "Low-E" energy-saving glass has widespread uses, from office buildings to residential windows. Basically, it reflects the sun's UV rays in the summer and helps retain heat inside during the colder months. Here's an illustration of how Low-E glass works.

Under the right conditions, the heat from this concentrated sunlight reflection as shown on the left can reach up to near 180 degrees. That kind of concentrated temperature is more than hot enough to damage residential vinyl siding and in some cases, plastic car parts.

With springtime already here and summer on the way, you may experience these kinds of customer concerns at any time. Keep in mind that damage caused by this kind of sunlight reflection is not a defect, and therefore it is not a matter for warranty.

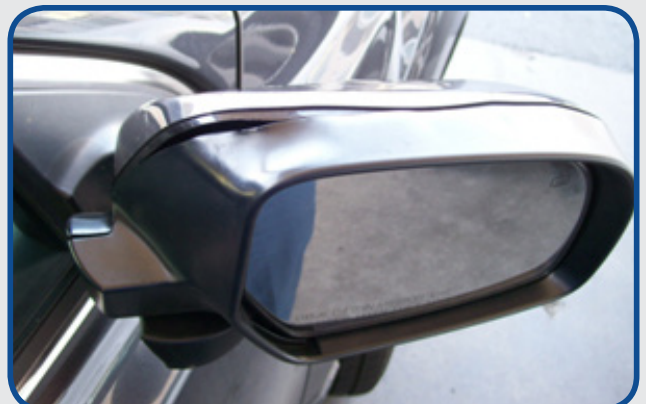
The photo to the right shows an example of a sunlight-damaged Subaru door mirror.

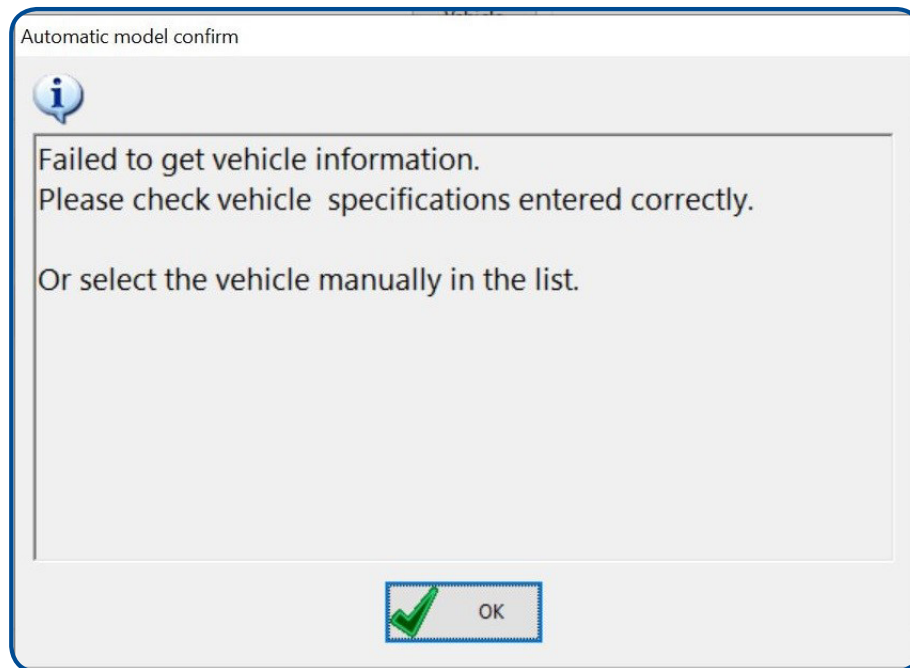
When attempting to identify the 2019MY Impreza sedan with SSM4, the following error message is displayed. This will not affect the SSM functionality, simply click "OK" to proceed.

2019MY Impreza Sedan is the only known vehicle that will display this message in error. This concern will be corrected with the October 2019 SSM software update. To identify which version is installed simply check the date on the SSM boot window. The photo below shows SSM version from April 2019.
