Articles Contained in this Issue

TECH TIPS GREATEST TIPS

Diagnosing P0128 on Thermo Control Valve Equipped Vehicles

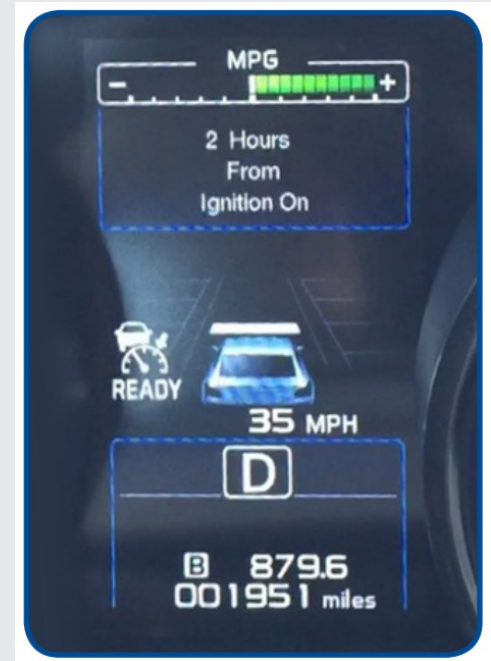
An added feature of the Combination Meter is an alert message (accompanied by a single “beep” sound) which will be displayed in the Telltale section above the odometer after 2 hours of driving have elapsed from ignition ON. The “beep” is the same sound heard when the low fuel lamp is first illuminated. This message is provided simply as a notification to make the driver aware they have been driving for 2 hours and it may be a good time to consider taking a break, checking fuel level, etc. Like other alerts shown on the Telltale display, it cannot be turned off or adjusted. This feature has been included on Subaru vehicles for several years, but unless the vehicle is driven for approximately 2 hours or more, many customers may have never experienced it. Until the Owner's Manual is revised, information will be limited regarding this message.

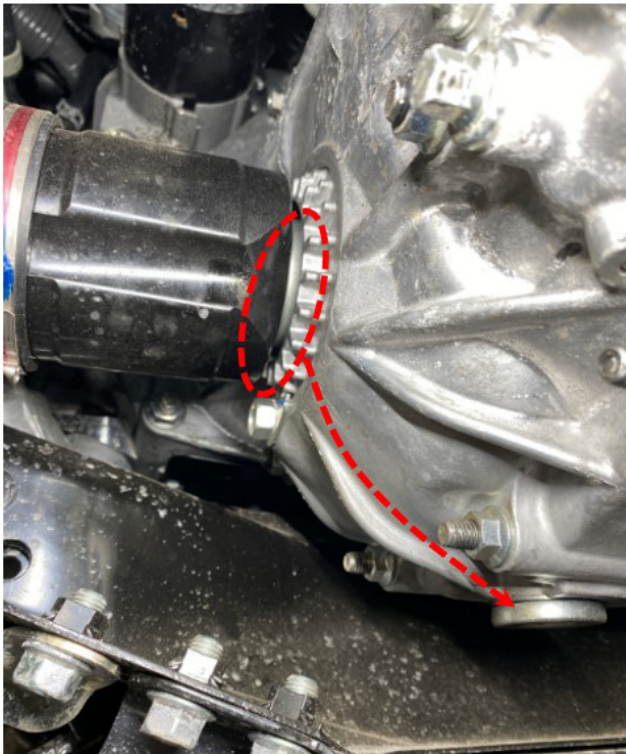
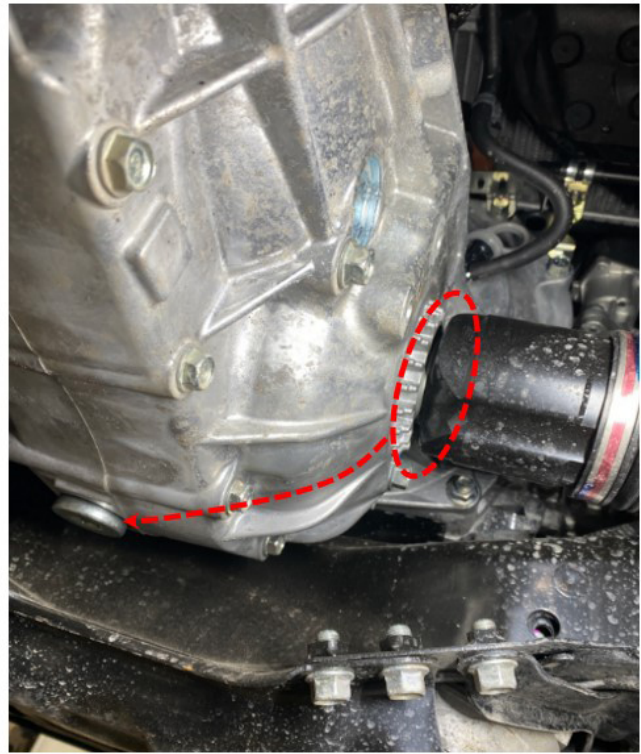
Fig.1 Junction of Transmission and CV drive shaft

During inspection of a new vehicle equipped with a manual or CVT transmission, there may be oil residue found in the following areas.

- The CV shaft, bottom of the transmission or on the drain plug
- The propeller shaft and the thermal barrier.

This is due to a small amount of oil spillage during the assembly process.

If this symptom is found it is recommended to:

- 1) Clean the area so it is free of any residue.
- 2) Drive the vehicle for several miles (recommendation: 10 miles).
- 3) Re-check whether oil residue is duplicated. If no new oil is found, no action is needed.

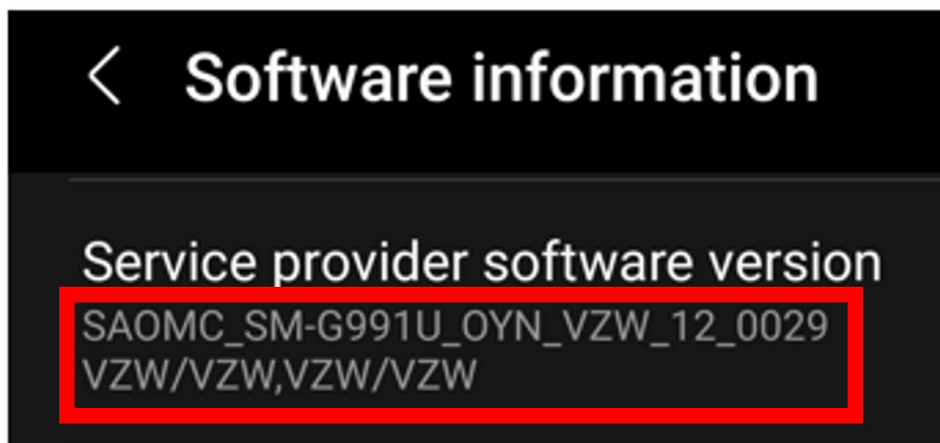
For Android phones: Navigate to Settings > About phone > Software information. Locate "Service provider software version."
