ARTICLES CONTAINED IN THIS ISSUE

07 2014 FORESTER TURBO, ECM ELECTRICAL TESTING REMINDER

07 2014 FORESTER NON-TURBO ECM AND BIU LOCATIONS

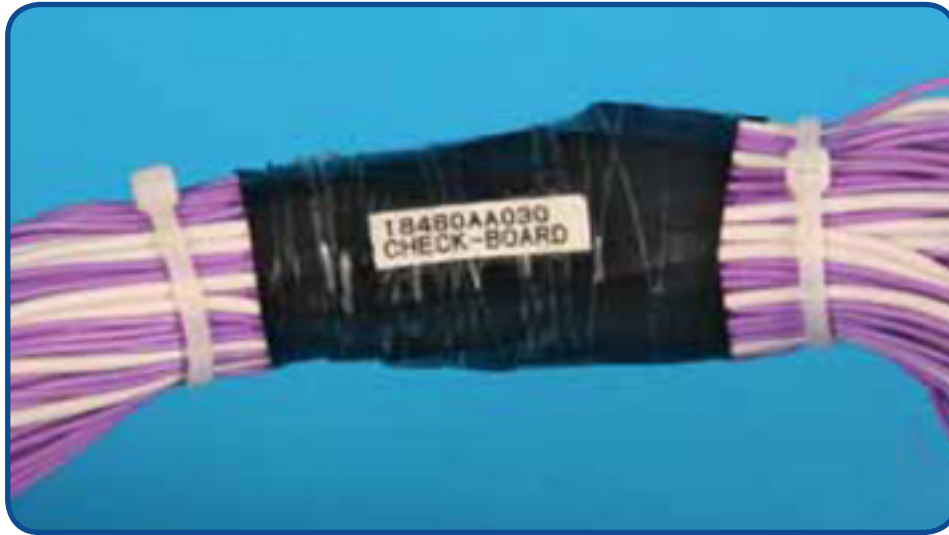
Keep in mind, with the ECM now located in the engine compartment on 2014 Forester Turbo models, all the harness connectors and terminals for the ECM wiring are weather proof. Under NO circumstances should any ECM terminal or connector be tested by back-probing. The weatherproof seal will be damaged and allow moisture to enter the wiring. Engine harness damage from back-probing is not a matter for warranty and can only result from an improper repair procedure. A new test harness, 18460AA030 called a CHECK-BOARD has been developed for diagnosing the ECM wiring on these vehicles.

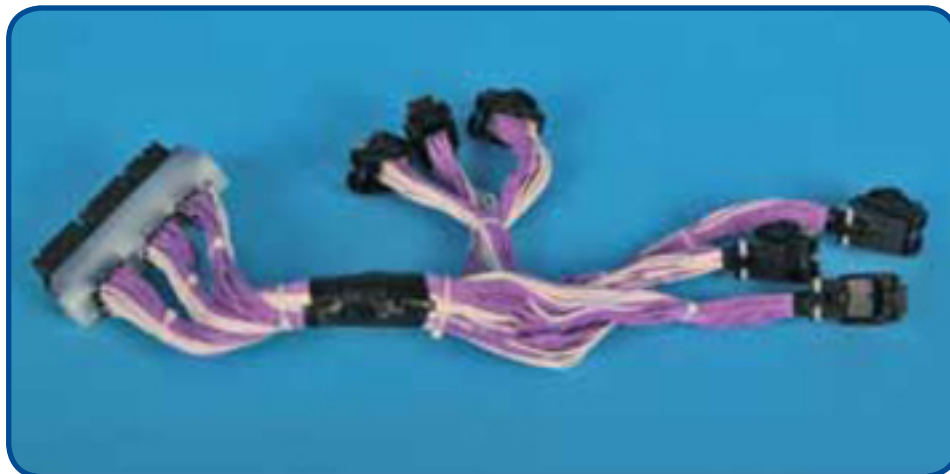
The CHECK-BOARD is a series circuit harness with parallel circuit connectors which fits in between the ECM and the ECM harness connectors. When installing, always connect the weatherproof connectors to the ECM.

It is recommended this harness only be installed during diagnosis.

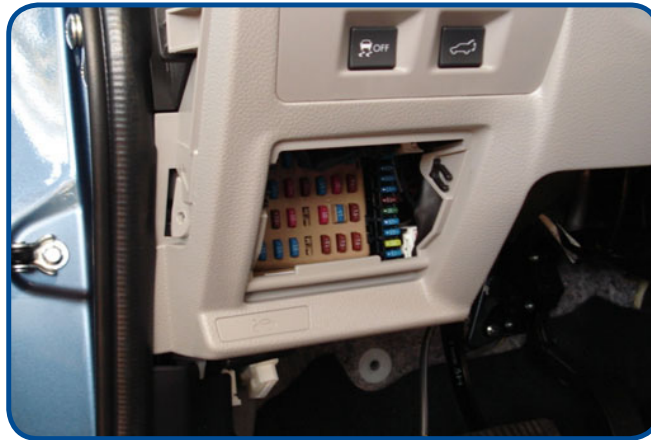
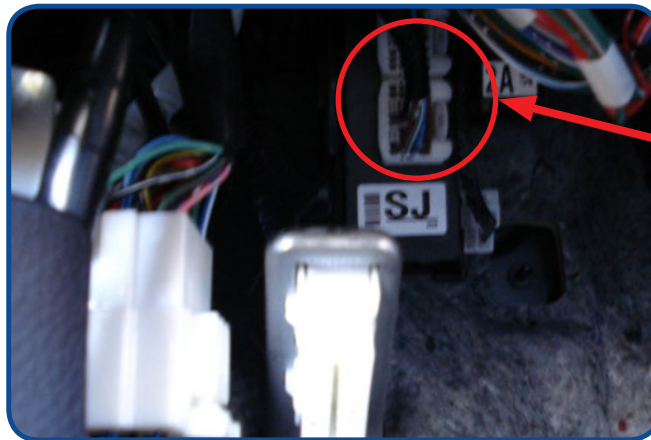
BIU is located behind the fuse box

Tech line has received calls recently regarding questions on pin locations not matching up; powers and grounds in the wrong locations, post-repair no start conditions and various trouble codes appearing which were not there before the vehicle was repaired. After questioning the tech and investigating the complaint, we have found the ECM and/or the BIU have been confused with one another. Keep in mind the Turbo Forester has a special test harness for the ECM as described on pg. 2 in this issue of TIPS. The The 2014 Non-Turbo Forester still has the ECM inside the vehicle cabin behind the glove box. The BIU is located behind the in-car fuse box. Confusing these two control units can cause false readings when troubleshooting as well as electrical problems and false trouble codes. The photos below show the location of both control units.

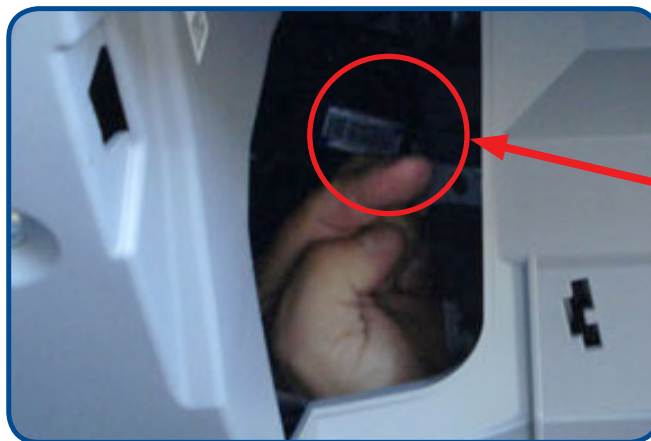
ECM is located behind the glove box
