PIT5756 Various Electrical Concerns (Inspect UBEC Bolts For Being Loose)

Brand:	Model:	Model Years:	VIN: from	to	Engine:	Transmissions:
Chevrolet	Silverado 1500 (New Model)	2019	All	All	All	All
Chevrolet	Silverado	2020	All	All	All	All
GMC	Sierra 1500 (New Model)	2019	All	All	All	All
GMC	Sierra	2020	All	All	All	All

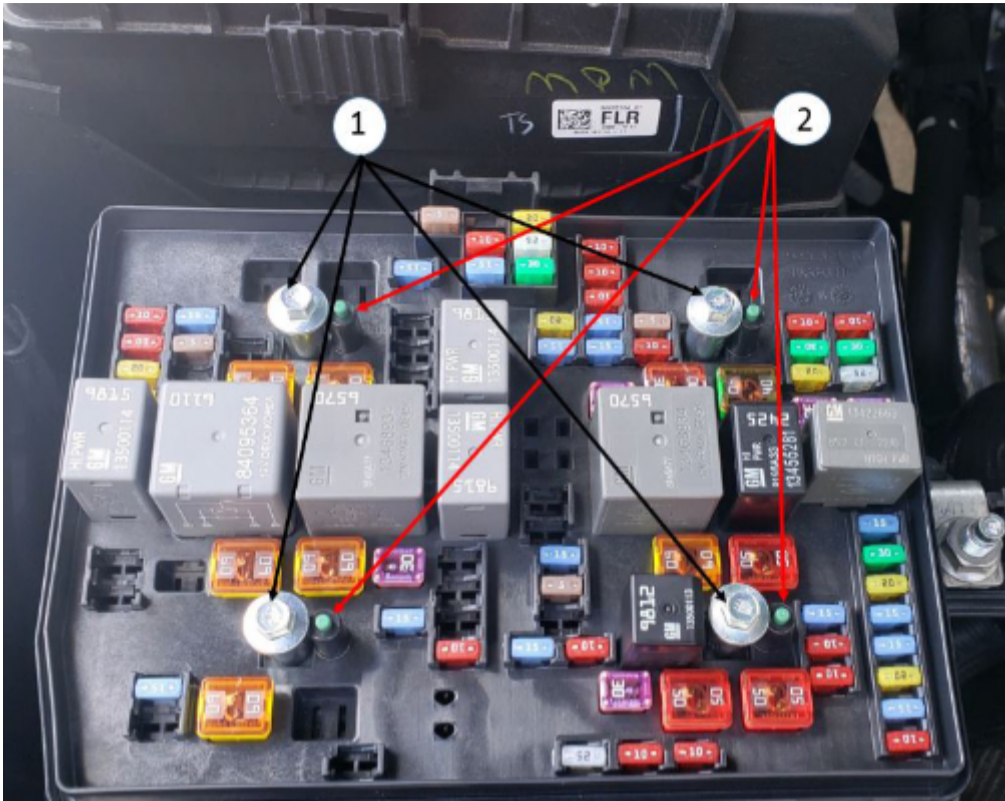
Involved Region or Country	North America
Condition	Some customers may comment on any number of electrical related symptoms. The following are some of the known reported ones: - No crank - No start - Starter grinds or re-engages after the engine starts - Headlights flicker or flash - SES MIL - IPC gauges sweep/fluctuate and/or various IPC warning lights or messages - High or low system voltage - May have any of the following DTC's: B1325, B2750, B305D, B297B, C0049, P0562, P0700, U0100, U0101, U0102, U3006 Some of these concerns may be noticed with powertrain movement, like when accelerating or braking.
Cause	These concerns could be caused by the X50A Underhood Fuse Block bolts (1), shown below, being loose. The X50A has built in indicators (2), which pop up as the X50A bolts are tightened down, to indicate that the X50A is fully installed. In some cases, even if these green indicators (2) are popped up, the bolts (1) may still be loose.

Inspect the X50A Underhood Fuse Block bolts (1) and verify they are properly torqued to 53 lb in (6Nm).
