JLRTB02058NAS2

# TECHNICAL BULLETIN

Tapping Noise From A-Pillar Area

| MODEL: | MODEL YEAR: | VIN: | ASSEMBLY PLANT: |
|---|---|---|---|
| Defender (LE) | 2020-2022 | 000584-091510 | Nitra (Slovakia) |

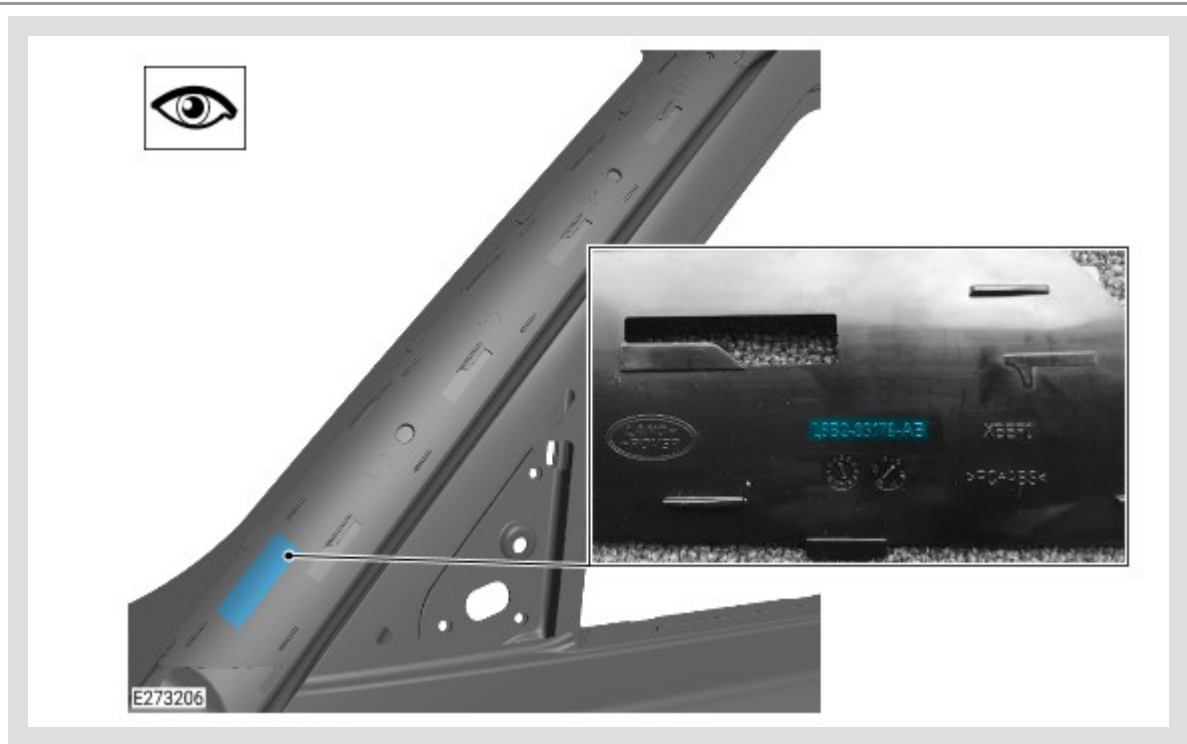
Locate the windshield moulding carrier part number.

- If the part number is **L8B2-03178-AB**, **L8B2-03179-AB**, **L8B2-03178-AC** or **L8B2-03179-AC**, continue to **step 24**.
- If the part number is **L8B2-03178-AD** or **L8B2-03179-AD**, continue to **step 25**.
