## PRODUCT CAMPAIGN BULLETIN

**APPLICABILITY:** 2026MY Forester

**NUMBER:** WRF-26R

**SUBJECT:** Safety Recall and Stop Sale: Forester  
Power Moonroof Glass Adhesion

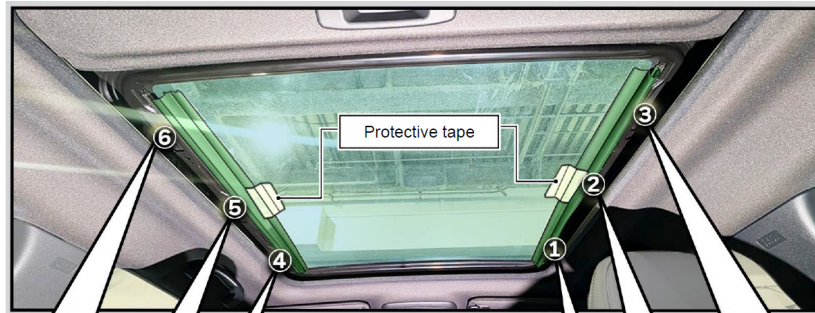
1.4 Using a flashlight to illuminate the bracket, visually inspect all six mounting brackets shown in the diagram below. Ensure that all brackets have both black primer and grey glass frit. If only grey frit is found on any of the brackets, proceed to Step 2 (sunroof assembly replacement). If both primer and grey frits are present on all six brackets, reinstall the lower lid covers. The procedure is complete.

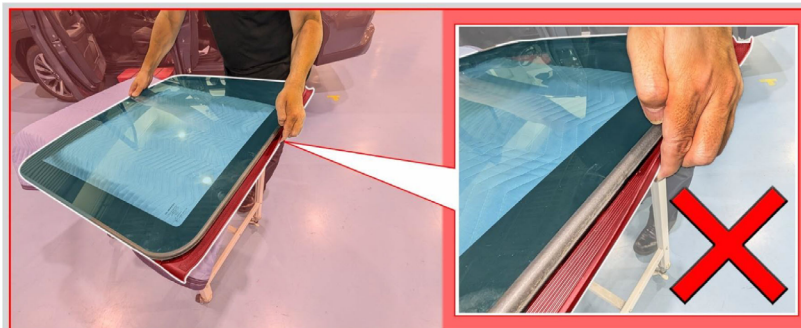
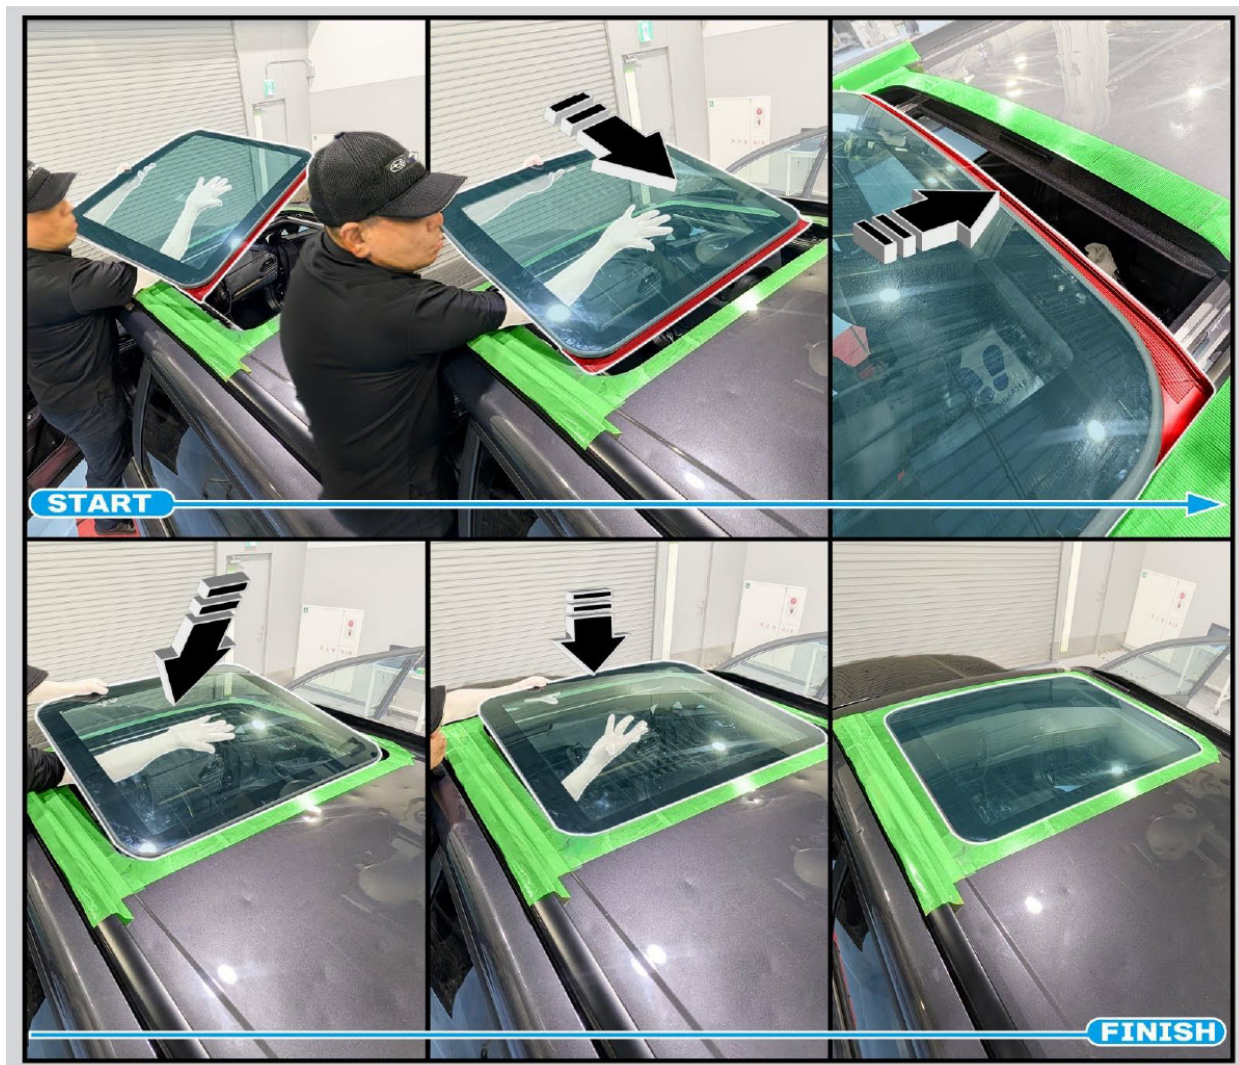
- DO NOT handle the sunroof lid assembly from the rear section. Grabbing or bending the rear section will cause deformation and/or separation from the glass.
- Handle the assembly with care.

## 2.5 Install NEW sunroof lid assembly.

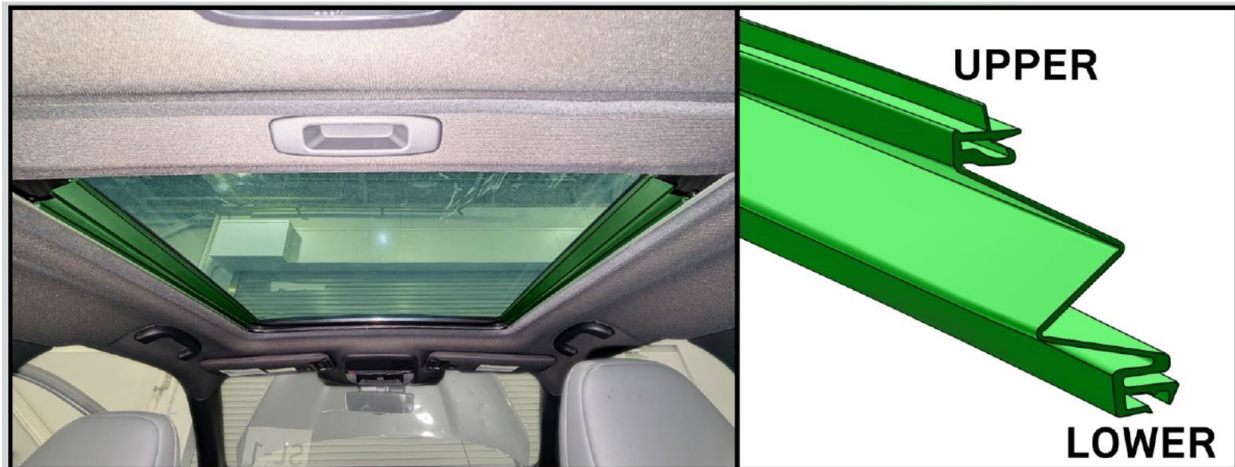
It is possible to install lid covers upside down. Confirm orientation with the image below.

2.9 Install lid covers, press in until the cover has fully engaged support.
