# Warranty Field Campaign

| Campaign Number: c7263 | Revision: | Released Date: 19-May-2026 |
| BES CM2450 EV111B Battery Bracket Replacement Campaign | | Expiration Date (U.S. and Canada): 14-May-2031 |

# **C7263, Attachment B - BES CM2450 EV111B Battery Bracket Replacement Campaign**

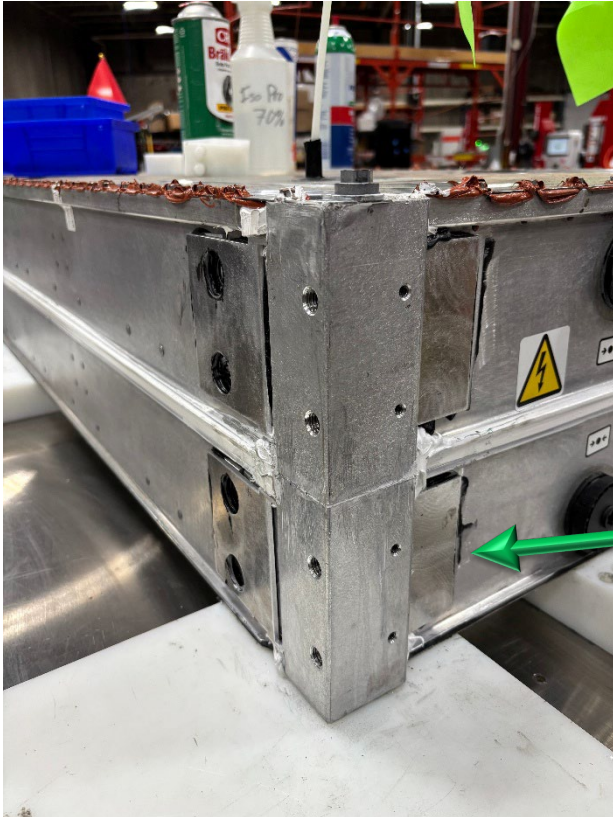
# Step 1: Corner Bracket Repair

Repairs to the corner bracket separation will be performed at a centralized location

Any battery packs with corner bracket separation will need to be replaced with a new/repared battery pack that will be supplied through coordination with the **Accelera Campaign Support Team**

**Do not order a new battery pack through the normal process to replace a battery pack with corner bracket separation as the only failure mode**

The replacement pack may have reinforcement plates installed but will not change any steps of the repair process

**If there is a battery with a failure mode that is not outlined in these instructions, order a replacement battery pack through the normal Battery ordering process**

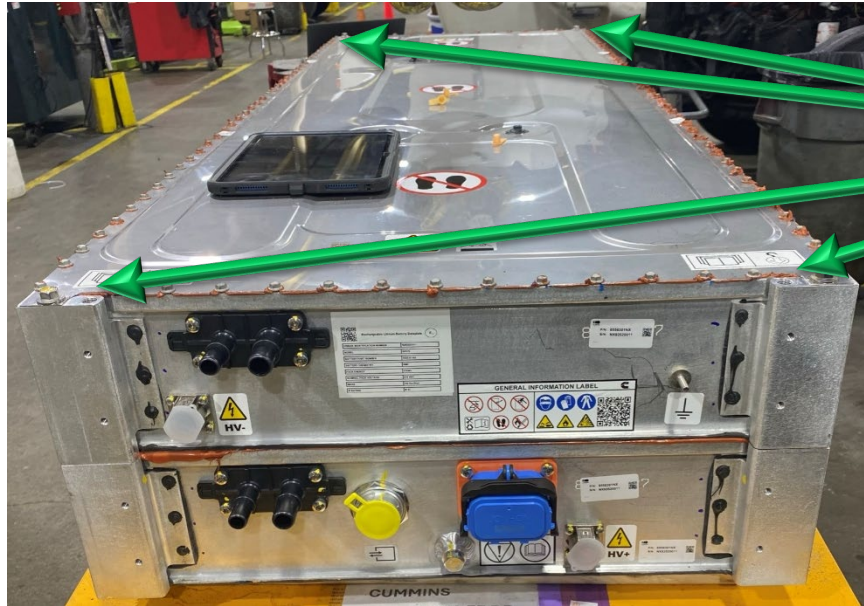
# Step 3: Lid Damage Inspection

Inspect the top 4 corners of the battery pack for damage to the lid that looks like the examples below
