## Technical product information

| Topic | Window Drop Glass Operation Continental GT/GTC 19-24MY |
| Transaction No. | 2080375/2 |

Window Drop Glass Operation | Continental GT/GTC |19-24MY

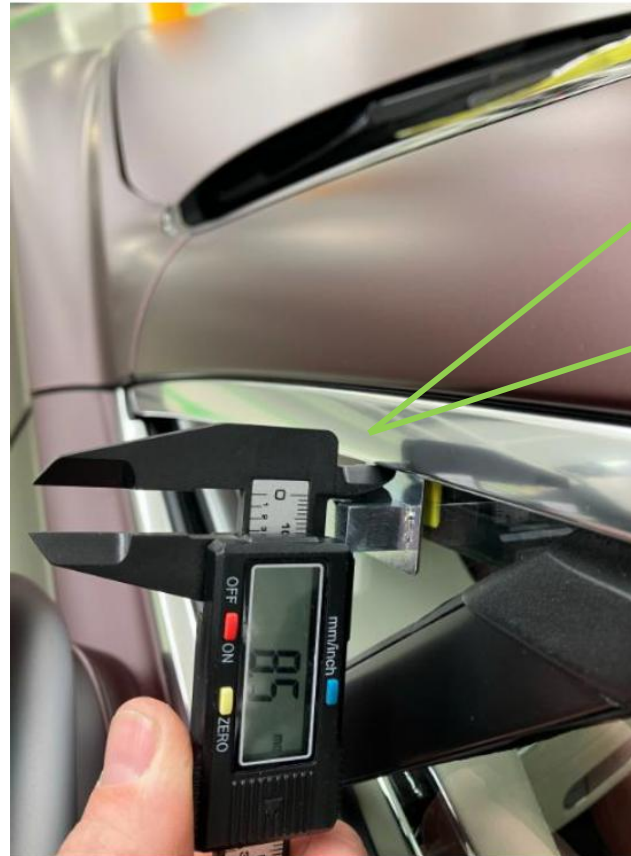
Place block 50mm in front of front div bar

Record measurement for all interlock points

From block to bright ware for all interlock points

**Specification**  
7.5mm  $\pm$  1mm  
(Interlock Tool WT10549/1)

If the measurement is out of specification  
refer to ElsaPro  
**Repair Group 64 'Front door quarter glass – To adjust'**

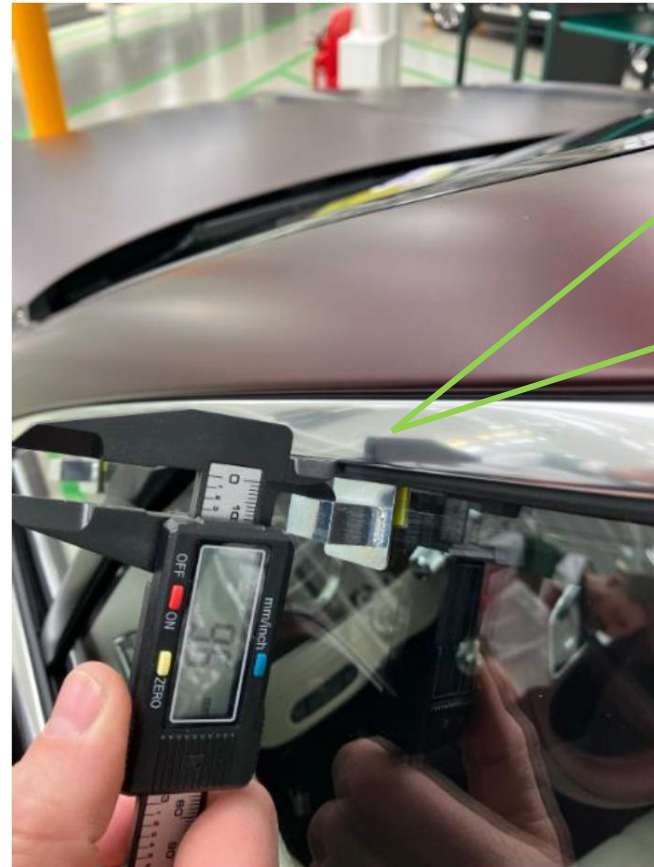
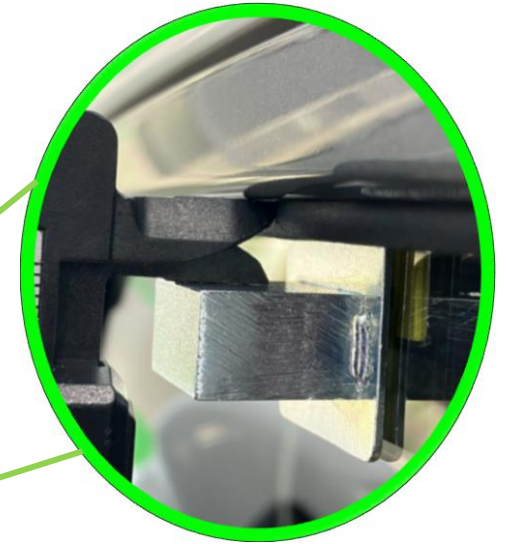
# INTERLOCK POINT 2

Place block 100mm in front of front div bar

Record measurement for all interlock points

From block to bright ware for all interlock points

8.5mm  $\pm$  1mm

**Repair Group 64 'Front door quarter glass – To adjust'**

*If the specification for interlock points 2, 3 or 4 cannot be achieved through normal adjustment, refer to page 6 of the glass reset procedure.*

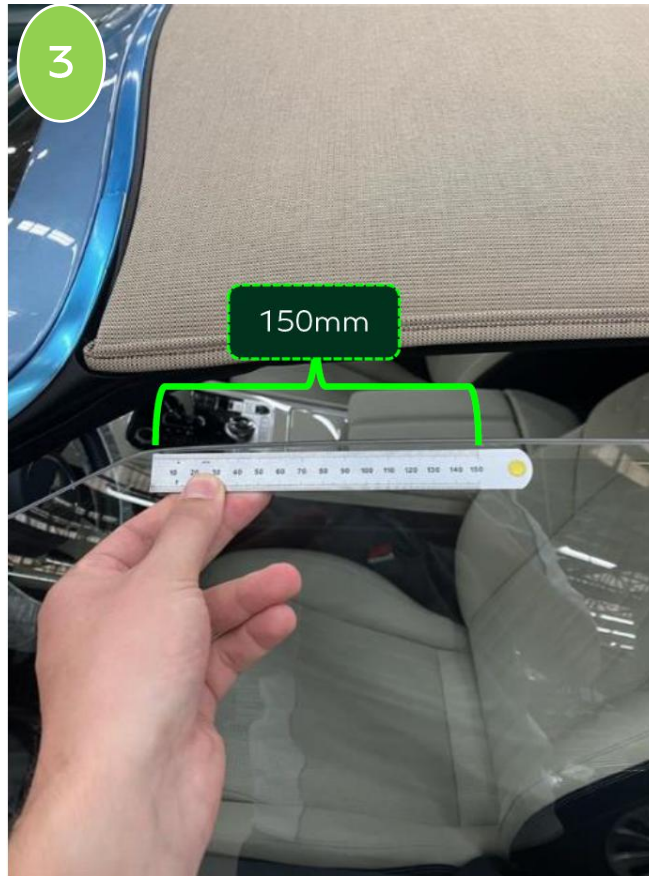
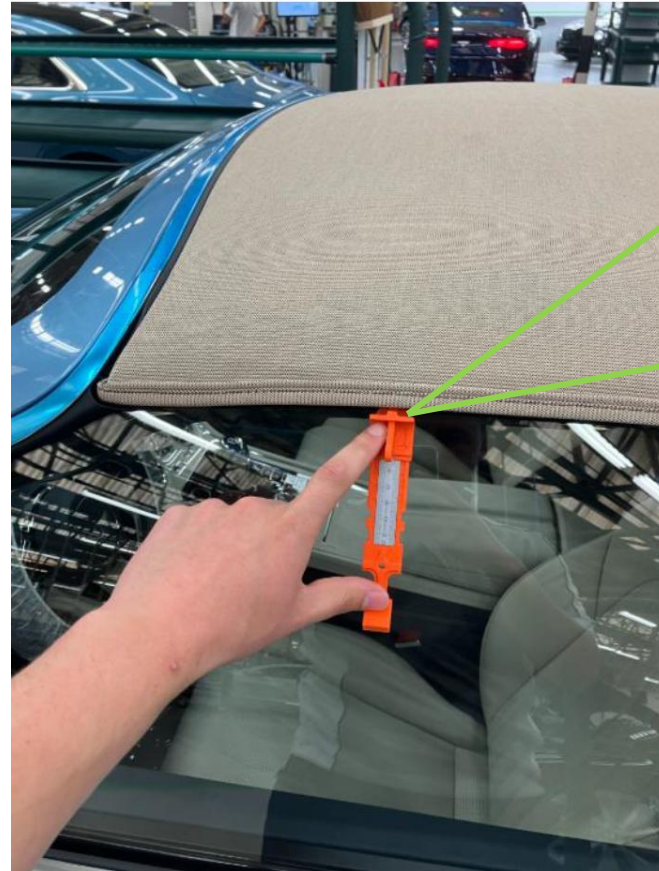
# INTERLOCK POINT 3

150mm from front corner of window glass as shown

1. Hook onto glass with door open at measured point
2. Close door and allow glass to close
3. Lightly push gauge to top and take measurement at indicated point. Do not deform the seal.

**Specification**  
7mm  $\pm$  1mm  
(Interlock Tool WT10554)

If the measurement is out of specification refer to ElsaPro Repair Group 64 'Front door quarter glass – To adjust'

*If the specification for interlock points 2, 3 or 4 cannot be achieved through normal adjustment, refer to page 6 of the glass reset procedure.*

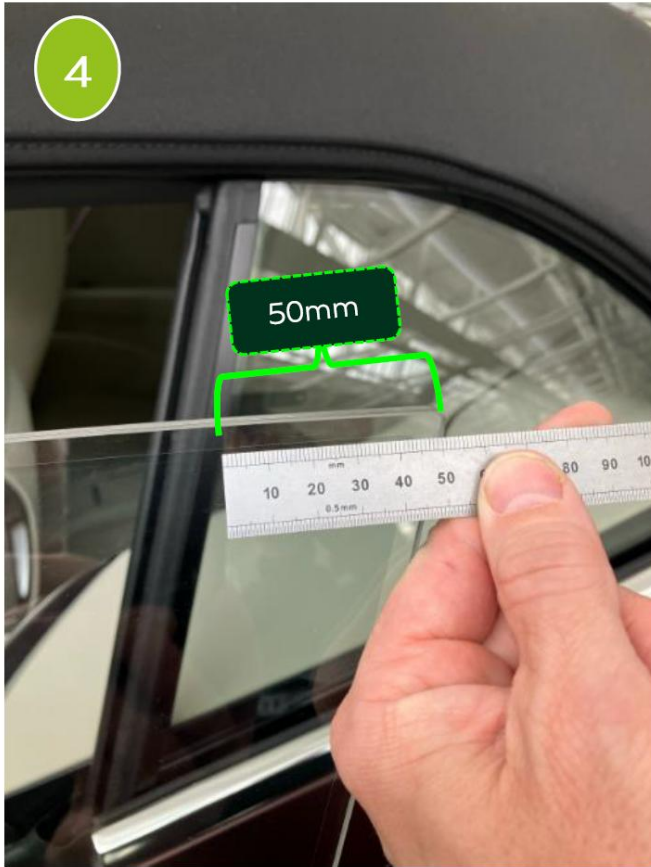
# INTERLOCK POINT 4

50mm from rear edge of the front door glass as shown

**Specification**  
8.5mm  $\pm$  1mm  
(Interlock Tool WT10554)

If the measurement is out of specification refer to ElsaPro **Repair Group 64 'Front door quarter glass – To adjust'**

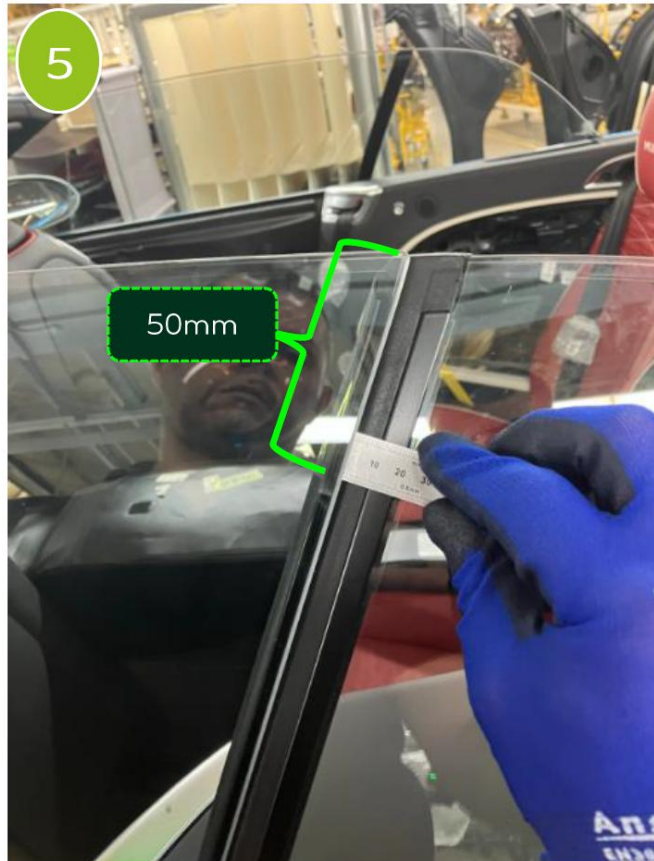
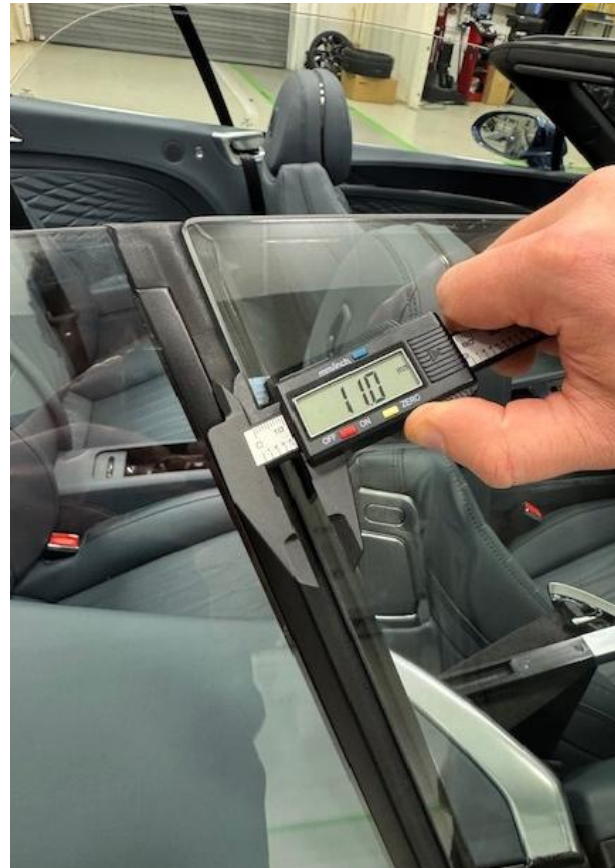
# INTERLOCK POINT 5 ROOF DOWN

Take measurement  
50mm from top of glass

Record measurement

**Specification**  
11mm  $\pm$  1mm  
(Ruler/vernier)

If the measurement is out of  
specification refer to ElsaPro  
**Repair Group 64 'Front door  
quarter glass – To adjust'**

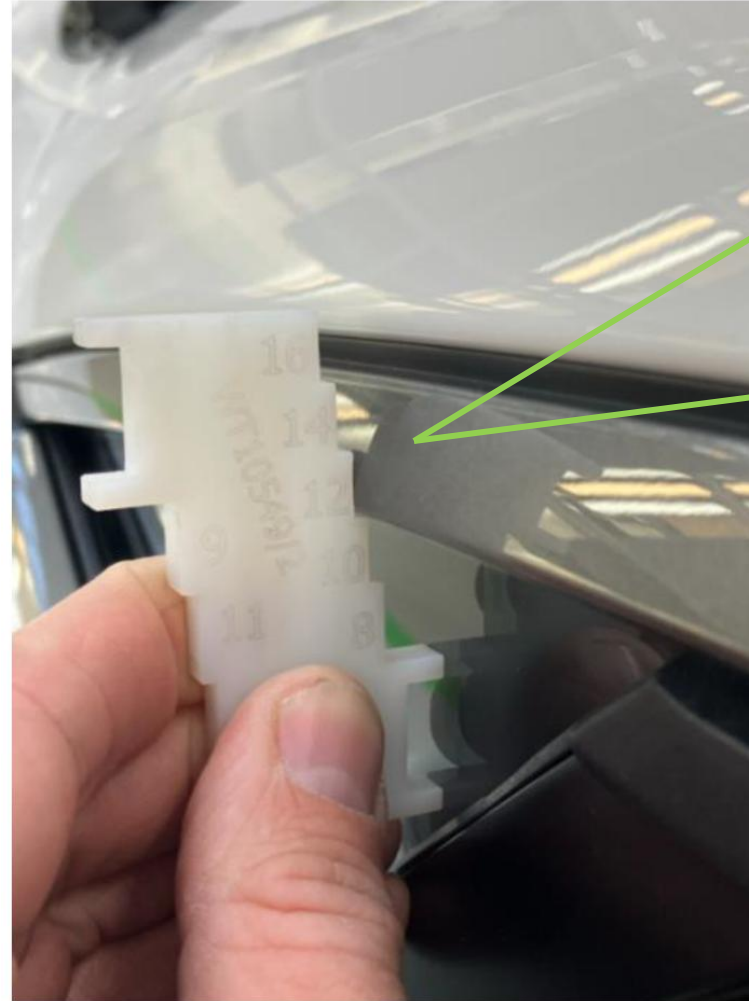
# PROFILE POINT 1

50mm in front of front div  
bar

**Specification**  
10mm  $\pm$  1mm  
(Profile Tool WT10549/2)

Flat against glass to  
brightware

If the measurement is out of  
specification refer to ElsaPro  
**Repair Group 64 'Slide glass  
checking and adjusting'**

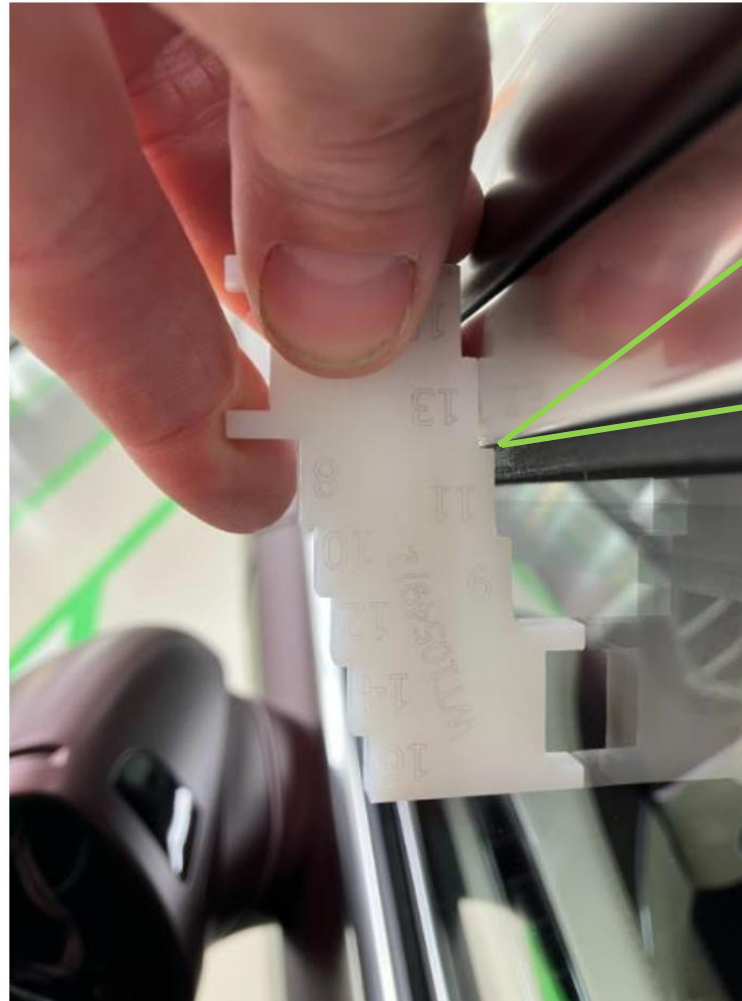
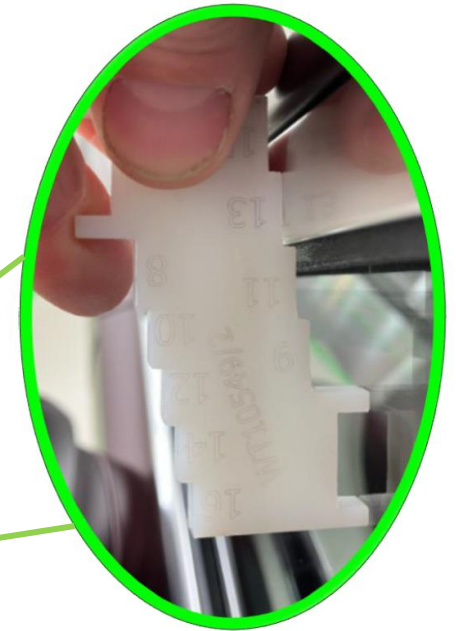
# PROFILE POINT 2

Place block 50mm in front  
of front div bar

Flat against glass to  
brightware

**Specification**  
14mm  $\pm$  2mm  
(Profile Tool WT10549/2)

If the measurement is out of  
specification refer to ElsaPro  
**Repair Group 64 'Slide glass  
checking and adjusting'**

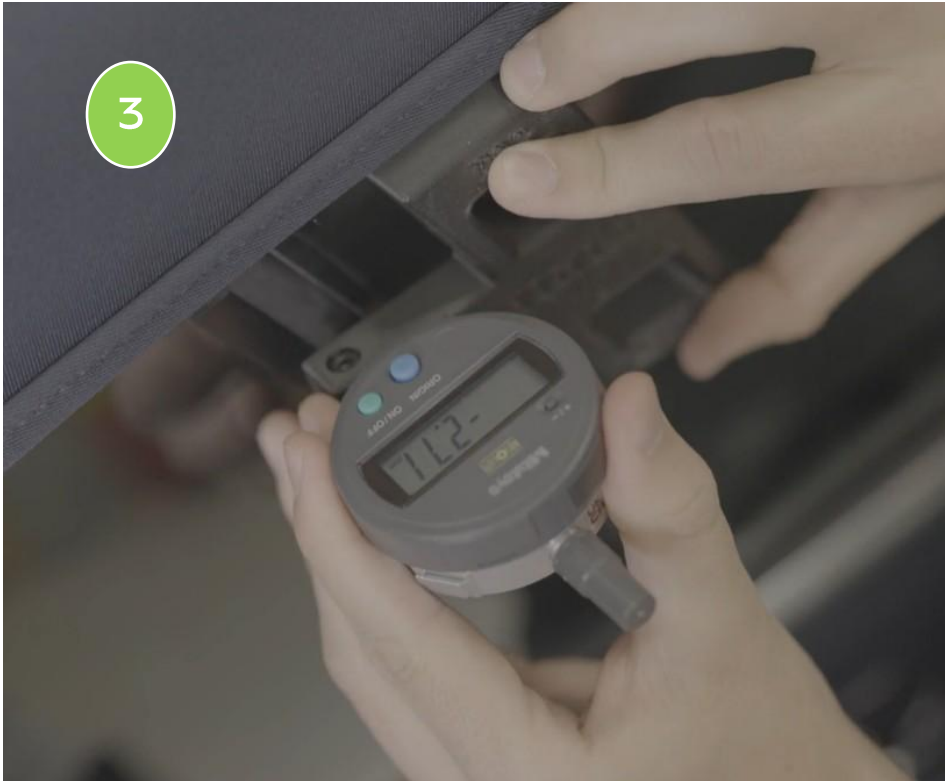
# PROFILE POINT 3 ROOF UP (DIGITAL DTI GAUGE - LATEST TOOL)

Align and position the tool on the front window so that its contact face rests flat against the roof trim, zero the tool.

Then slide it along the surface until it makes full, even contact with the rear glass. Record the measurement.

**Specification**  
0mm +0 / -2.5mm

**Repair Group 64**  
**'Slide glass checking and adjusting'**

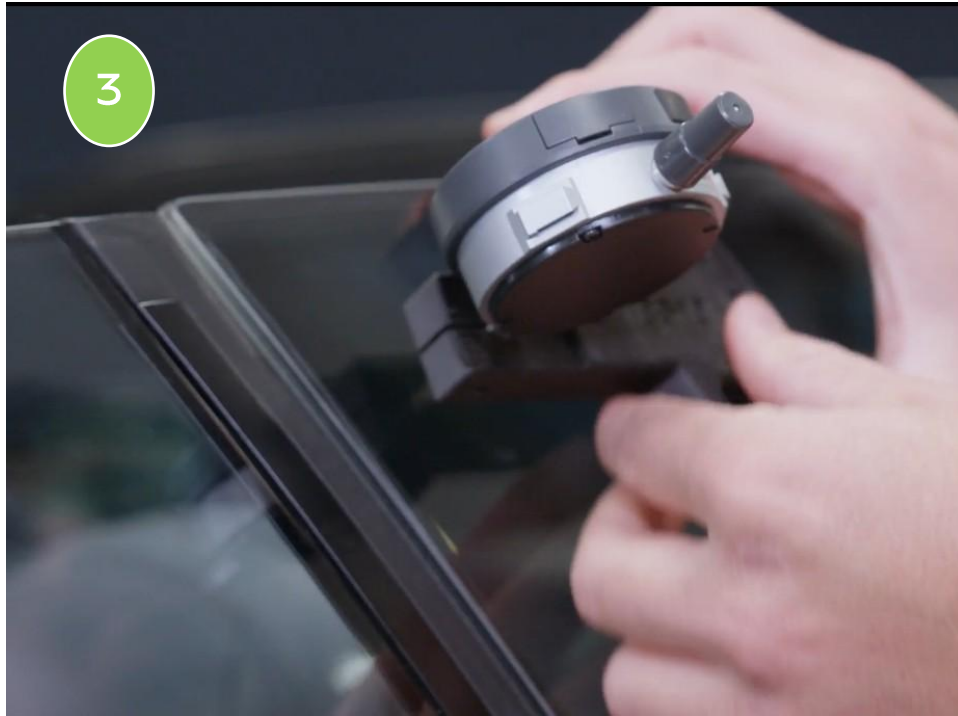
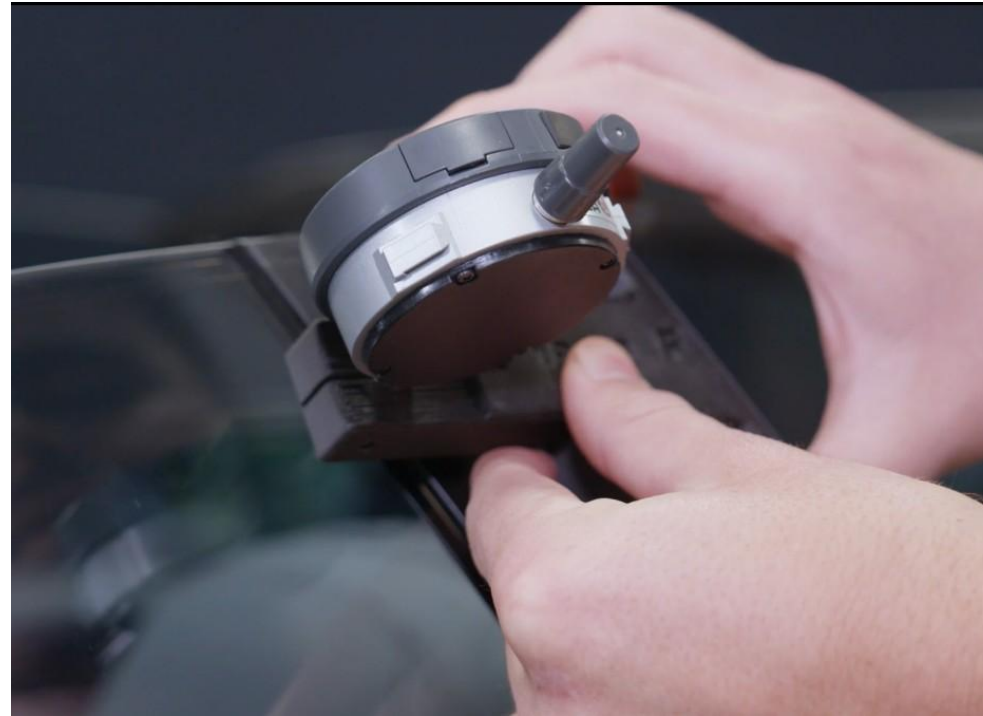
## PROFILE POINT 3 ROOF DOWN (DIGITAL DTI GAUGE - LATEST TOOL)

Align and place the tool on the front window, ensuring the contact face sits level with the top of the glass, zero the tool.

Then slide it along the surface until it makes full, even contact with the rear glass.  
Record the measurement.

**Specification**  
0mm +0 / -3mm

**Repair Group**  
**64 'Slide glass**  
**checking and**  
**adjusting'**

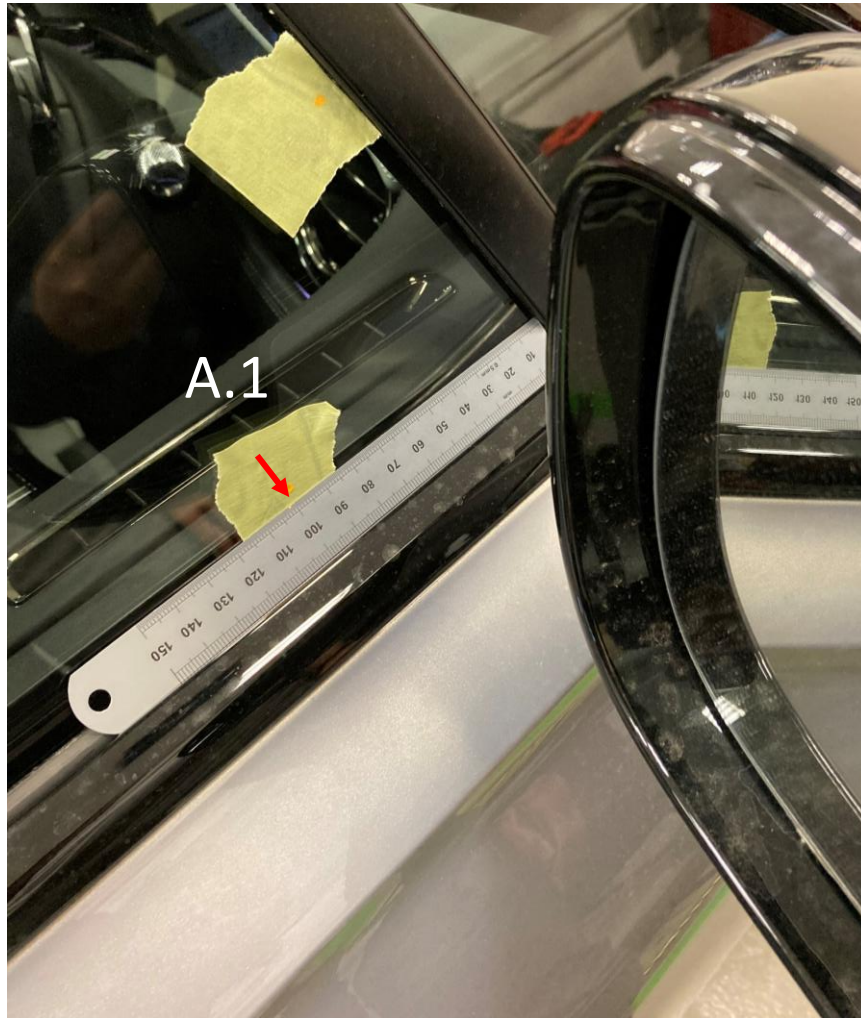
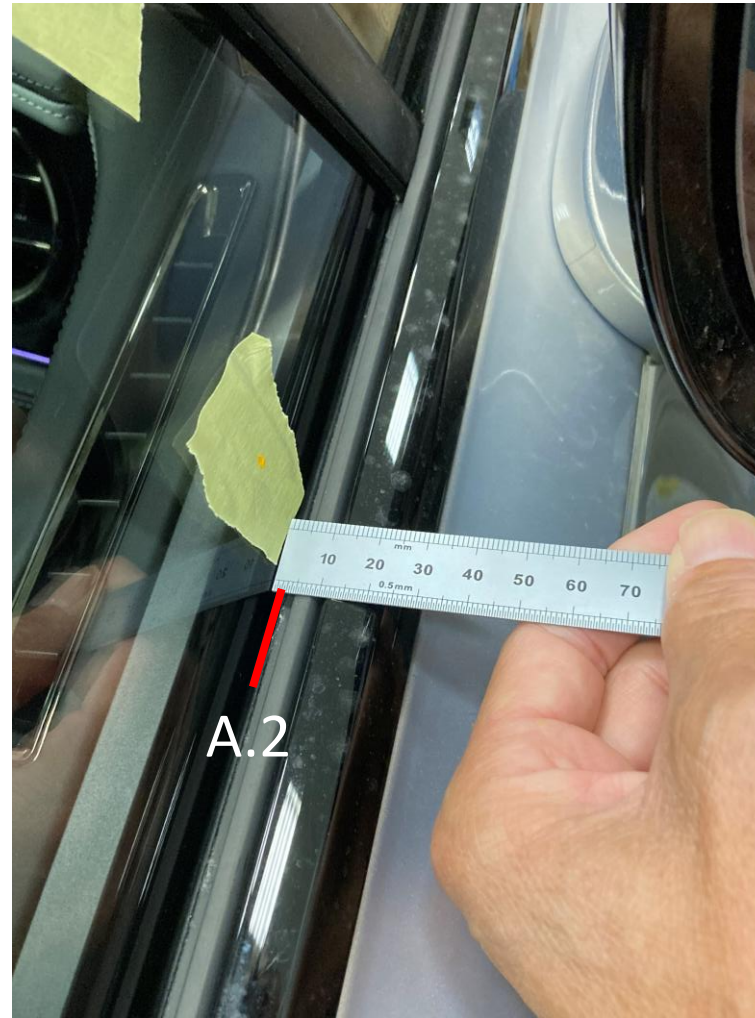
# WAIST SEAL MEASUREMENT POINT A

Mark on tape 100mm from div bar (A.1)

Measure from first lip rubber seal to window glass (A.2)

**Repair Group 64 'Slide glass checking and adjusting'**

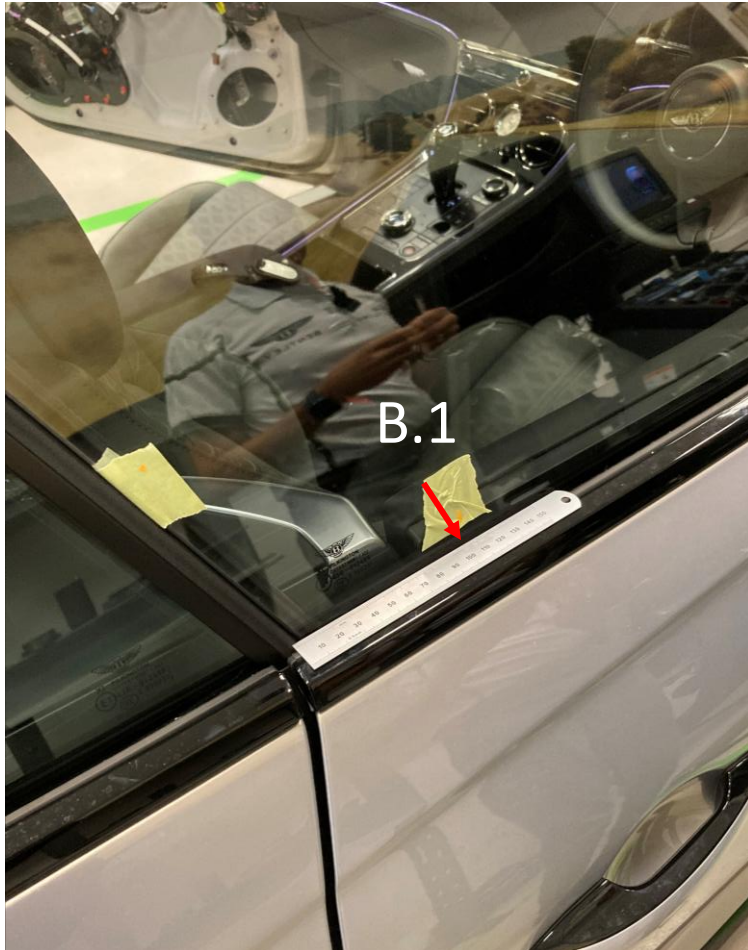
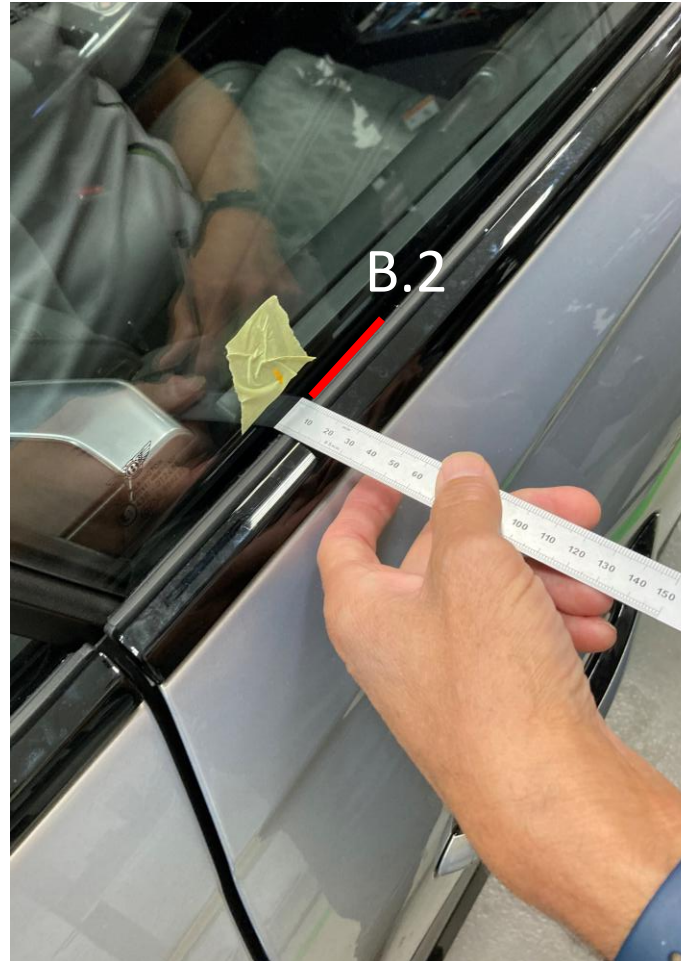
# WAIST SEAL MEASUREMENT POINT B

Mark on tape 100mm from  
div bar (B.1)

Measure from first lip  
rubber seal to window glass  
(B.2)

**Repair Group 64 'Slide glass  
checking and adjusting'**

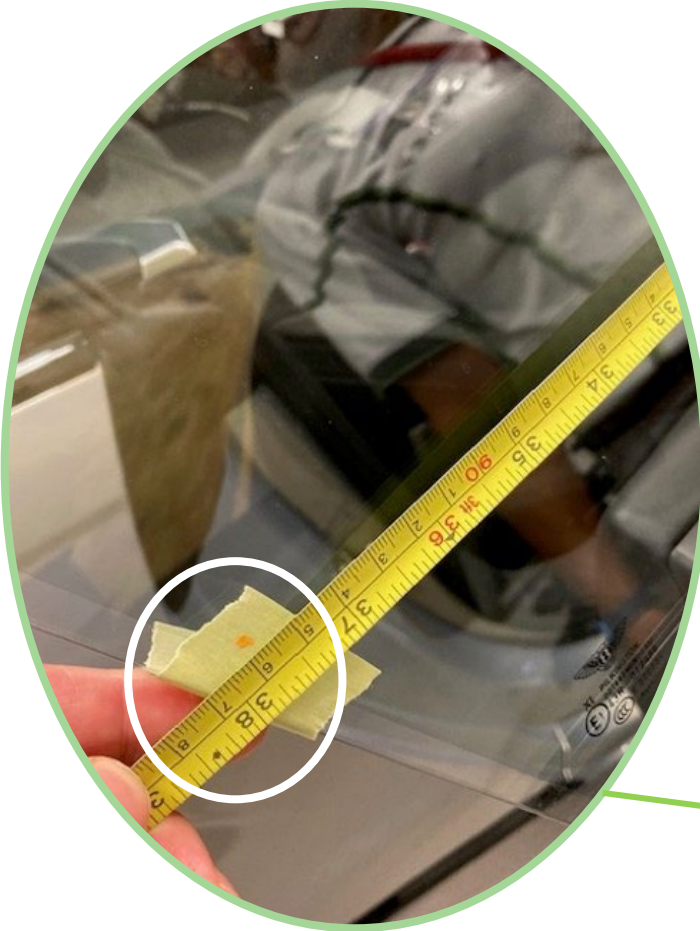
Measuring from front div bar to rear of  
the glass

**Specification**  
971mm +2mm

If out of specification, refer to the next  
slide to adjust the glass position

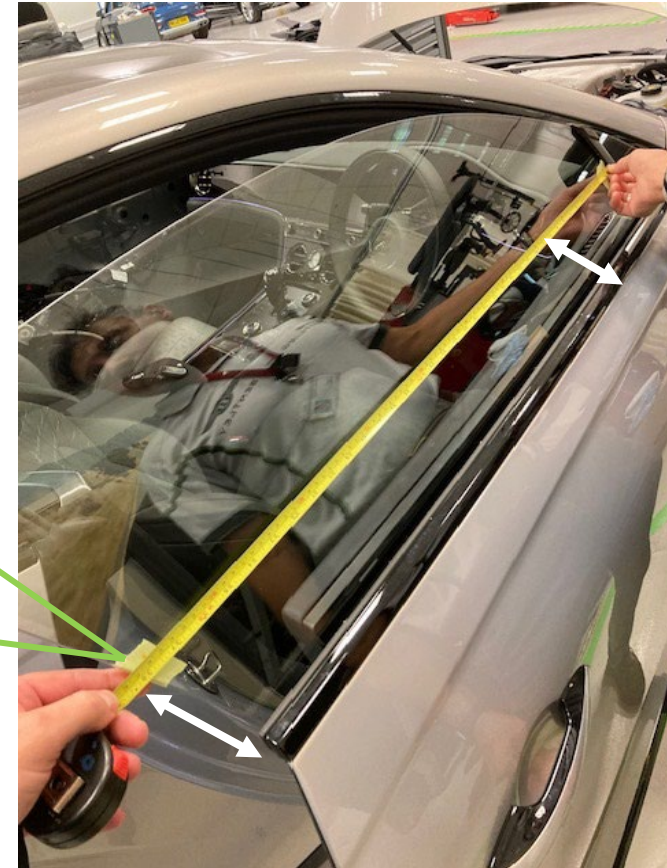
Measure 100mm up from  
the waist rail
