Product Improvement  
Campaign2022-2026MY  
Carnival (KA4) and  
2025-2026MY Carnival  
Hybrid (KA4 HEV)

PI2602

June 2026

2ND ROW SEAT (LH & RH) FOLDING  
TENSION SPRING REPLACEMENT (PI2602)

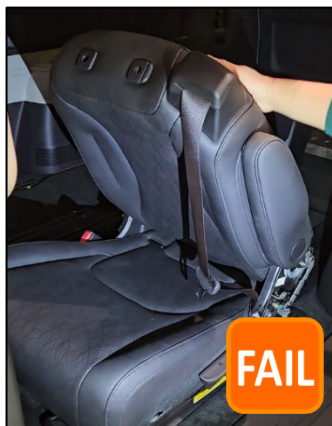
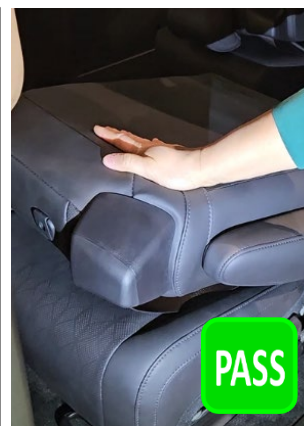
The new tension springs will cause the seat back to tilt forward at a slower speed. If the seat back does not fold down flat to the seat cushion, then the spring tensioner(s) were not installed correctly.

32. The seat back should fold down and lay flat against the bottom seat cushion.
