GROUP	MODEL
ELE	2025-2026MY K5 (DL3) w/2.5L GDI THETA III
NUMBER	DATE
419	June 2026

SERVICE ACTION: BATTERY WIRING HARNESS COVERING INSPECTION/REPLACEMENT (SA645)

This bulletin provides information for inspecting the 12V battery wiring harness on certain 2025-2026 MY K5 (DL3) vehicles equipped with the Theta III 2.5L GDI engine, produced from February 20, 2024, through March 13, 2026. The subject vehicles may exhibit an illuminated Malfunction Indicator Lamp (MIL) along with a low engine oil warning light and/or battery warning light displayed on the instrument cluster, caused by abrasion of the wiring harness over time. One or more of the Diagnostic Trouble Codes (DTCs) listed on page 2 may be stored. Follow the procedure outlined in this publication to inspect the battery wiring harness and replace the battery harness bracket, or, if required, replace the battery wiring harness assembly. Before performing this procedure, confirm that the vehicle is included in the affected VIN range.

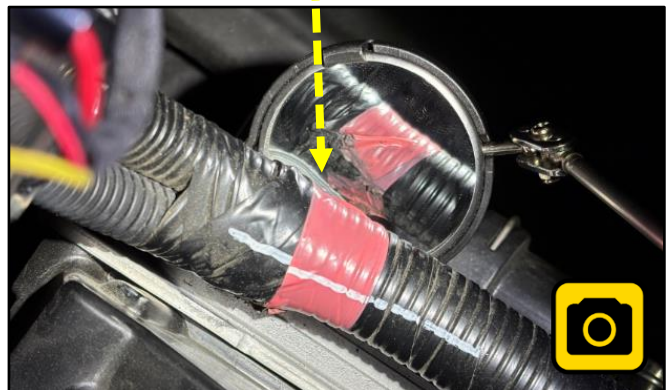
- 3b. Take one (1) clear photo of the battery wiring harness (C) covering condition next to the ATF warmer (D).

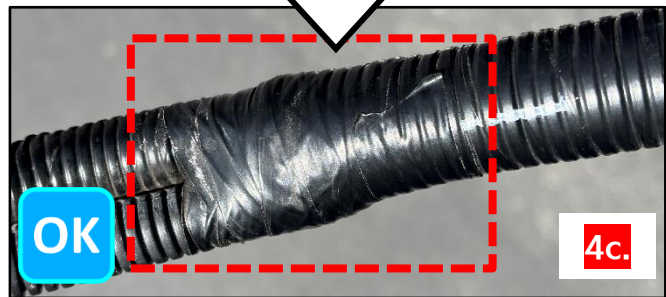
4c. • If there IS minor abrasion to the battery wiring harness (C) covering (OK). If there is no internal damage to wiring, then apply electrical tape to cover the affected area. Using KDS Tablet 'Warranty Claim Attachment' tab, take one (1) clear photo of the battery harness (C) affected area.

4d. If either conditions described above are (OK), proceed to the 'Replacement Procedure: (Battery Harness Bracket)' on page 5 and replace the existing wiring harness retaining bracket with an improved part.
