GROUP	MODEL
ELE	2016-2018MY Sorento (UMa)
NUMBER	DATE
297 (Rev 2, 06/16/2026)	May 2023

TECHNICAL SERVICE BULLETIN

MULTIFUNCTION SWITCH REPAIR (WTY031)

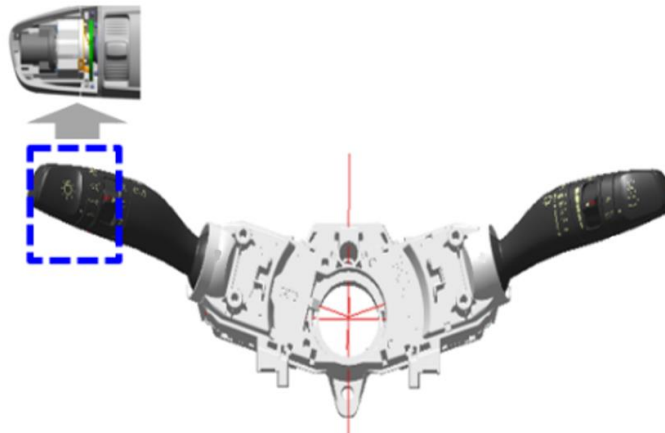
This bulletin provides information associated with the 'Multifunction Switch Warranty Extension Program' (WTY031) to repair the multifunction switch knob on 2016-2018MY Sorento (UMa) vehicles, produced at Kia Georgia from October 27, 2014 through March 7, 2018, which may exhibit an intermittent headlamp flickering. The vehicle's warranty for this issue will be extended from 5 years/60,000 miles to 15 years/150,000 miles, whichever comes first, starting from the date the vehicle was first put into service. The concern does not need to be duplicated in order to follow the procedure outlined in this publication to replace the multifunction switch moving block and outer cover with the new improved part.
