HYUNDAI
Technical Service Bulletin

GROUP BODY ELECTRICAL	NUMBER 26-BE-012H
DATE JUNE 2026	MODEL(S) PALISADE (LX2)

SUBJECT: CHECK FORWARD SAFETY SYSTEMS WARNING – FRONT VIEW CAMERA REPLACEMENT DTC C272246

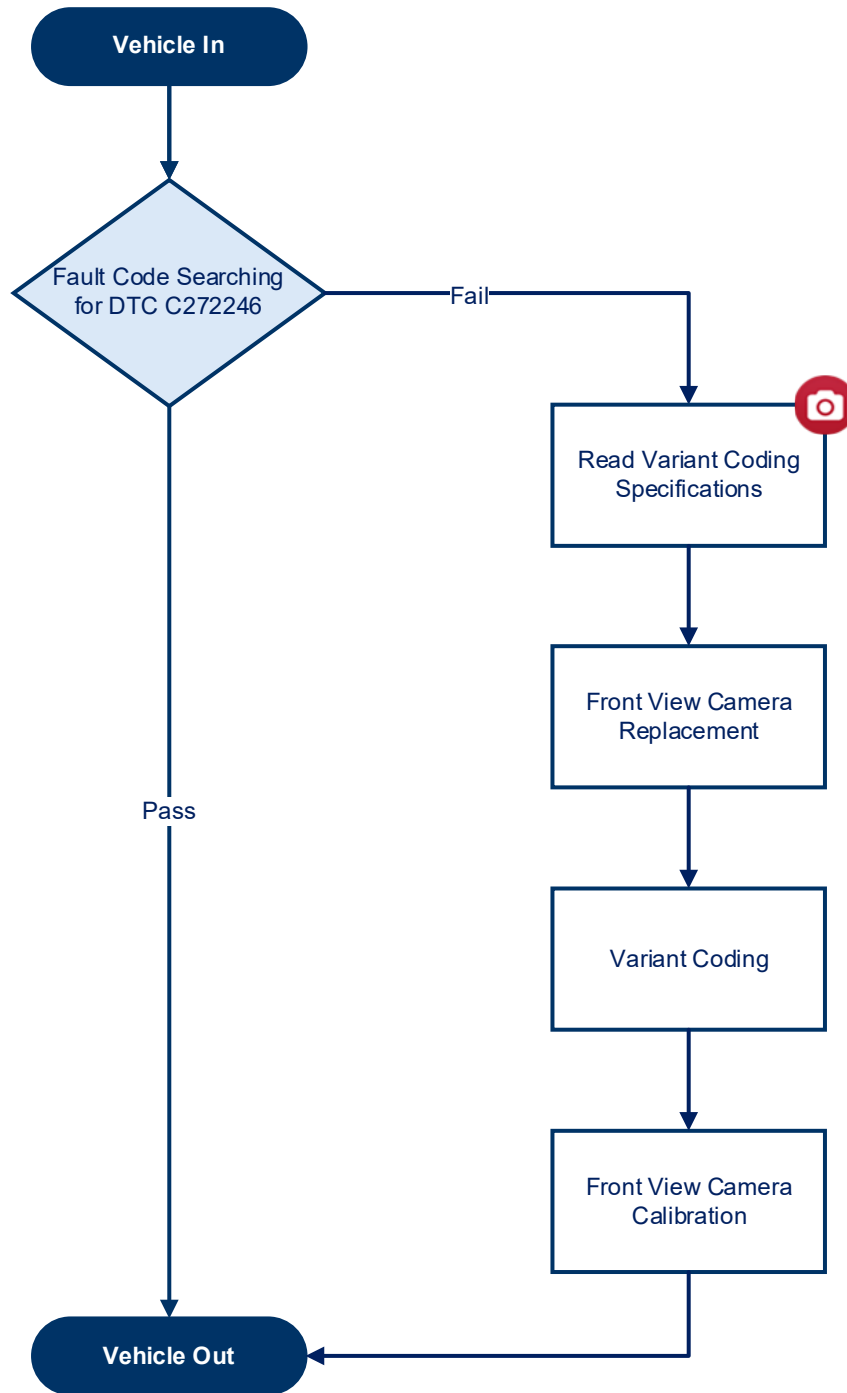
Flowchart

Description: Some Palisade (LX2) vehicles may display a “Check forward safety systems” warning message on the cluster along with DTC C272246, due to the front view camera calibration range being exceeded. This bulletin provides instructions to replace the front view camera when this DTC is active.

1. Connect the GDS and perform **Fault Code Searching (A)** for DTC **C272246** on the **FR_CMRI Front View Camera** system:
 - **PASS:** If **C272246** is **NOT** found, then this service procedure is now complete.
 - **FAIL:** If **C272246** is found, proceed to the [Front View Camera Replacement](#) section.
