TECHNICAL SERVICE BULLETIN

TECHNICAL SERVICE BULLETIN: 53-2073
SERVICE CAMPAIGN: 001302

TECHNICAL SERVICE BULLETIN 53-2073 REMEDY INSTRUCTIONS

FOREST RIVER	Make(s): SHASTA Model(s): SST18FQ, SST28BHS, SST521CK Model Year(s): 2026-2027	Repair Code: SB-741-09-00-004840 Allotted Time: .40 HRS. Inspection Code: N/A Allotted Time: N/A
	Concern: The direct vent furnace was inconsistently installed with excessive gap to the cabinet.	Photo(s) Required: NO Prior Authorization Required: YES Part(s) Number: N/A Part(s) Return: NO

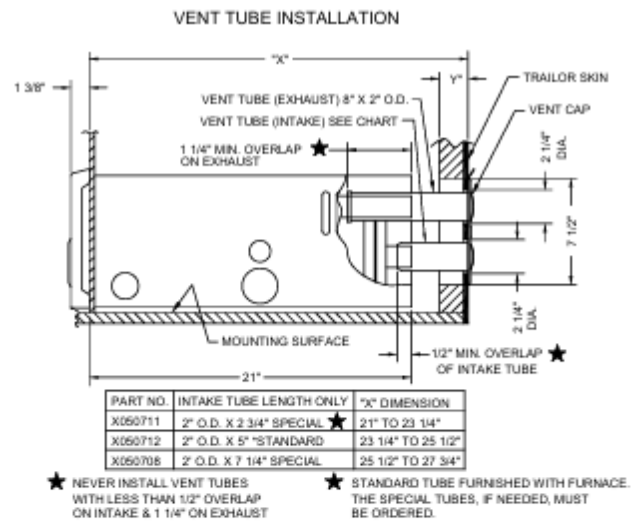
Figure 1

The furnace was inconsistently installed with excessive gap to the cabinet.

1. REMOVE SCREWS FROM FURNACE FLUE ON THE EXTERIOR OF THE UNIT AND LOOSEN SEAL
2. REMOVE THE 2 SCREWS FROM THE FRONT OF THE FURNACE GRILL ON THE INTERIOR OF THE UNIT (SEE FIGURE 1)
