Service Engineering Operations
Customer Service Division

TO: All U.S. Ford and Lincoln Dealers
SUBJECT: **Customer Satisfaction Program 25N10 – Supplement #1**
Certain 2017-2025 F-450 – F-600 Chassis Cab Upfitted with an Aerial Bucket
Frame Rail Crack
REF: **Customer Satisfaction Program 25N10**
Dated February 11, 2026

CERTAIN 2017-2025 F-450 - F-600 CHASSIS CAB UPFITTED WITH AN AERIAL BUCKET — FRAME RAIL CRACK

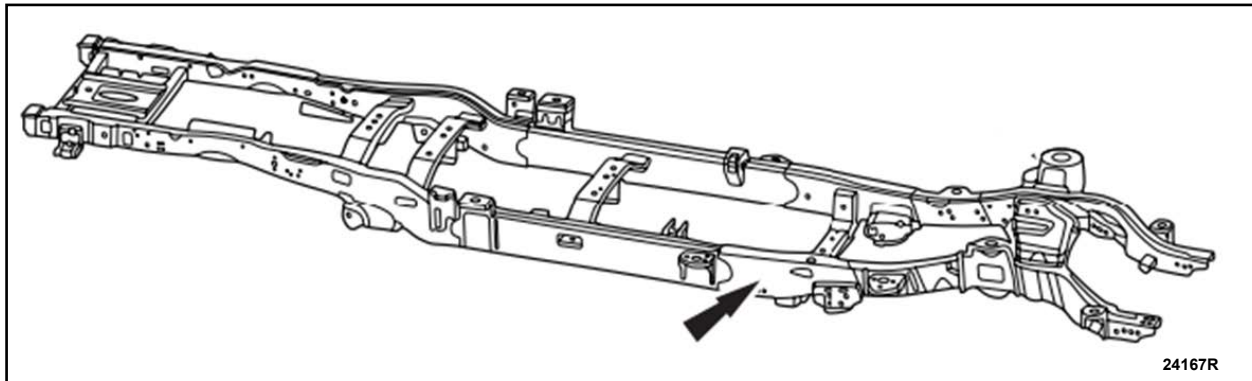
FIGURE 7

1. Locate the frame part number label. The frame part number label is located on the right-side outboard surface of the frame rail behind the transmission crossmember. See Figures 7 and 8.

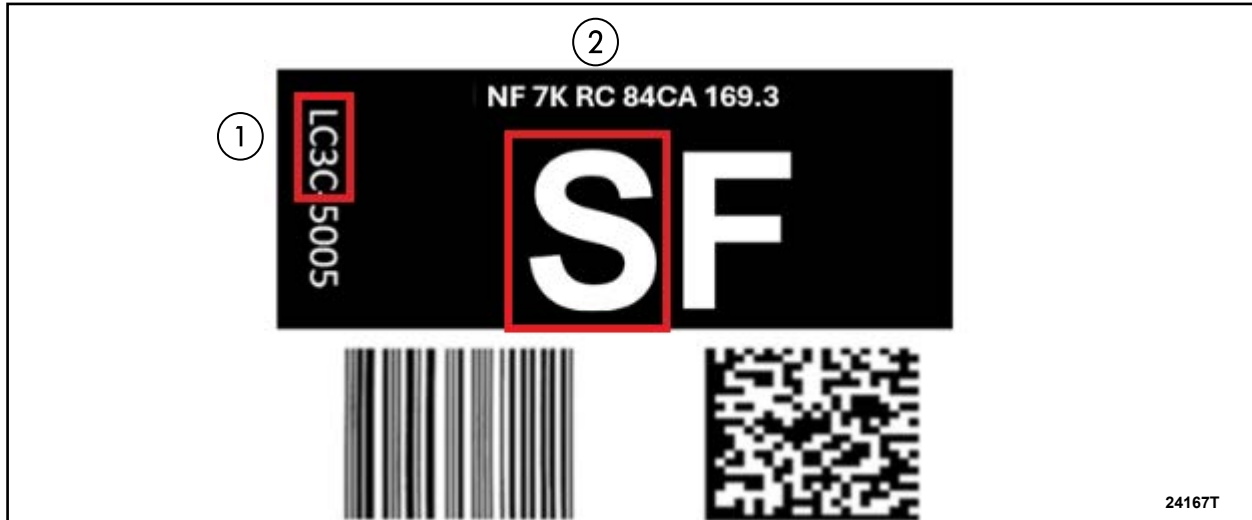
FIGURE 9

2. Locate the part number prefix and suffix on the part number label. Cross-reference the prefix and suffix in the Parts Requirement/Ordering Information section in the dealer bulletin to determine the required frame assembly service part number. See Figure 9.

- (1) Prefix.
- (2) Suffix.

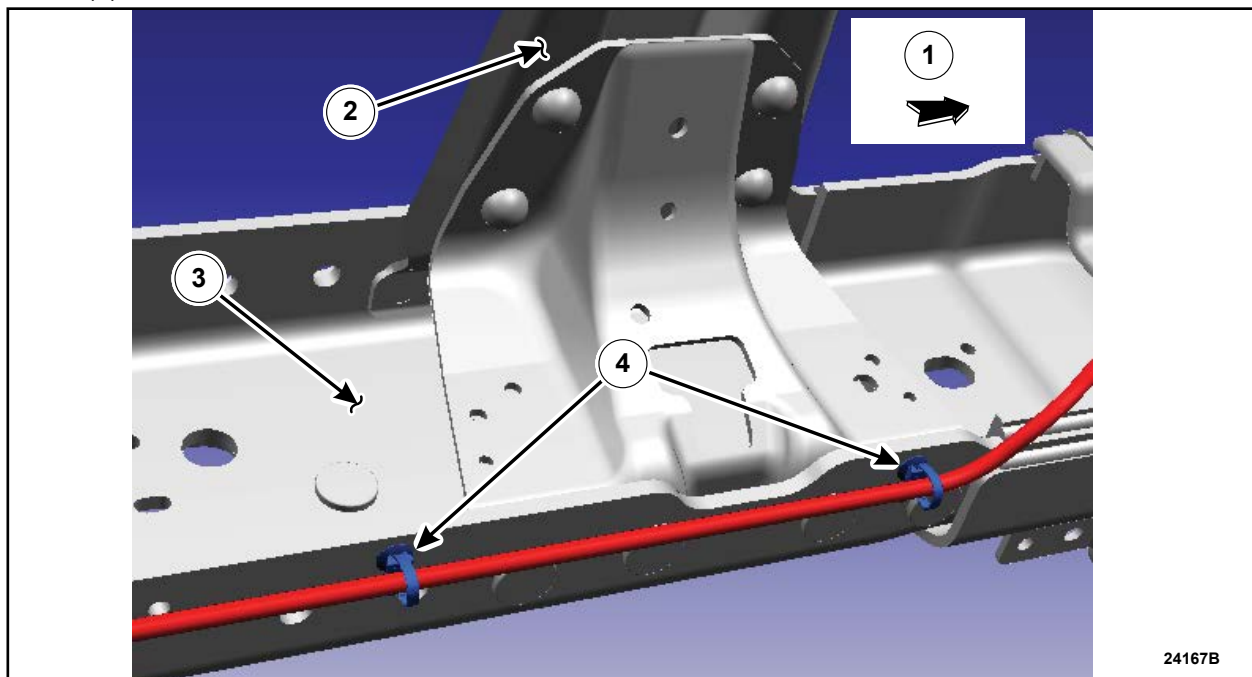
FIGURE 15

- (1) Front of Vehicle.
- (2) Number 4 crossmember.
- (3) Left hand frame rail.
- (4) Detach the Def retainers from the frame.

1. Detach the two (2) DEF pressure line retainers that retain the line to the frame, under the number 4 crossmember as shown in Figure 15. Position the DEF pressure line aside.

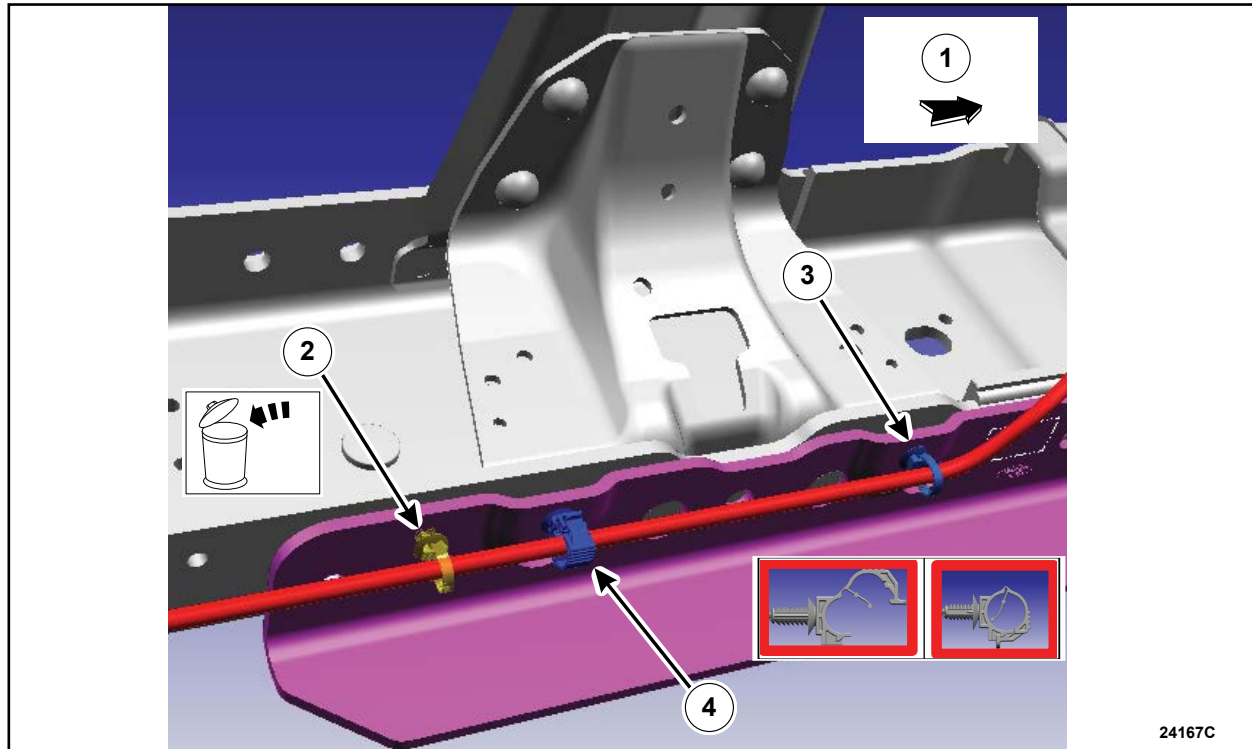
FIGURE 16

- (1) Front of Vehicle.
- (2) Fully remove the rear retainer from the DEF pressure line.
- (3) Reuse and install the original front DEF pressure line retainer to the lower bracket.
- (4) Attach and install the rear DEF pressure retainer.

2. Once the LH side lower bracket has been installed, position back the DEF pressure line and attach the existing front line to frame retainer to the lower bracket. Then, remove and discard the original rear line to frame retainer from the DEF pressure line. Then, attach the supplied clasp retainer to the DEF pressure line and install into the rear lower bracket retainer hole as shown in Figure 16.

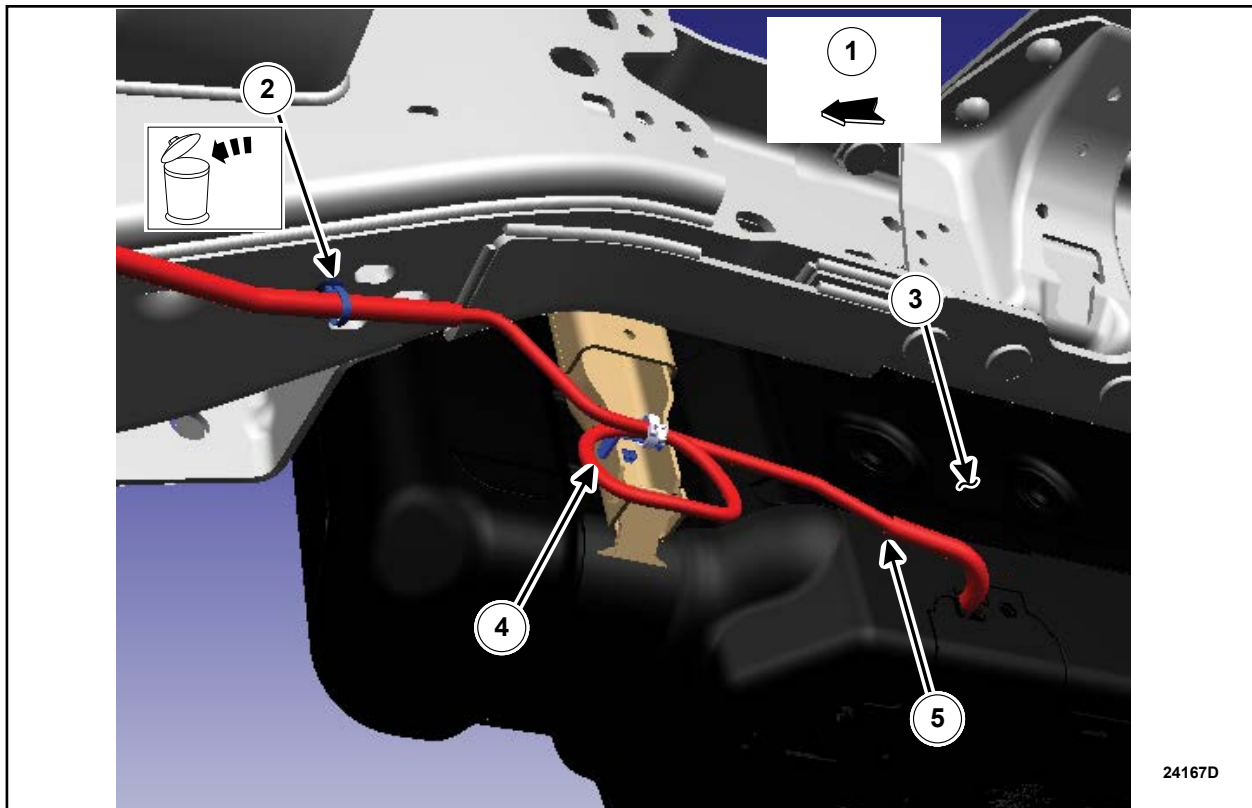
FIGURE 17

- (1) Front of Vehicle.
- (2) DEF pressure line retainer to frame location.
- (3) Reductant tank.
- (4) Do not disconnect or remove this retainer.
- (5) DEF pressure line.

1. Detach the single DEF pressure line retainer from the RH lower frame as shown in Figure 17. Then, completely remove and discard the retainer from the DEF pressure line.

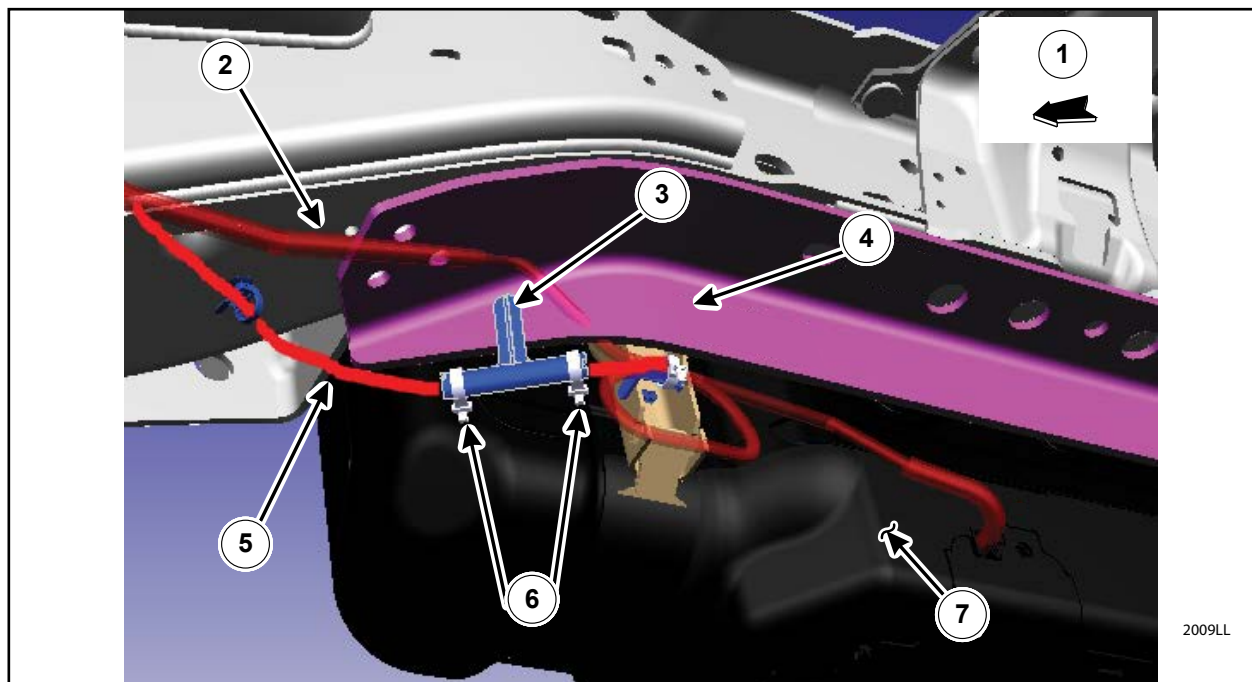
FIGURE 18

NOTE: Figure 18 shows the different T clip locations for between the regular cab vehicles and Crew and Super Cab vehicles. Holes are pre drilled on bracket for T clip, will need to drill new hole for routing clip.

- (1) Front of Vehicle.
- (2) Original DEF pressure line routing.
- (3) Regular cab T clip location.
- (4) Crew and super cab T clip location.
- (5) New DEF pressure line routing.
- (6) Attach the T clip to the line using zip ties.
- (7) Reductant tank.

2. Once the RH side lower bracket has been installed, install the supplied T clip to the lower bracket and route the DEF pressure line toward the T clip and attach the T clip to the DEF pressure line with two (2) of the supplied zip ties as shown in Figure 18.

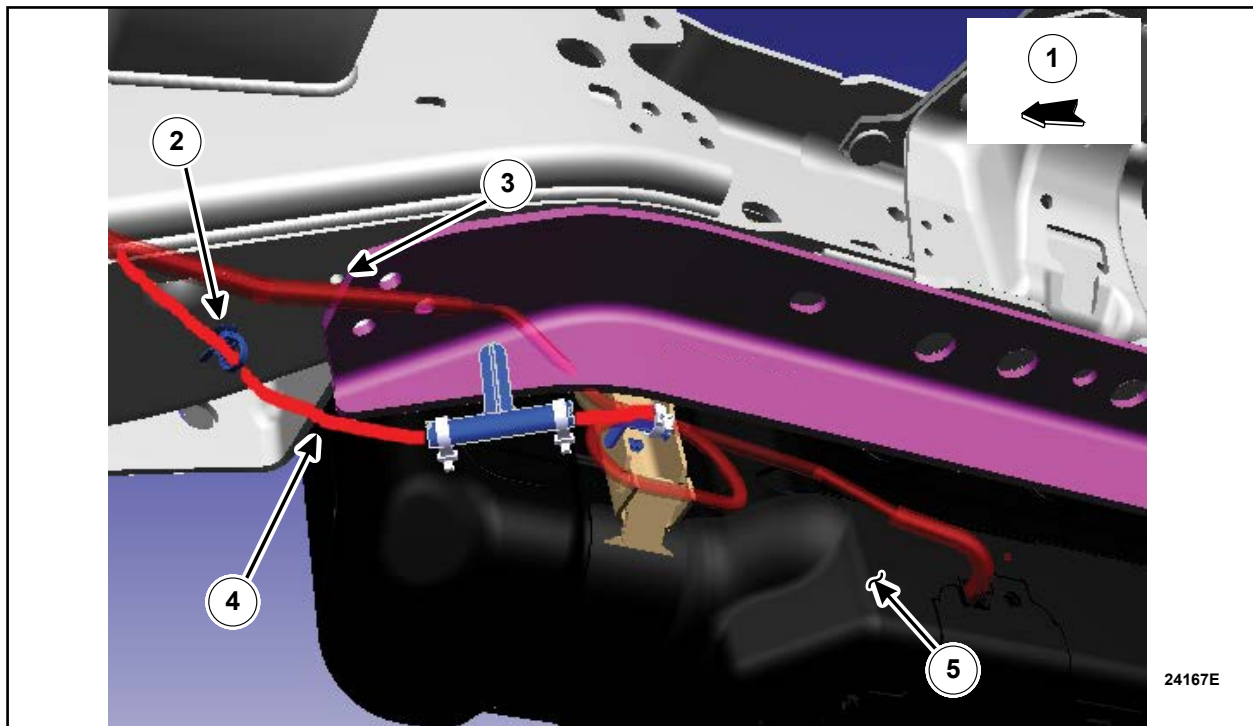
FIGURE 19

- (1) Front of Vehicle.
- (2) Relocate retainer hole in this location.
- (3) Original DEF pressure line retainer hole.
- (4) New DEF pressure line routing.
- (5) Reductant tank.

3. Using a drill and an 8mm (0.31 in) bit, drill a *new* hole location, for the *new* routing clip, forward of the lower frame rail bracket. Using a small brush and Motorcraft® High Temperature Anti-Corrosion Coating (PM-13-A), apply the coating in and around the hole that was just drilled, to cover any bare metal present from the drilling of the hole. Then, install the supplied push pin zip tie into the new hole location and position the DEF pressure line and secure in place with the zip tie as shown in Figure 17.

NOTE: The *new* drill hole location should be determined by positioning the DEF pressure line in its natural relaxed position toward the frame and marking a location for the *new* drill hole, forward of the *new* reinforcement bracket as shown in Figure 19.

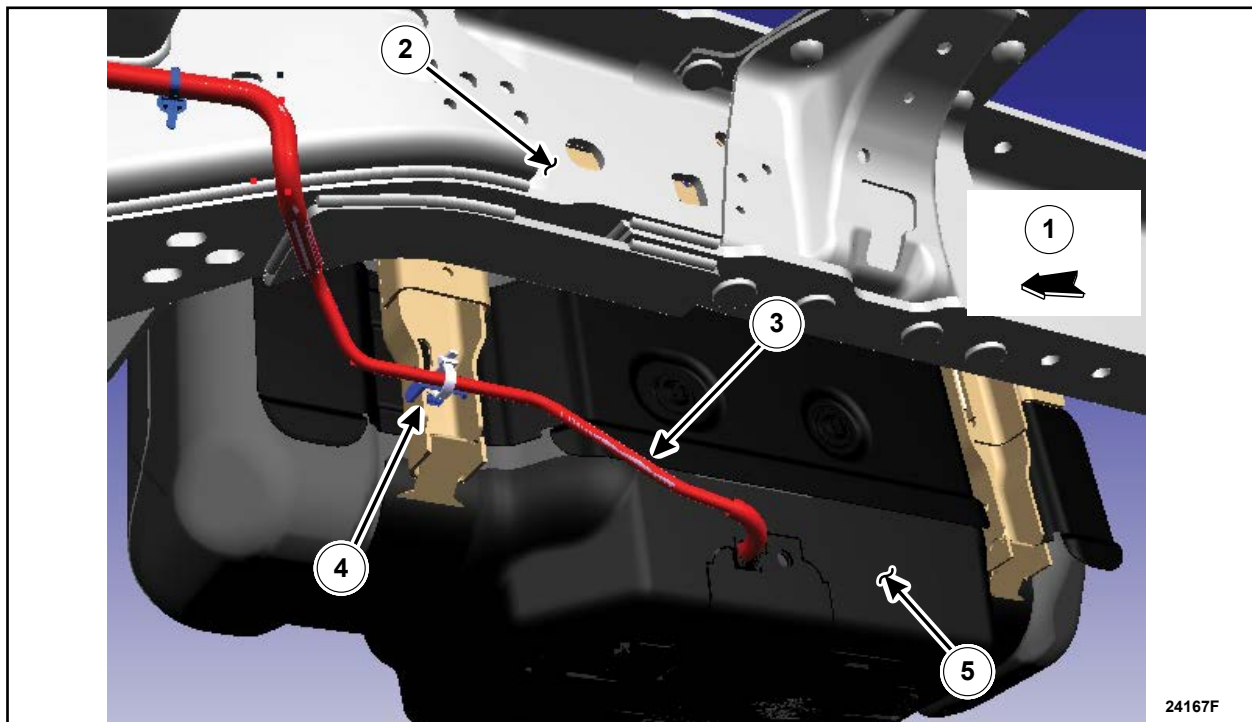
FIGURE 20

- (1) Front of Vehicle.
- (2) Right hand frame rail.
- (3) DEF pressure line.
- (4) Remove and discard the clip and zip tie.
- (5) Reductant tank.

1. Remove and discard the clip and zip tie from the area shown in Figure 20.

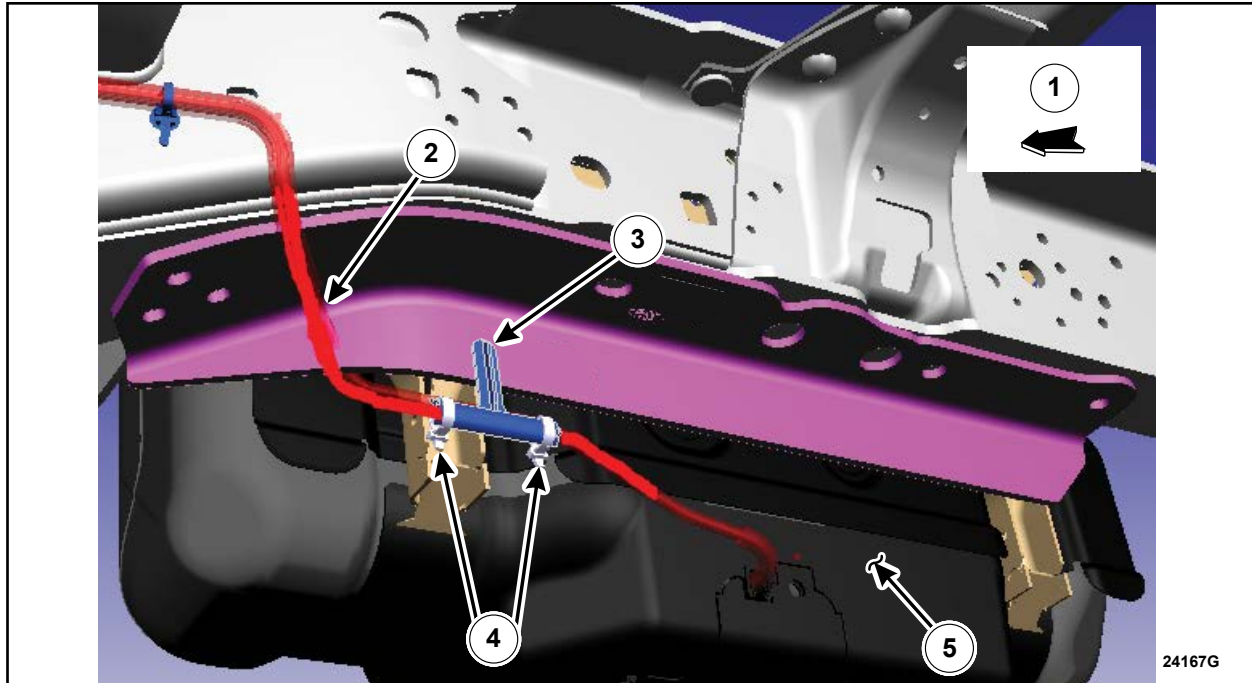
FIGURE 21

- (1) Front of Vehicle.
- (2) New DEF pressure line routing.
- (3) T clip location.
- (4) Attach the T clip to the line using zip ties.
- (5) Reductant tank.

2. Once the RH side lower bracket has been installed, install the supplied T clip to the existing hole in the lower reinforcement bracket and route the DEF pressure line toward the T clip and attach the T clip to the DEF pressure line with two (2) of the supplied zip ties as shown in Figure 21.

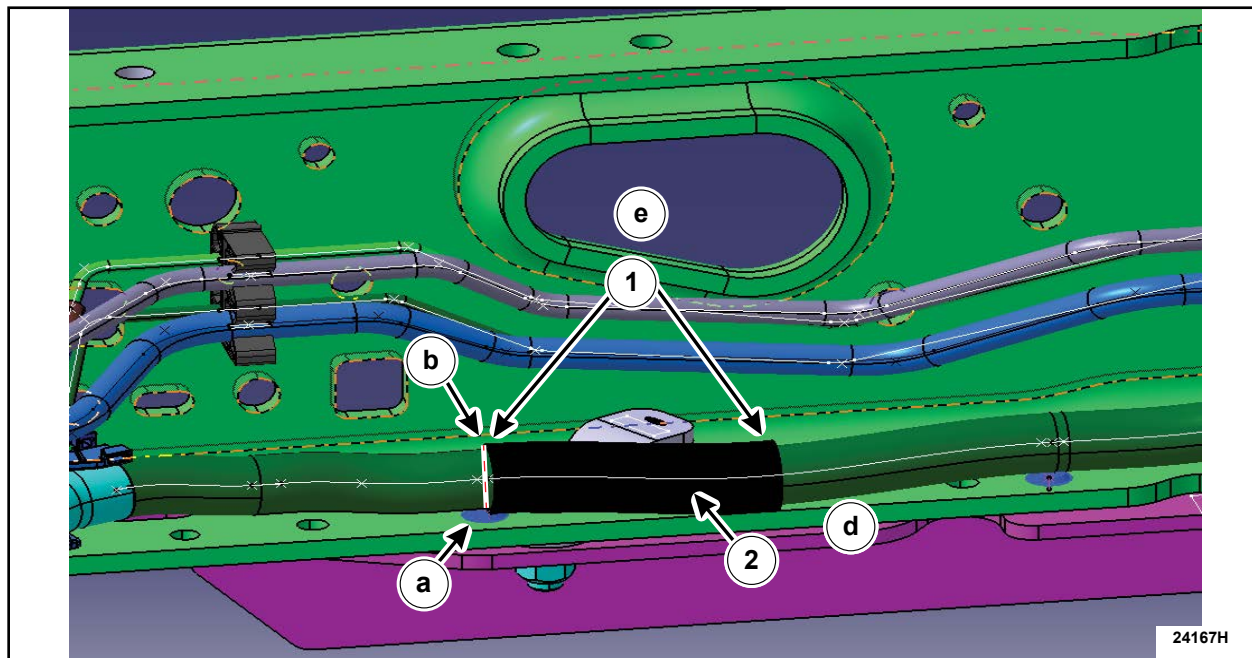
FIGURE 22

- (1) Secure both ends with anti-abrasion tape.
(2) 100 mm long crush shield.

- Remove the tie strap push pin (a) from the hole indicated in Figure 22.
- Mark the location of the push pin on the harness (b).
- Cut off the existing push pin from the harness removed in sub-step a.
- Install the provided crush shield (d) on the harness with the rear edge of the shield aligning the mark made in second bullet point (above). See Figure 22.
- Secure both ends of the crush shield with the supplied Coroplast Tape (e).
- Install the supplied push pin zip tie in same location as the previously marked (original) location on the harness (b).

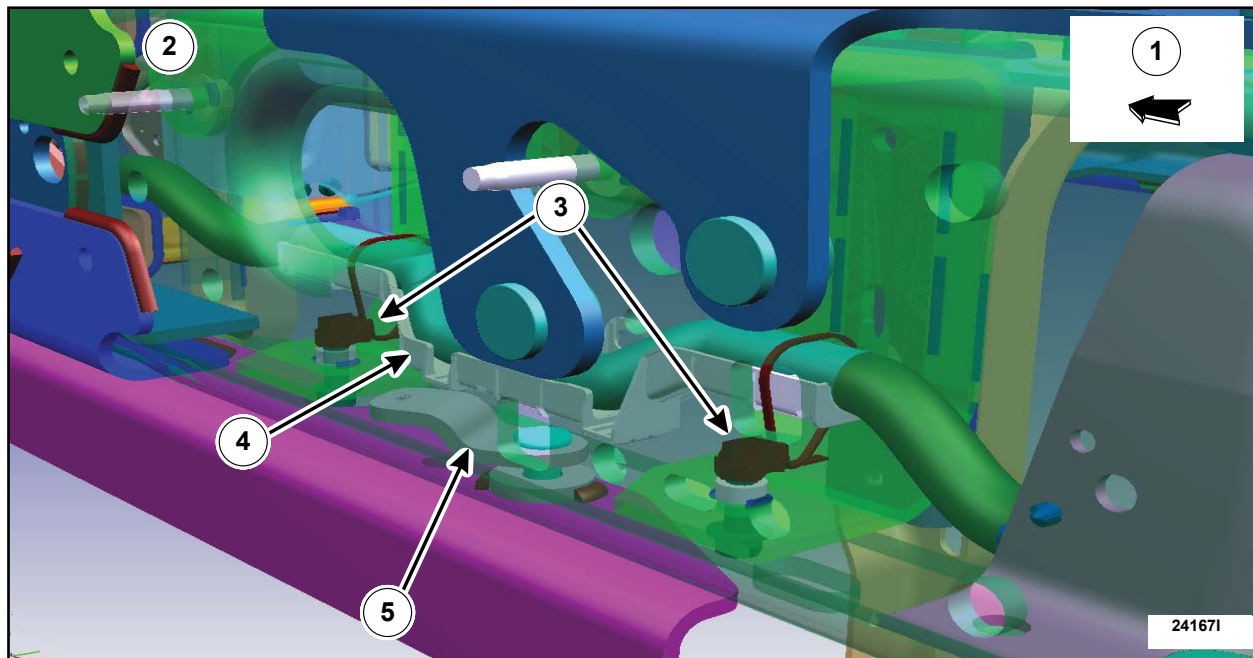
FIGURE 23

- (1) Front of Vehicle.
- (2) Left hand side frame rail transparent view.
- (3) Stud clip locations and inboard direction.
- (4) Wire harness shield.
- (5) Lower bracket rear flag stud.

- a. Position the supplied stud clips onto the studs with the zip ties side facing inboard as shown in Figure 23.
- b. Secure the harness to the stud clips with the zip ties.
- c. Ensure that the harness shield is positioned above the flag stud and the stud clips are fully seated on the studs.

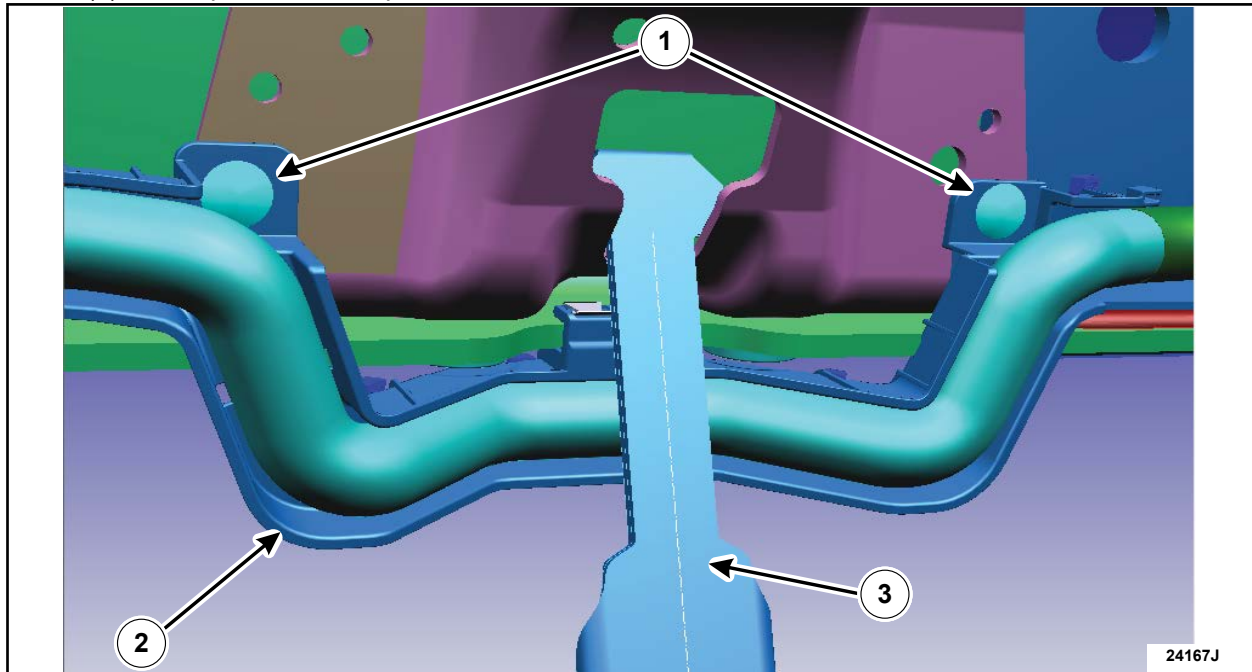
FIGURE 24

- (1) Harness shield push pins.
- (2) Wiring harness shield.
- (3) Mid ship fuel tank strap.

1. From the left hand side lower frame rail, remove the harness shield push pins as shown in Figure 24.

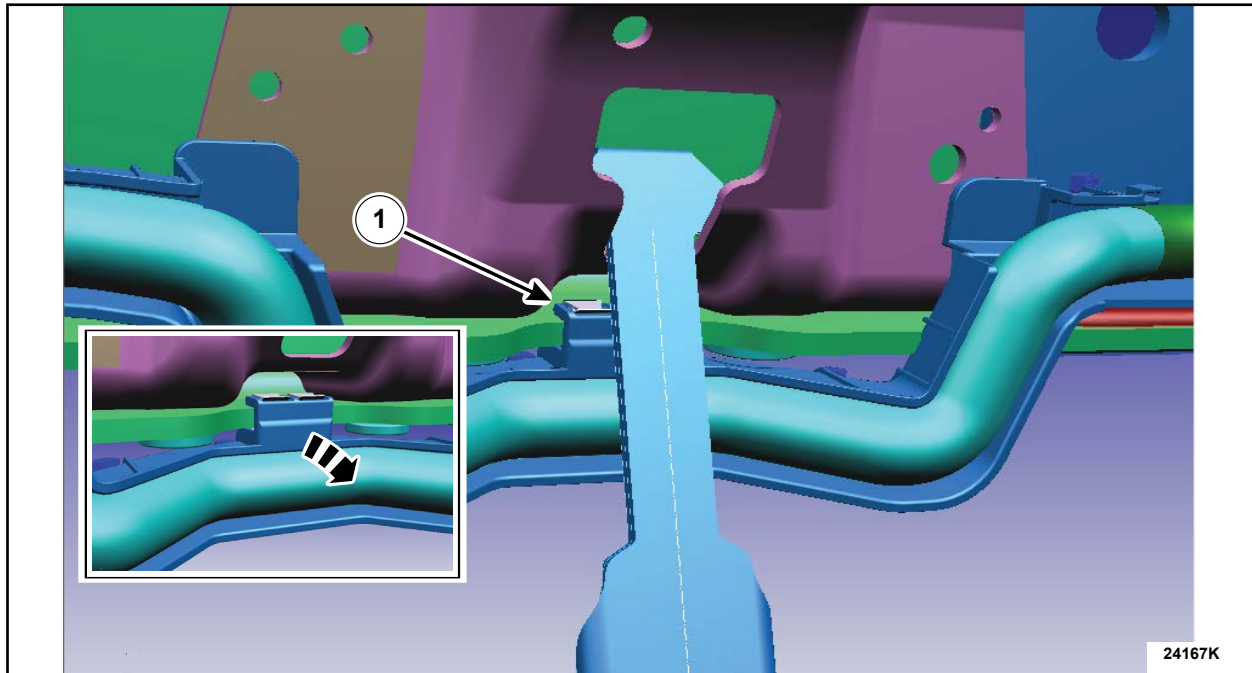
FIGURE 25

(1) Edge biter.

2. Detach the edge biter clip from the frames lower flange as shown in Figure 25.

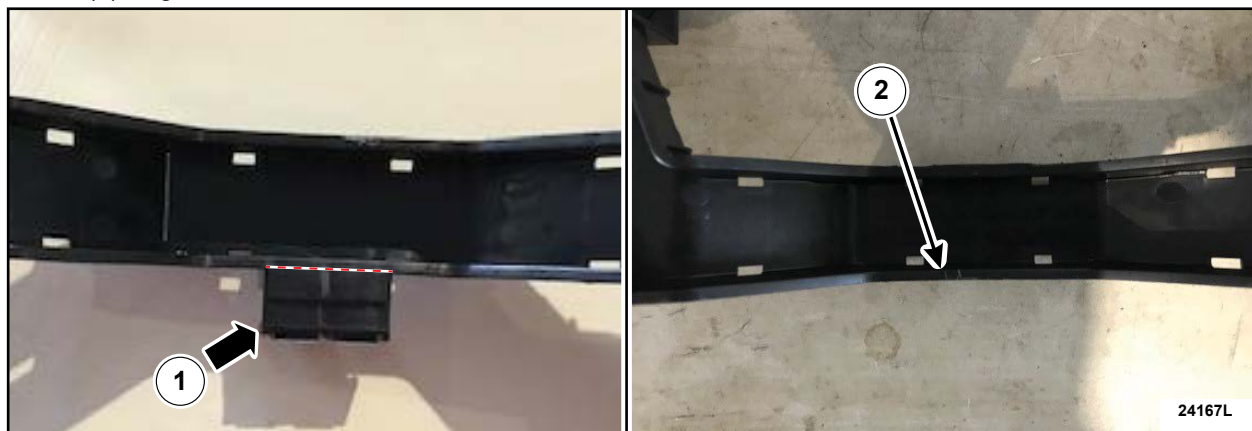
FIGURE 26

(1) Remove the edge biter.

(2) Edge biter removed.

4. Using a suitable cutting tool, remove the edge biter clip flush with the surface of the harness shield as shown in Figure 26.

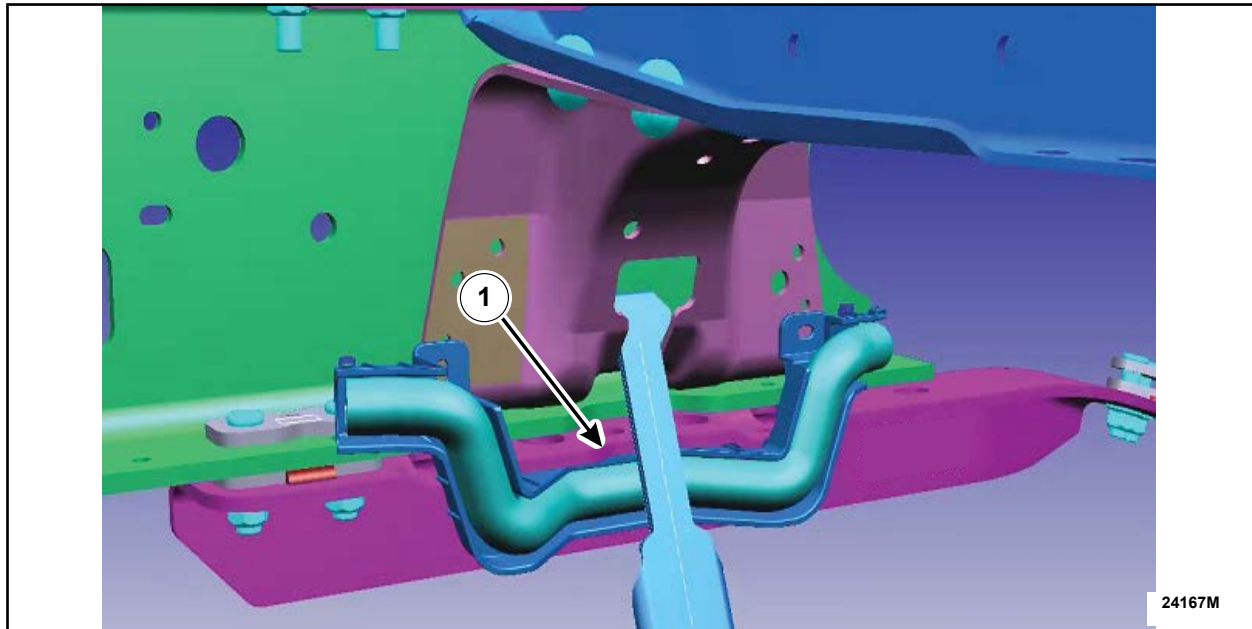
FIGURE 27

(1) Position the shield under the frame rail bracket.

5. Reattach the shield to the harness, in the same locations as they were removed from in Step 3, using seven (7) of the similar supplied tie straps.
6. Once the frame rail bracket has been installed, position the middle of the harness shield under the frame rail bracket as shown in Figure 27. Then, using two (2) of the supplied tie straps, secure the harness shield in the same location as the push pins were removed from in Step 1.

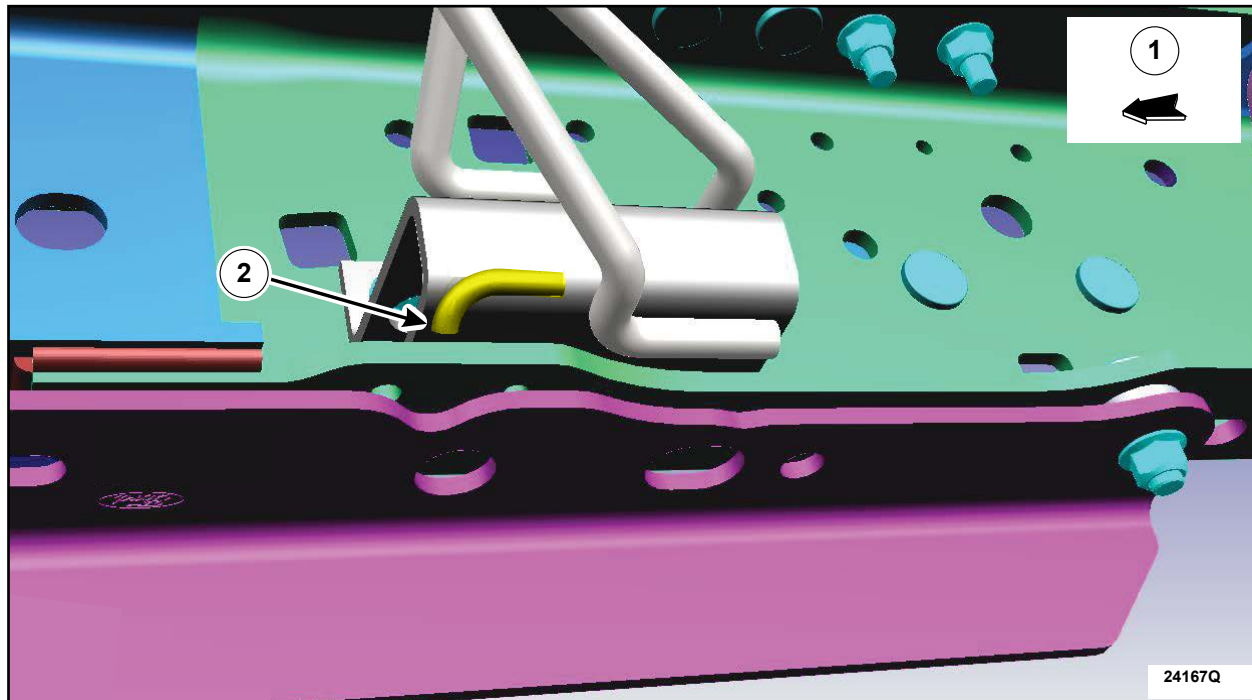
FIGURE 31

- (1) Front of Vehicle.
- (2) Final result.

3. Figure 31 shows the final result once the exhaust hanger portion is removed.
