SERVICE BULLETIN

APPLICABILITY: 2020+ MY Legacy & Outback
 2022+ MY WRX (A/T Only)
 2019+ MY Ascent

NUMBER: 16-151-24R

SUBJECT: TR690 Chain Slip, Judder, Shudder, & Hesitation Concerns

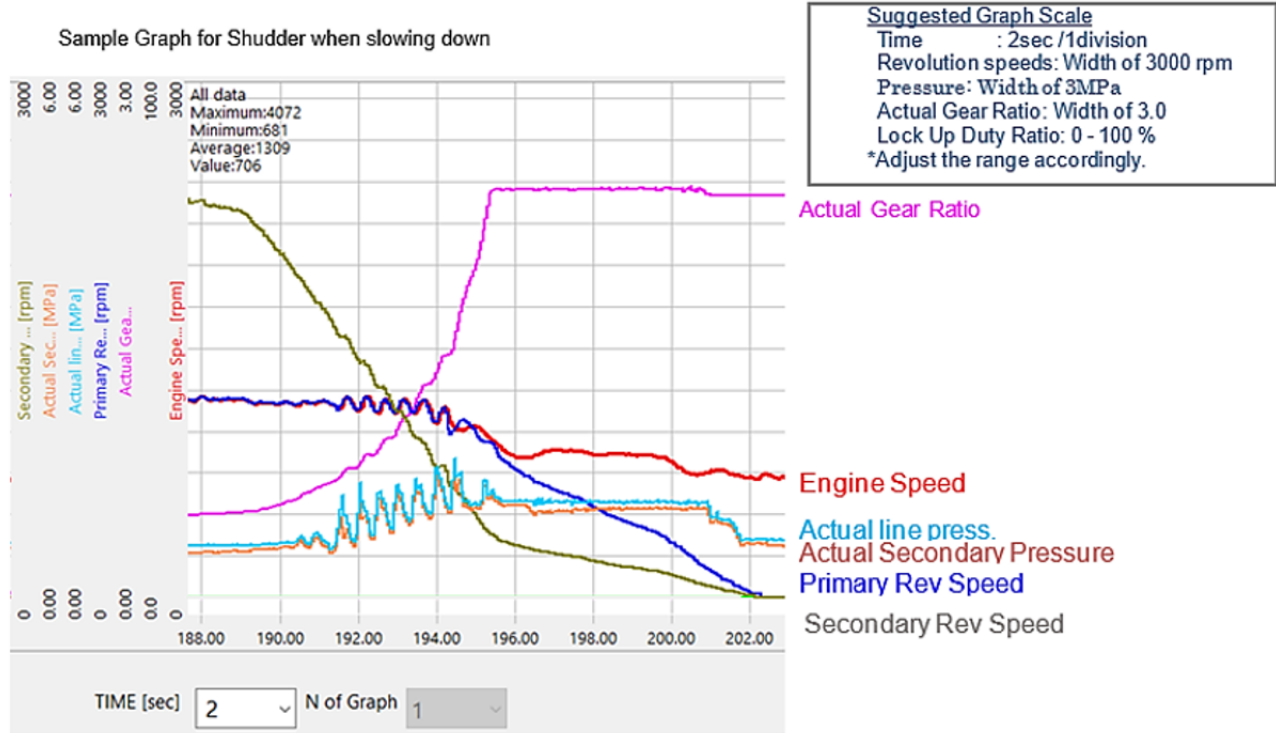
**A jerk or judder sensation felt from the powertrain during braking
with the air conditioning on.**

IMPORTANT: 2023-24MY Legacy & Outback 2.4L, 2023-24MY Ascent, and 2023-24MY WRX vehicles, refer to TSB 16-150-24
