Subject: MYMAZDA APP CONNECTED VEHICLE ERROR CODE DESCRIPTION AND RECOVERY INFORMATION	Service Alert No.: SA-040/26
	Last Issued : 06/15/2026

DESCRIPTION

Some customers may experience a Connected Vehicle failure. The MyMazda App may display an Error Code. This document provides Error Code description and recovery information to assist with repairs.

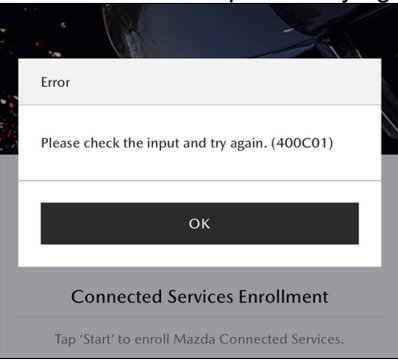
400C01

Description	It occurs when customer's input contains invalid value or there is blank at required items.	
MyMazda App Message	<p>Please check the input and try again. (400C01)</p>

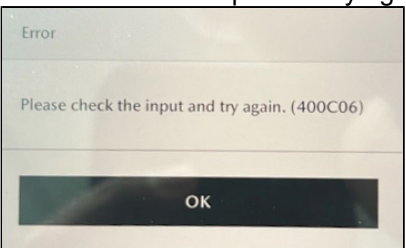
<p>MyMazda App Message</p>	<p>Please check the input and try again. (400C06)</p>

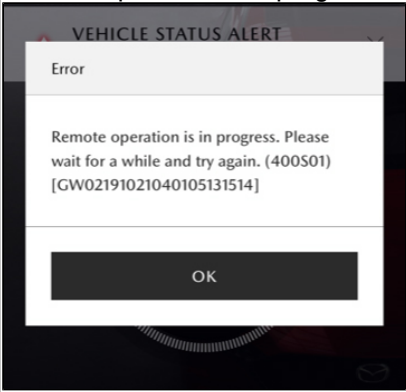
400S01

<p>Description</p>	<p>Occurs when the next remote operation is performed before the previous remote operation request has completed. In addition, it occurs in the following cases; All steps were not completed when replacing the TCU, and keys could not be exchanged.</p>	
<p>MyMazda App Message</p>	<p>Remote operation is in progress. Please wait for a while and try again. (400S01)</p>

<p>Only one remote request can be completed per 60-second period.</p>	
<p>Cause</p>	<p>Multiple execution of remote control.</p>	
<p>Process Flow</p>

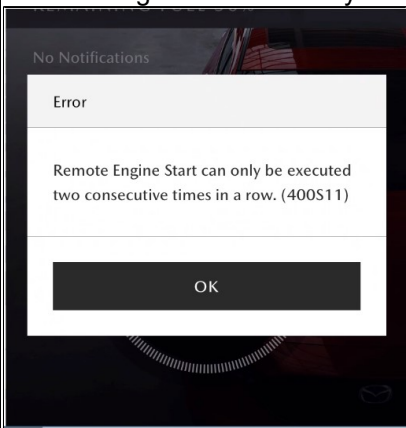
<p>MyMazda App Message</p>	<p>Remote Engine Start can only be executed two consecutive times in a row. (400S11)</p>

<p>If Remote Engine Start is used, the engine will stop running automatically after 15 minutes for safety, security and emissions. Remote Engine Start can only be used 2 consecutive times while the vehicle is not driven. After the vehicle has been driven, the use count is reset.</p>	
<p>Cause</p>	<p>Exceeded the number of times the remote engine start.</p>	
<p>Process Flow</p>

<p>Confirmation/ Recovery</p>	<p>Customer</p>	<p>Check whether the request operation has been performed more than 3 times. Check whether the following conditions (required conditions for execution) are met.</p> <ul style="list-style-type: none"> • The vehicle has stopped after driving for more than 100 meters. • 24 hours have passed since the last execution <p>Turn on IG-on, check the reception strength icon at the bottom right of the center display.</p>

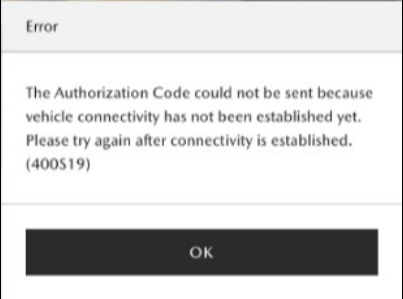
400S19

<p>Description</p>	<p>This occurs when an OTP display request is made when the vehicle is not ready for OTP display (opening process/blocking process/blockage error). *OTP = one time passcode Main factors:</p> <ul style="list-style-type: none"> • TCU exchange is being performed while the usage start process is being executed. • The WiFi contract (In-Car WiFi) is interfering and line operation is failing. 	
<p>MyMazda App Message</p>	<p>The Authorization Code could not be sent because vehicle connectivity has not been established yet. Please try again after connectivity is established. (400S19)</p>

<p>18PF OPENING COMMUNICATION LINE HAS NOT BEEN COMPLETED (OTP request before line opening completed)</p>	
<p>Cause</p>	<p>TCU replacement during OTP process In-Vehicle WiFi Contract interference</p>	
<p>Process Flow</p>
