Service Information Bulletin

B64 04 26

COOLANT HOSE CONTACTS STEERING SHAFT B48

E-Series	Model Description	Production Date	Affected Option Code
G60	530i, 530i xDrive Sedan	Vehicles produced from June 30, 2023	With B48 engine

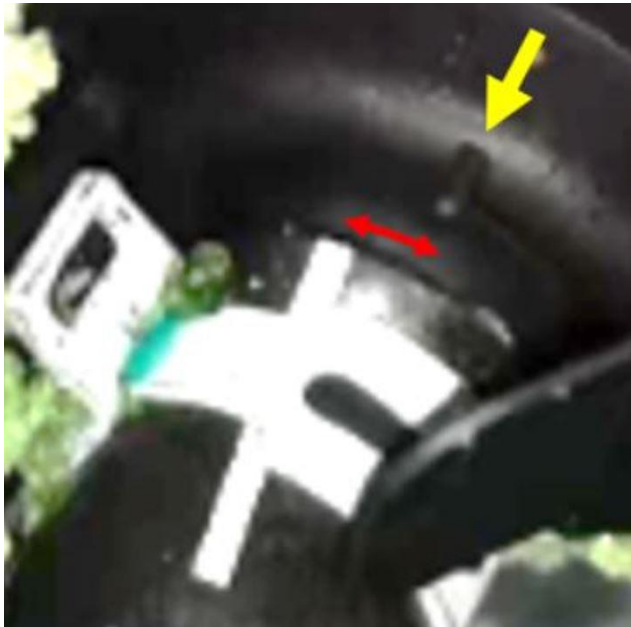
- 1) Check whether the component has been installed in such a way that the two markings (white line on the coolant feed hose and marking on the heating and air conditioning unit connection (yellow arrow)) line up.

Loosen the hose clamp and rotate the hose so that the alignment marks point towards one another.

NOTE 2: If the steering column contact has damaged the coolant hose and may have caused a coolant leak, then the hose must be replaced.
