## WTG2 – Update to Software Package VR28.13 SQ5 (Workshop Campaign)

| Model Year: | <b>As of 2024 up to 2026</b> |
| Model Line: | <b>Macan Electric (XAB)</b> |
| Concerns: | <b>Software update (software package VR28.13 SQ5)</b> |

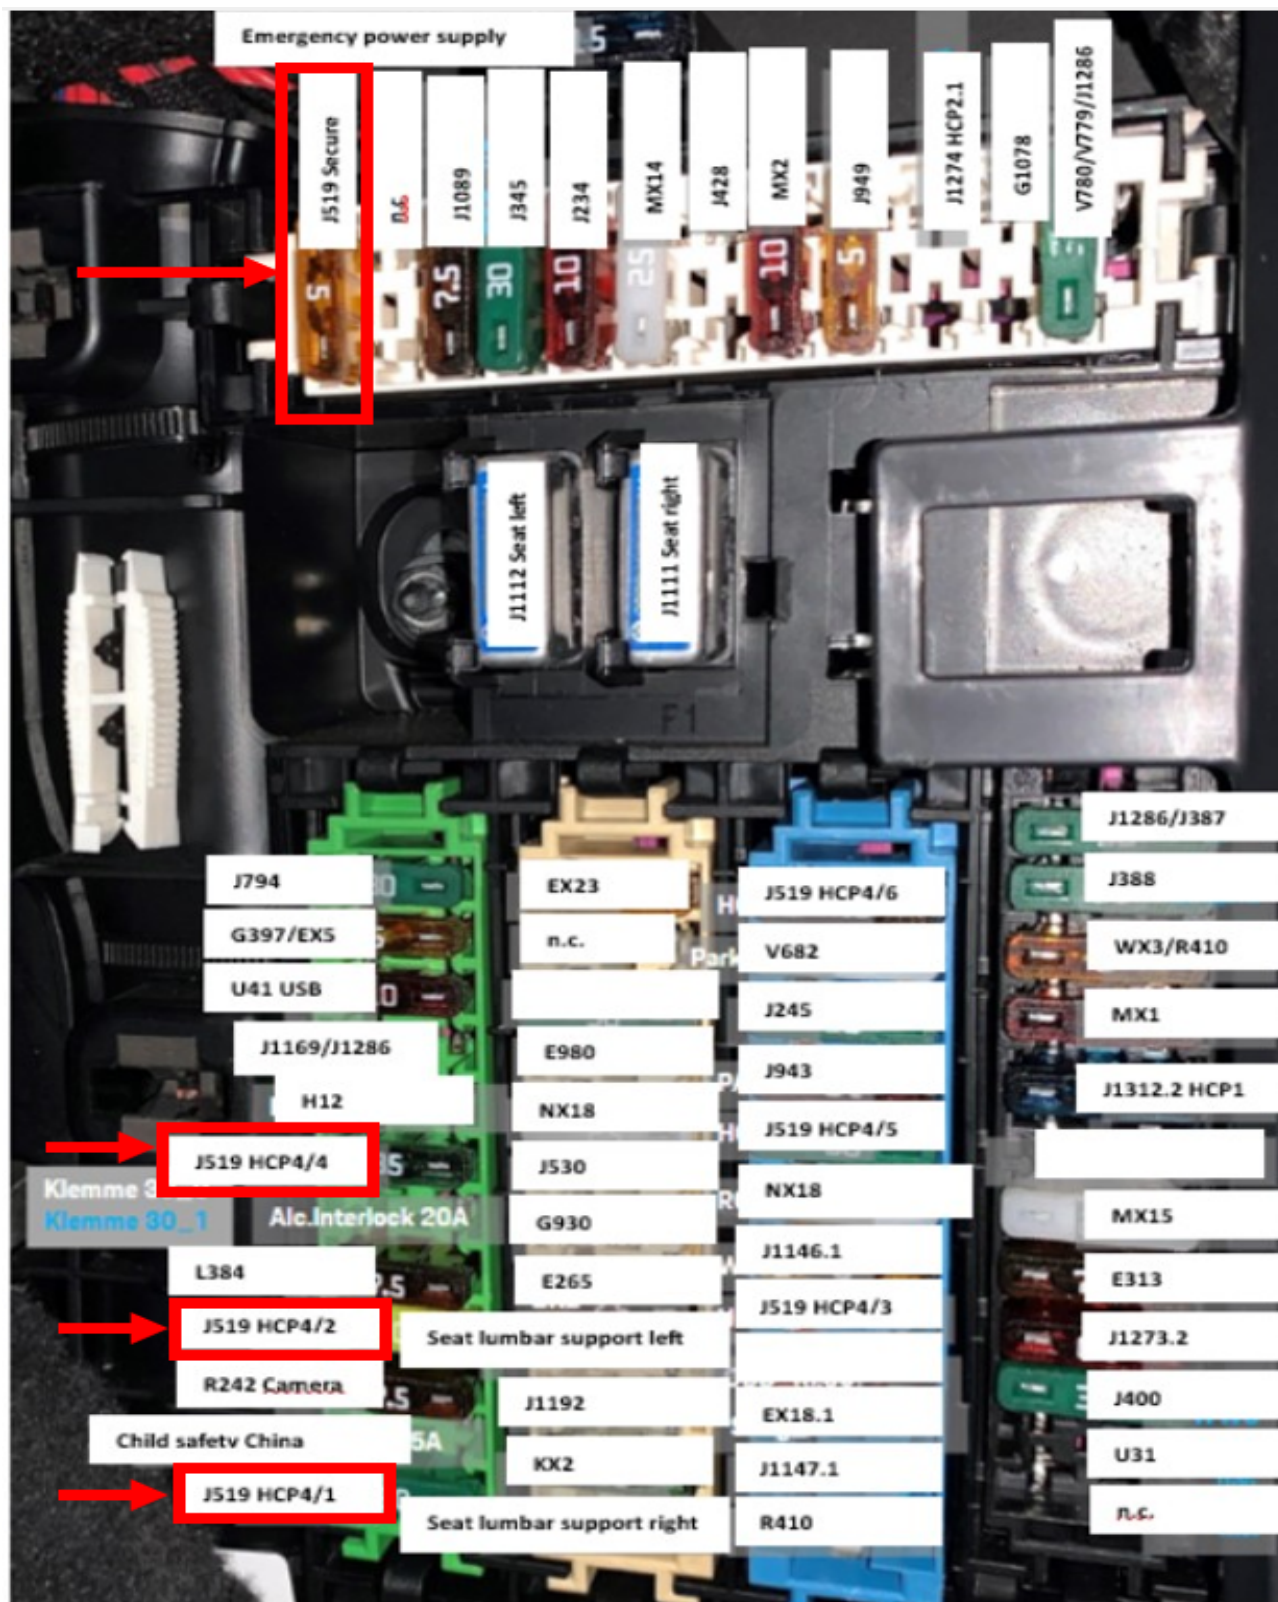
| <p><b>Body electronics main control unit HCP4 (J519)</b> reports programming and coding errors in the results view</p> | <p>The affected control unit was not successfully programmed and coded</p> | <p>Vehicle</p> | <p><b>Do not perform an ignition change!</b> This results in the destruction of the control unit. Remove fuses</p> <ul style="list-style-type: none"> <li>▪ J519 HCP4/1</li> <li>▪ J519 HCP4/2</li> <li>▪ J519 HCP4/4</li> <li>▪ J519 Secure</li> </ul> <p>Pull out, wait 30 seconds and reinsert correctly.<br/><b>The fuses have different parameters and must be</b></p> |

| | | | <p><b>reinserted at exactly the same location</b>; for the correct fuse positions, see: <i>⇒ Fuse positions</i></p> <p>Select <b>"Special function"</b> in the additional menu</p> <p>Campaign code:<br/><b>HCP4_ERROR_KD2</b><br/>and follow the Tester instructions</p> <ul style="list-style-type: none"><li>▪ <b>Please note!</b> HCP4 is therefore programmed, but not coded – <b>do not perform an ignition change!</b></li><li>▪ After successful programming of the control unit in the integration test, re-start using the 'Campaign' function <b>(F5)</b> (if not available, start the 'Repair' function with <b>(F8)</b> )</li><li>▪ After this has been performed successfully, continue with work step 3</li></ul> |
