Technical Service Bulletin: TSB260092

Alternate Viscous Damper Inspection Procedure

- B6.7 CM2450 B155B

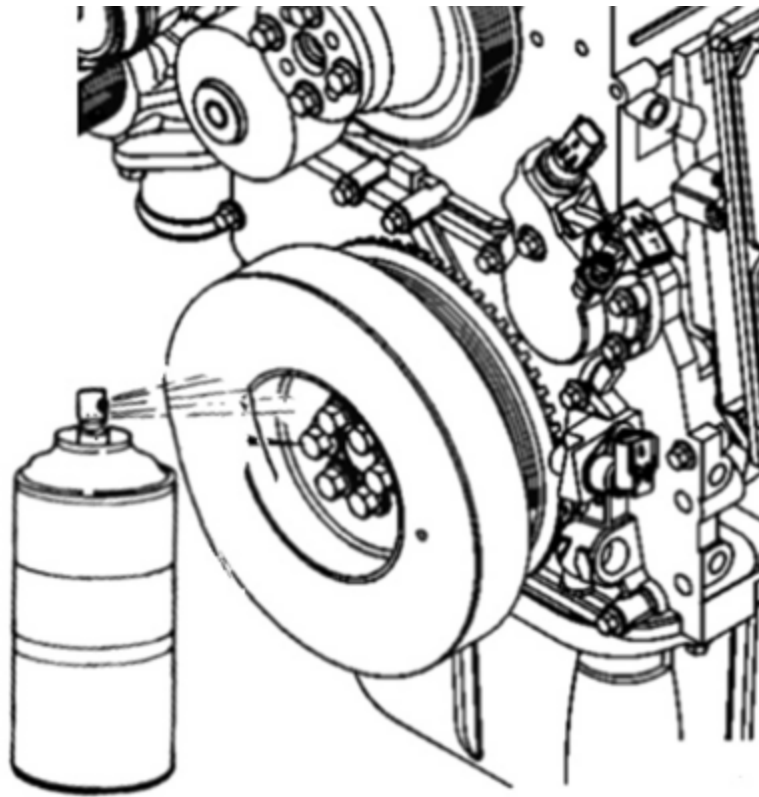
17r02714

Check for any raised surfaces or dents in the viscous vibration damper. Rotate the engine to inspect the entire circumference of the viscous vibration damper

Figure 3, Clean the face of the viscous vibration damper

Refer to Figure 3. Clean the face of the viscous vibration damper.
