Technical Service Bulletin: TSB260076

Pack Management Unit Fault Codes

- BES CM0904 EV104B
- BES CM2450 EV105B
- BES CM2450 EV107B

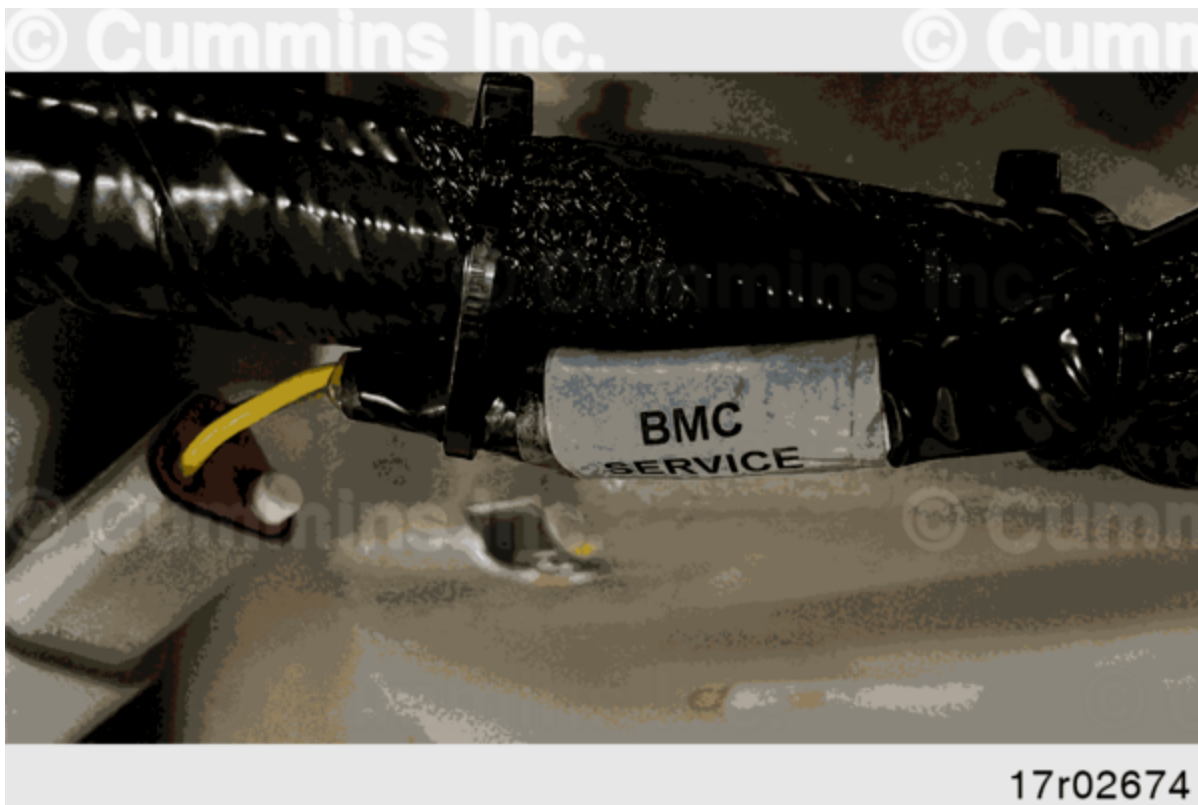
Figure 1, BMC SERVICE Connector

- Connect to pack management unit.
  - Refer to the Calibrate procedure in Energy Storage / Electronic Controls / Pack Management Unit for required tools.
- Disconnect low-voltage connector labeled BMC SERVICE near pack management unit.
- Connect data link 3-pin adapter to BMC SERVICE connector. See Figure 1.

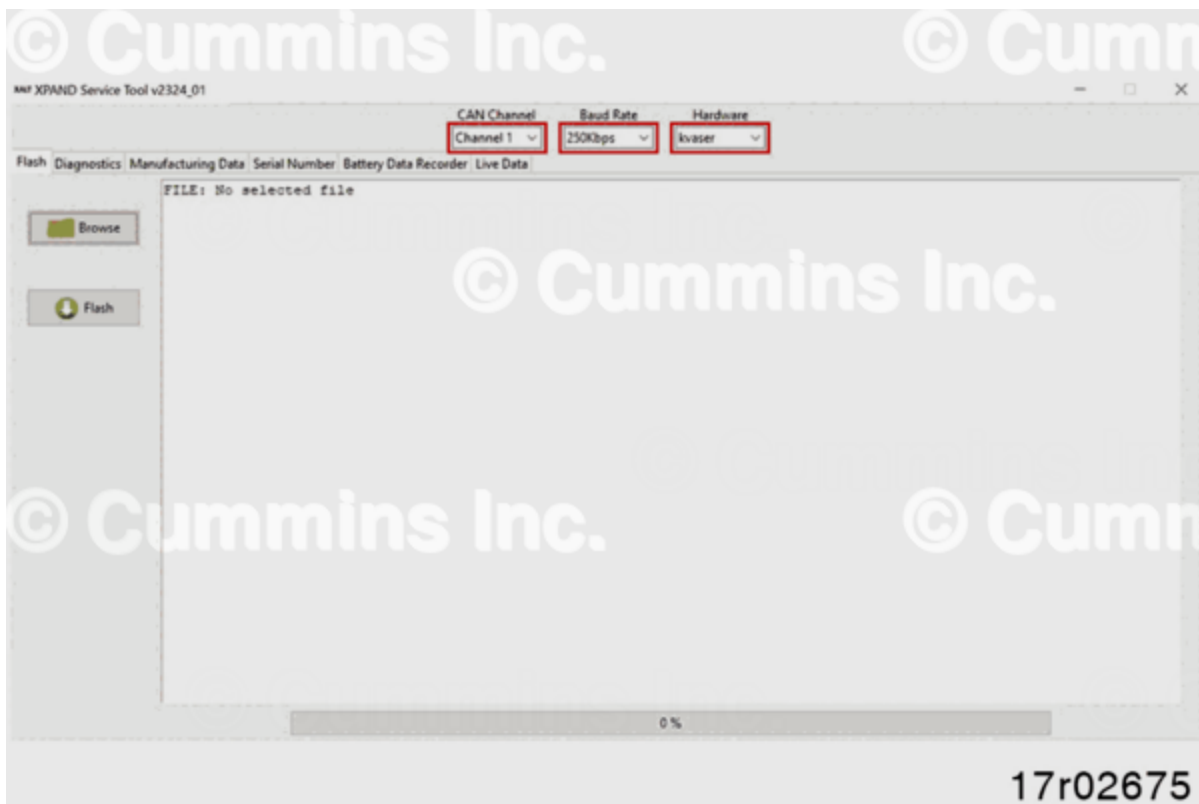
Figure 2, XPAND Service Tool

- Open XPAND service tool
  - Select Kvaser from Hardware section
  - Select 250 kbps from baud rate section
  - Select channel 1 from CAN Channel.
  - See Figure 2.
